Dipole Impedance Measurement

Equipment Location	Equipment Name	Model Name	Date of Verification
UL Verification Services Inc. 47173 Benicia Street Fremont, CA 94538, U.S.A.	Dipole Antenna	D3700V2-1039	October 2, 2023

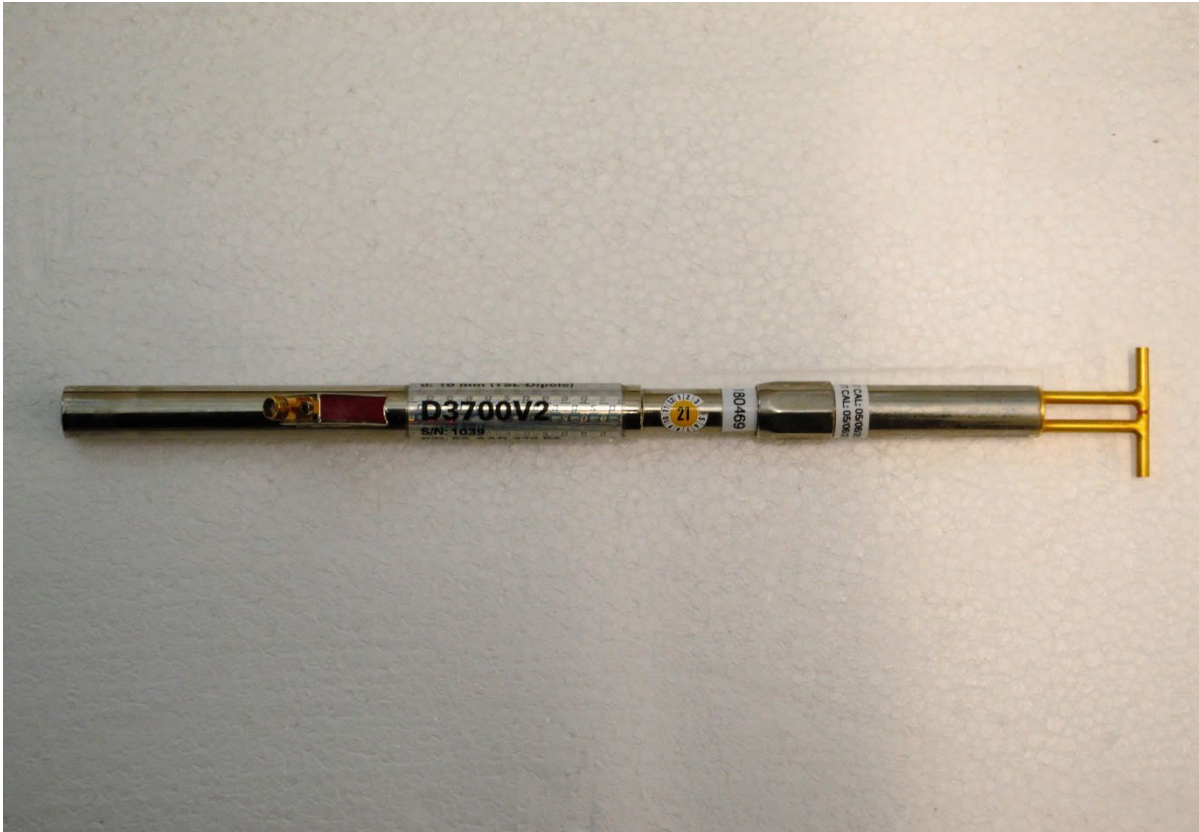
1) Photo of Dipole

- The connector of dipole contains no abnormalities.

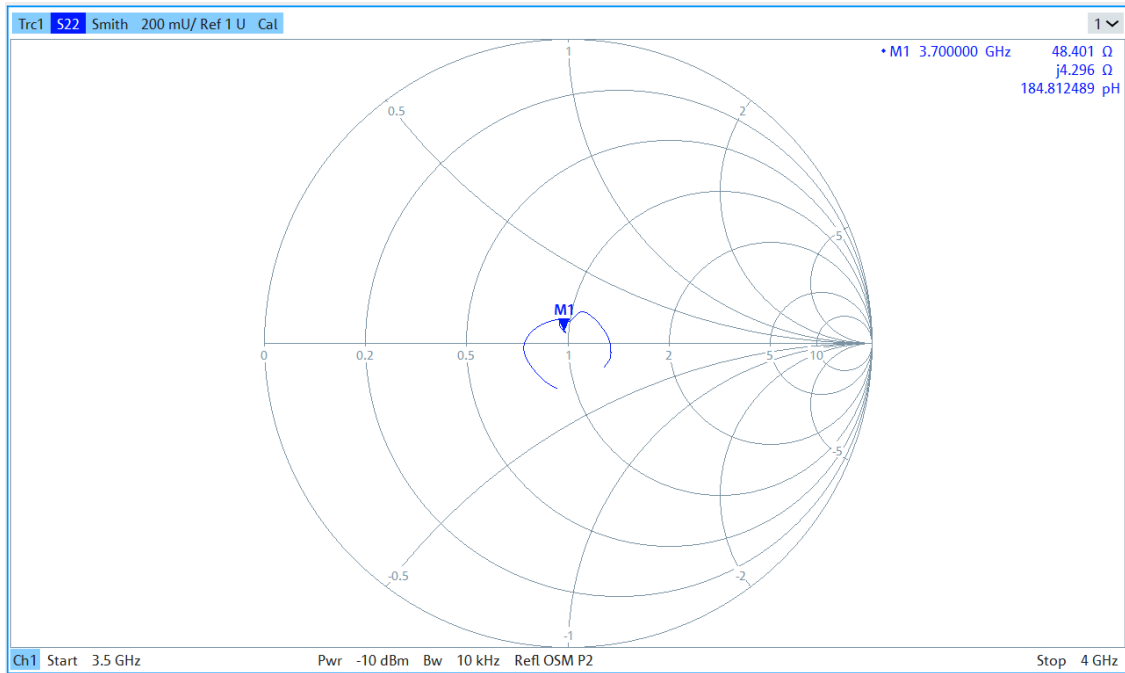
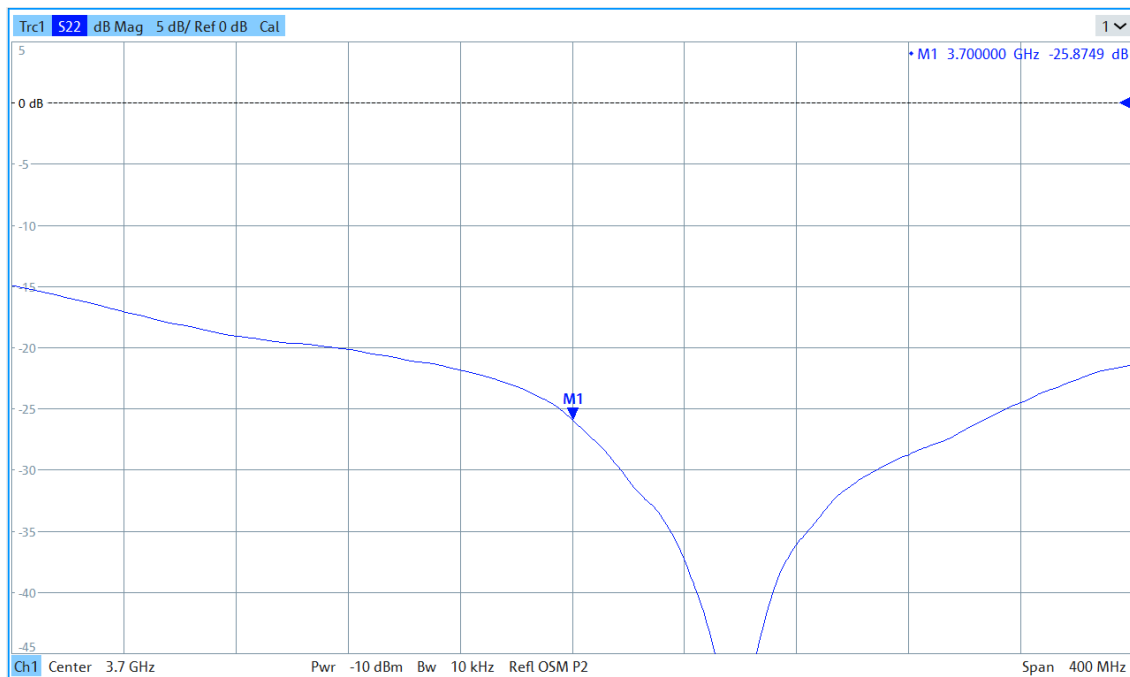
2) Impedance and Return/Loss

- Return/Loss is greater than the -20 dB cutoff and Impedance is within 5 Ω of previous value.
