REPORT ON

Environmental Testing of the McMurdo Limited 406 MHz Fastfind Plus PLB with internal GPS position encoded data and 121.5 MHz Radio locating device

Report No: SX608213 December 2001

TÜV Product Service Segensworth Road Fareham Hampshire United Kingdom PO15 5RH

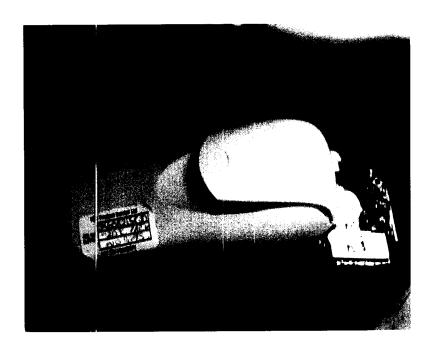
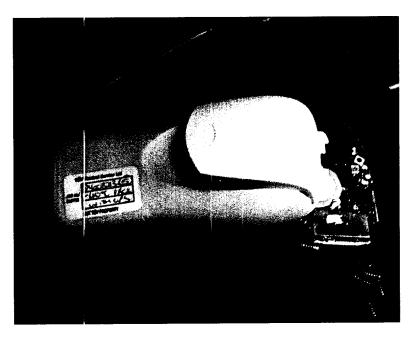
Both failed units were stripped down for visual inspection, (photos below).

These units are pre-production units. Electrically they function exactly as the production standard. There is one wire link salvage to a resistor and a cut track salvage.
