Dipole Impedance Measurement

Equipment Location	Equipment Name	Model Name	Date of Verification
UL Verification Services Inc. 47173 Benicia Street Fremont, CA 94538, U.S.A.	Dipole Antenna	D1900V2-5d140	April 14, 2023

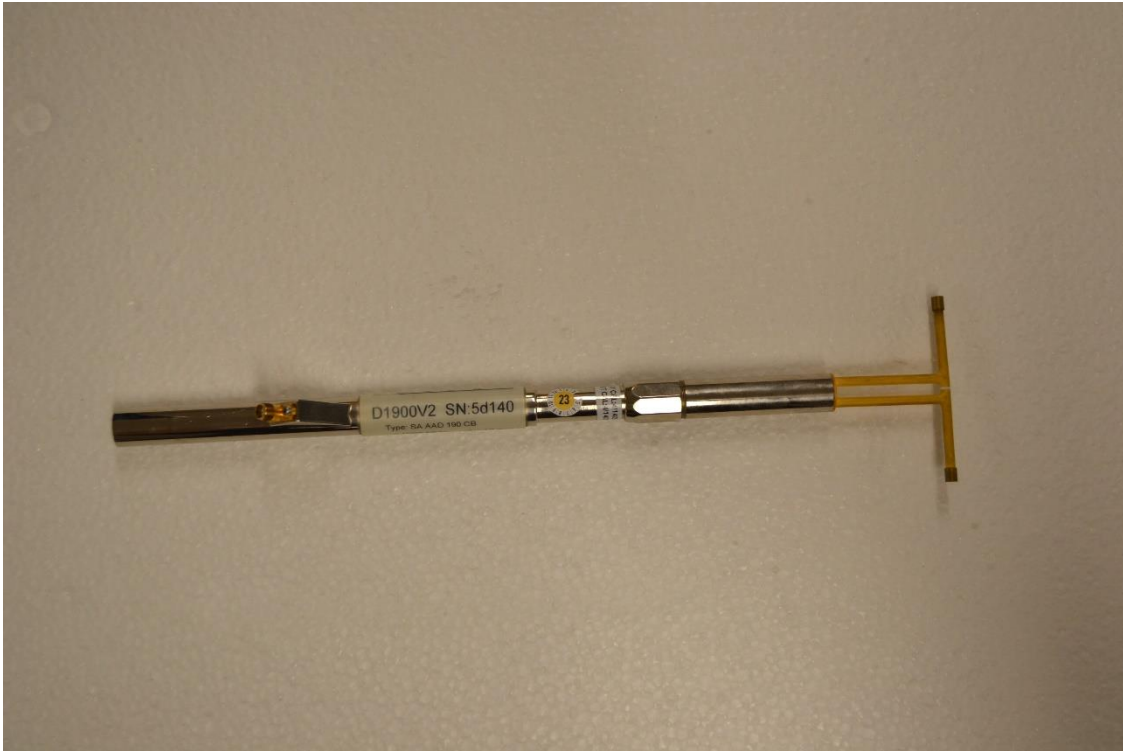
1) Photo of Dipole

- The connector of dipole contains no abnormalities.

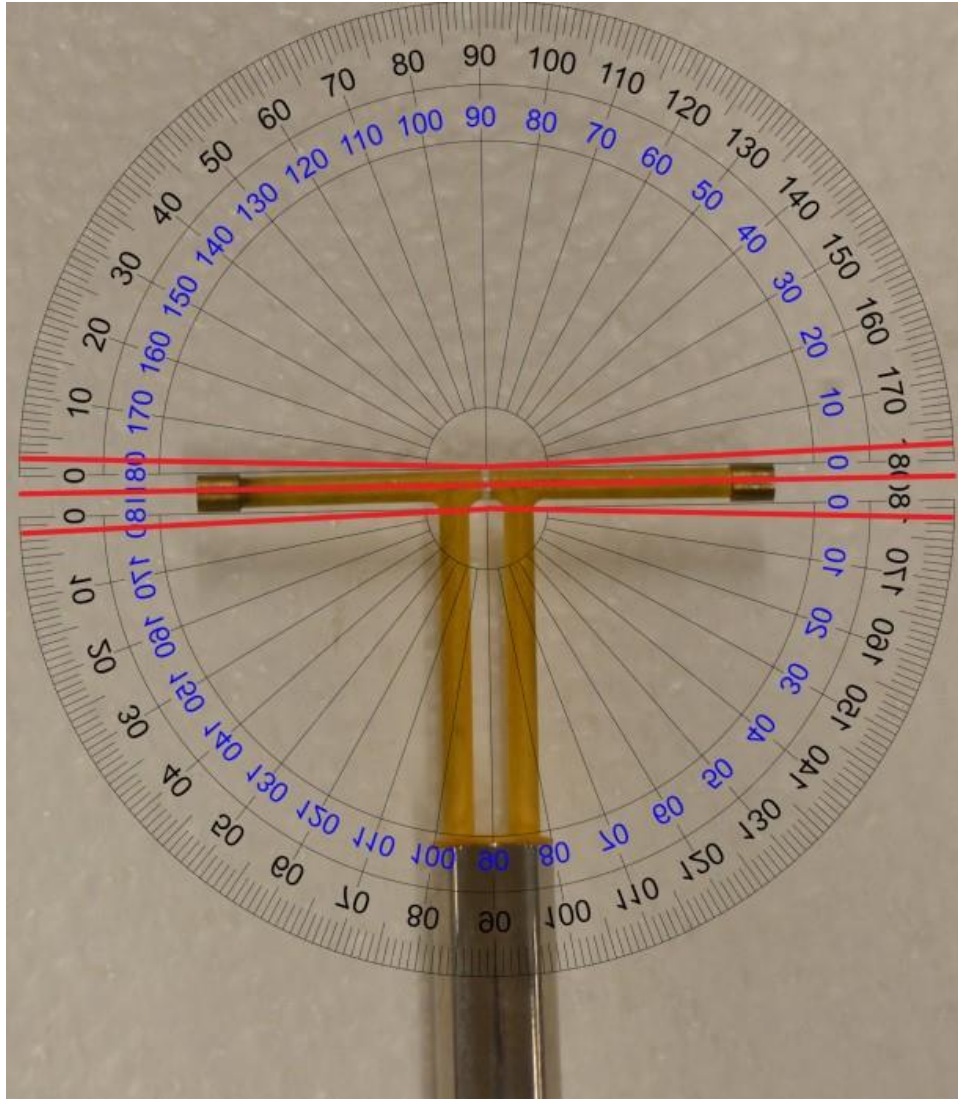
3) Dipole Arms

- The center red line indicates that the arms of the dipole fall within $\pm 2^\circ$

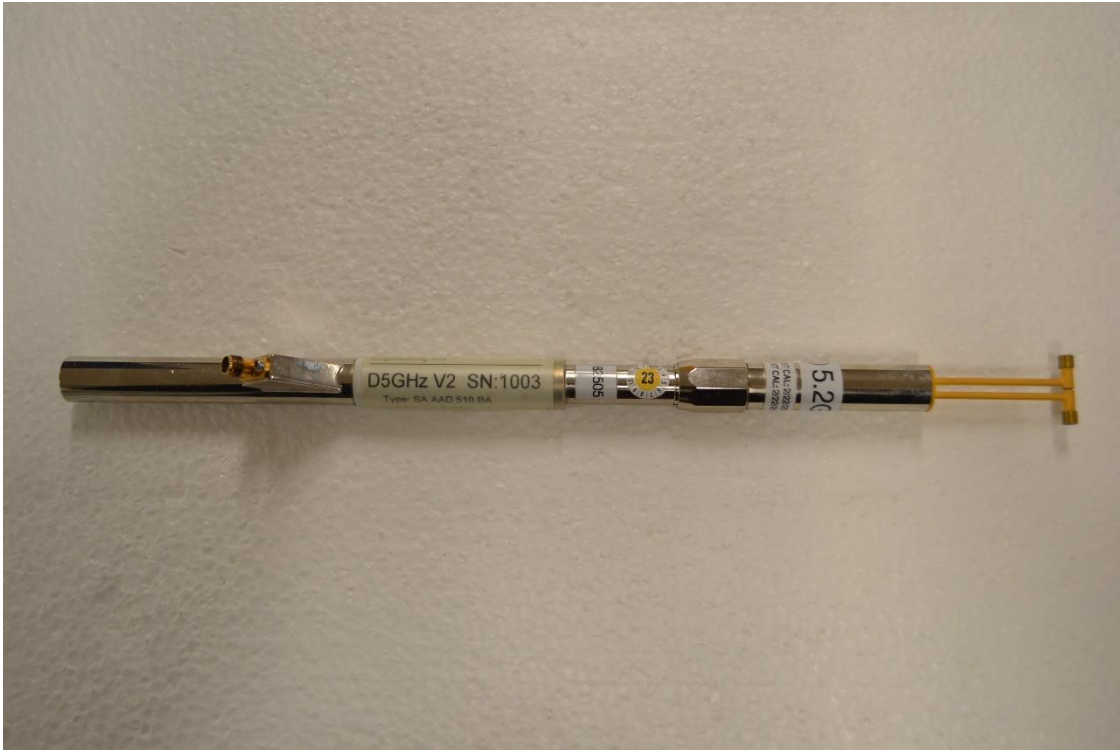
7) Photo of Dipole

- The connector of dipole contains no abnormalities.

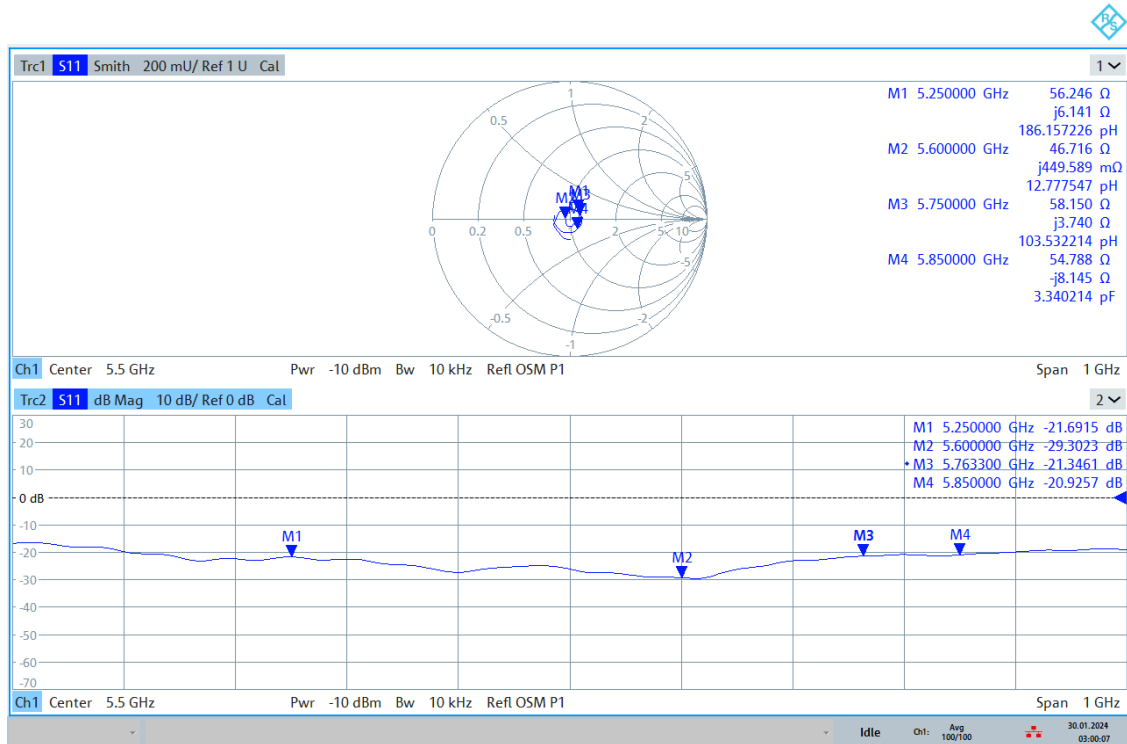
8) Impedance and Return/Loss

- Return/Loss is greater than the -20 dB cutoff and Impedance is within 5 Ω of previous value.

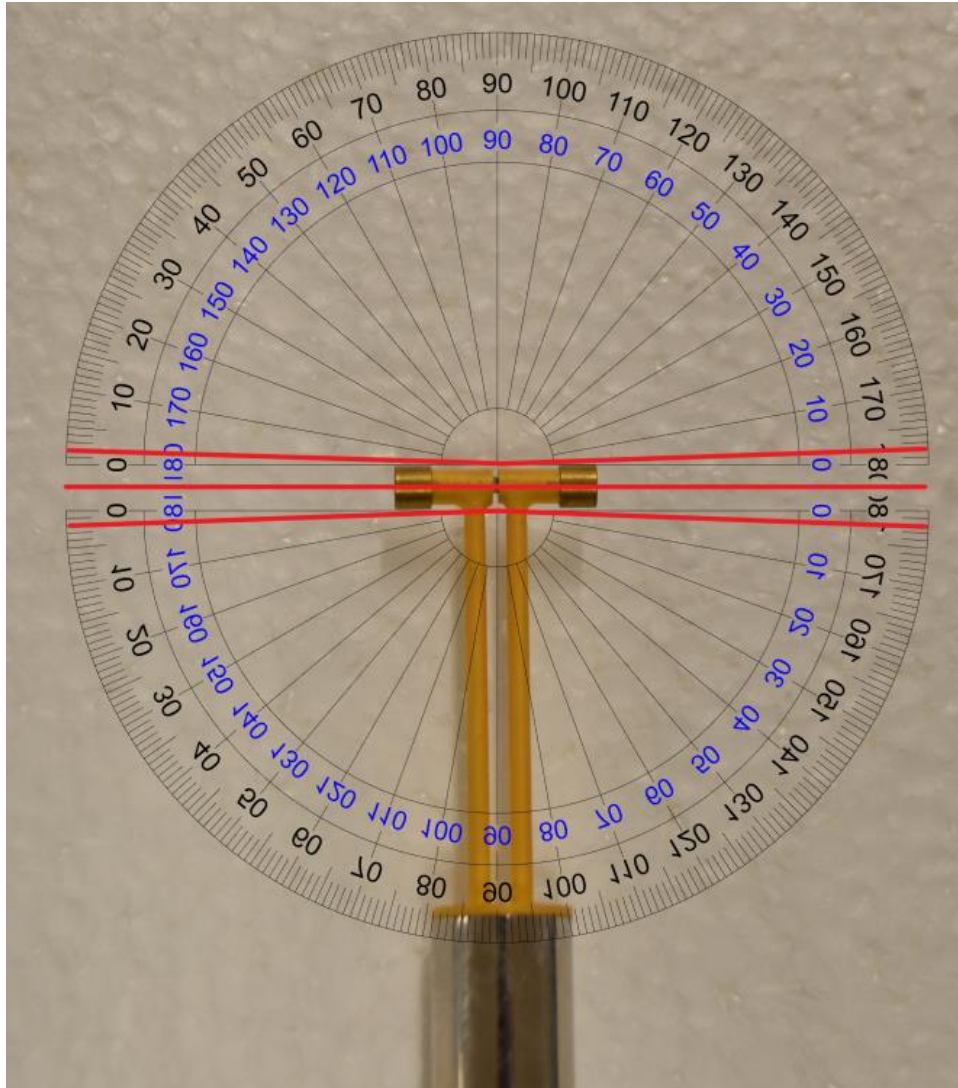
9) Dipole Arms

- The center red line indicates that the arms of the dipole fall within $\pm 2^\circ$

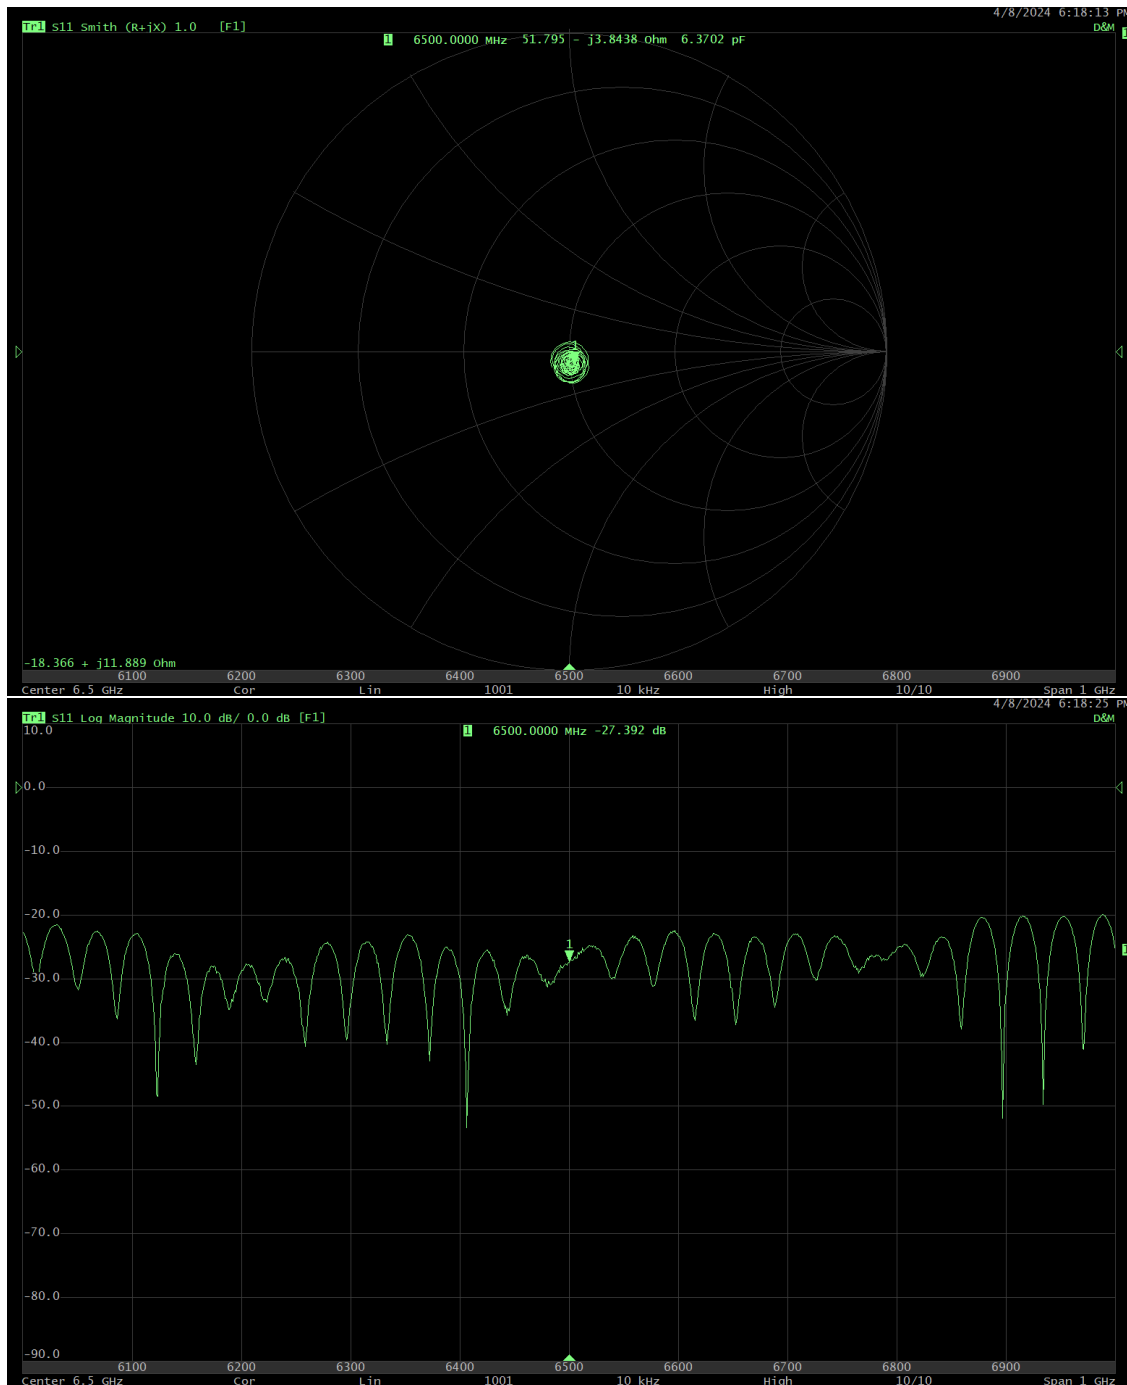
11) Impedance and Return/Loss

- Return/Loss is greater than the -20 dB cutoff and Impedance is within 5 Ω of previous value.

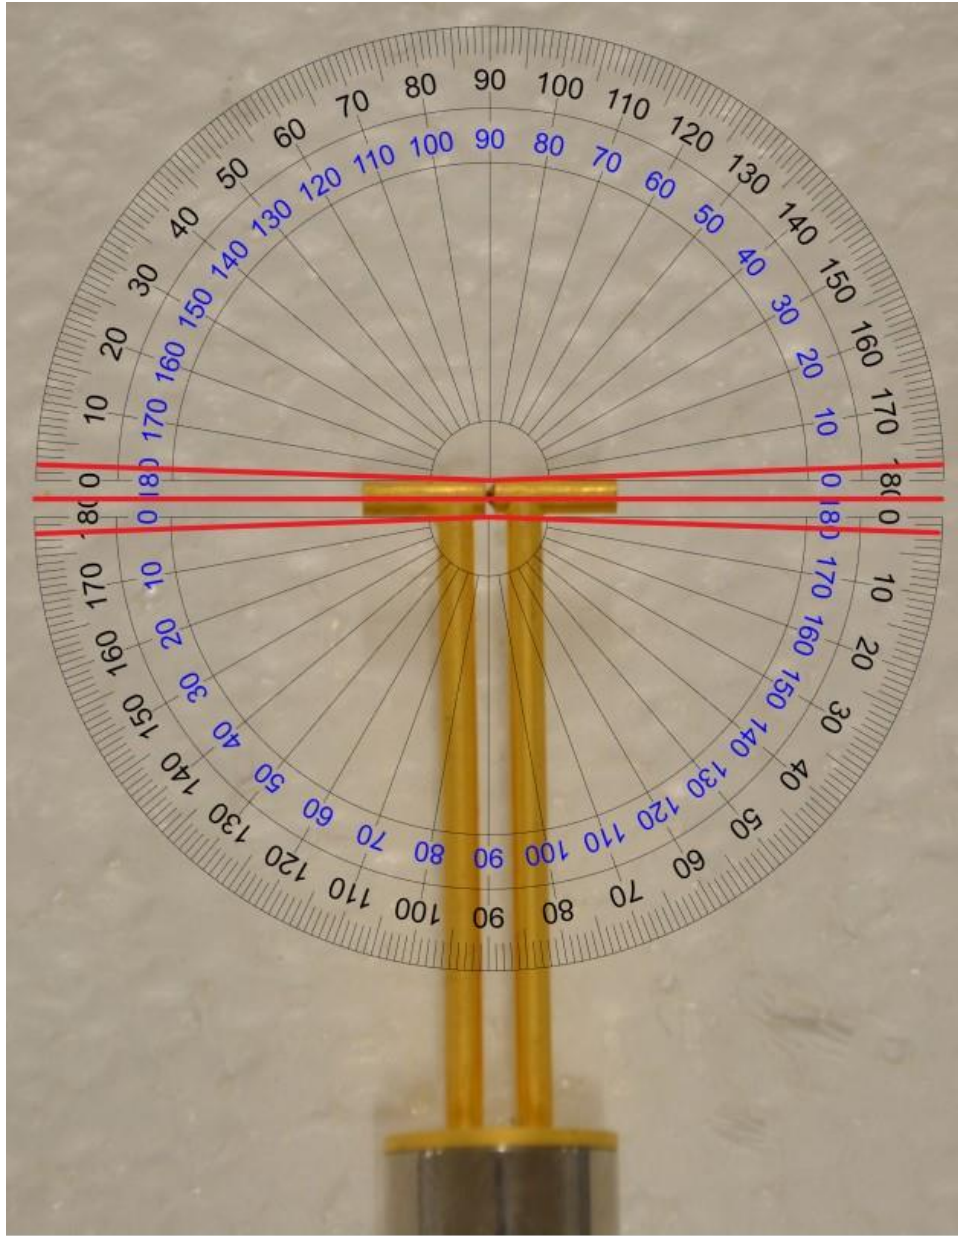
12) Dipole Arms

- The center red line indicates that the arms of the dipole fall within $\pm 2^\circ$

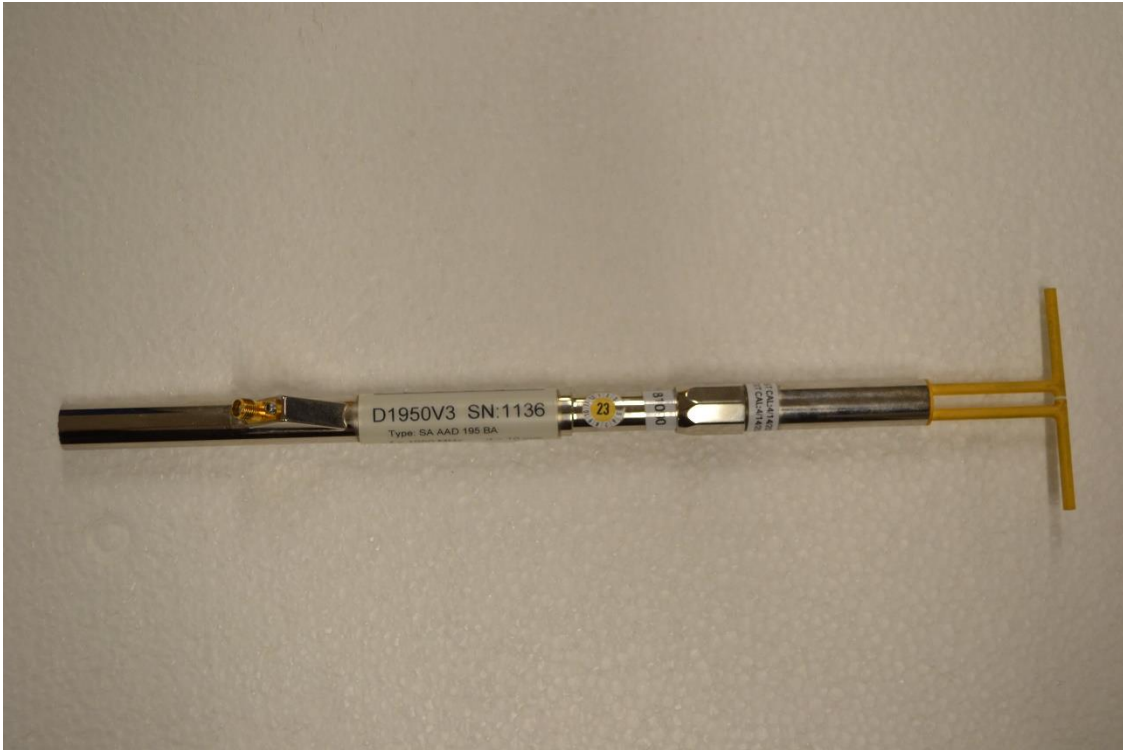
13) Photo of Dipole

- The connector of dipole contains no abnormalities.

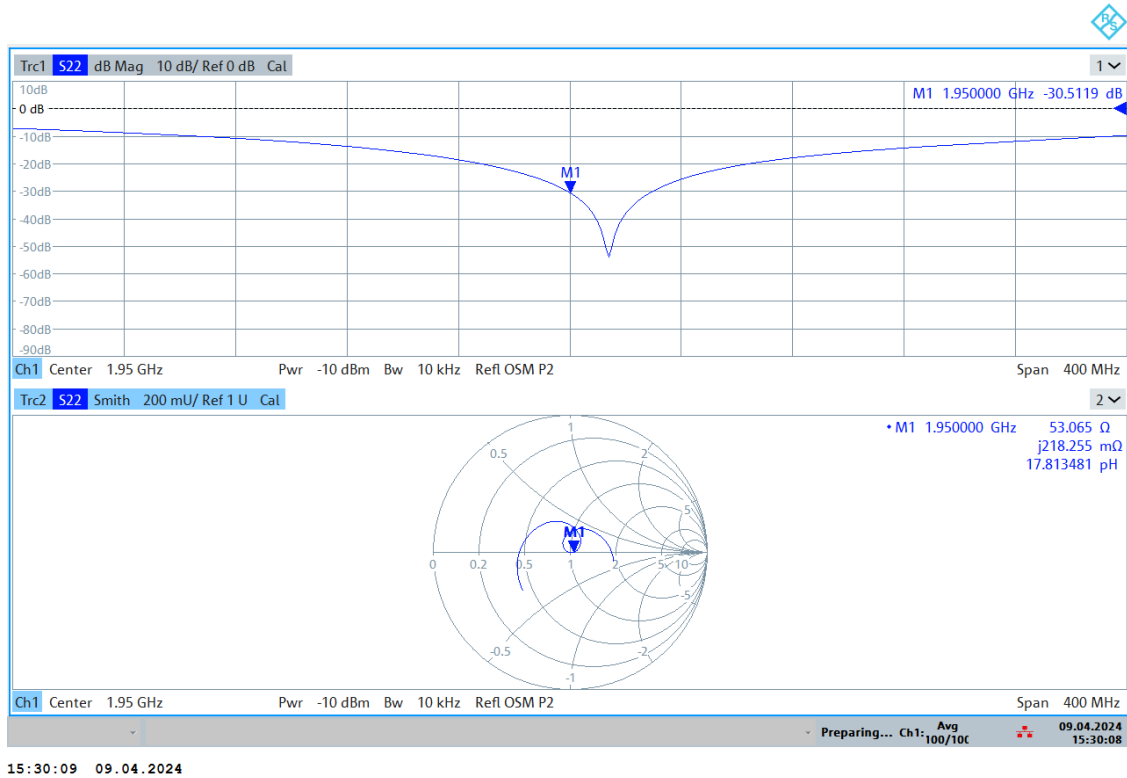
14) Impedance and Return/Loss

- Return/Loss is greater than the -20 dB cutoff and Impedance is within 5 Ω of previous value.

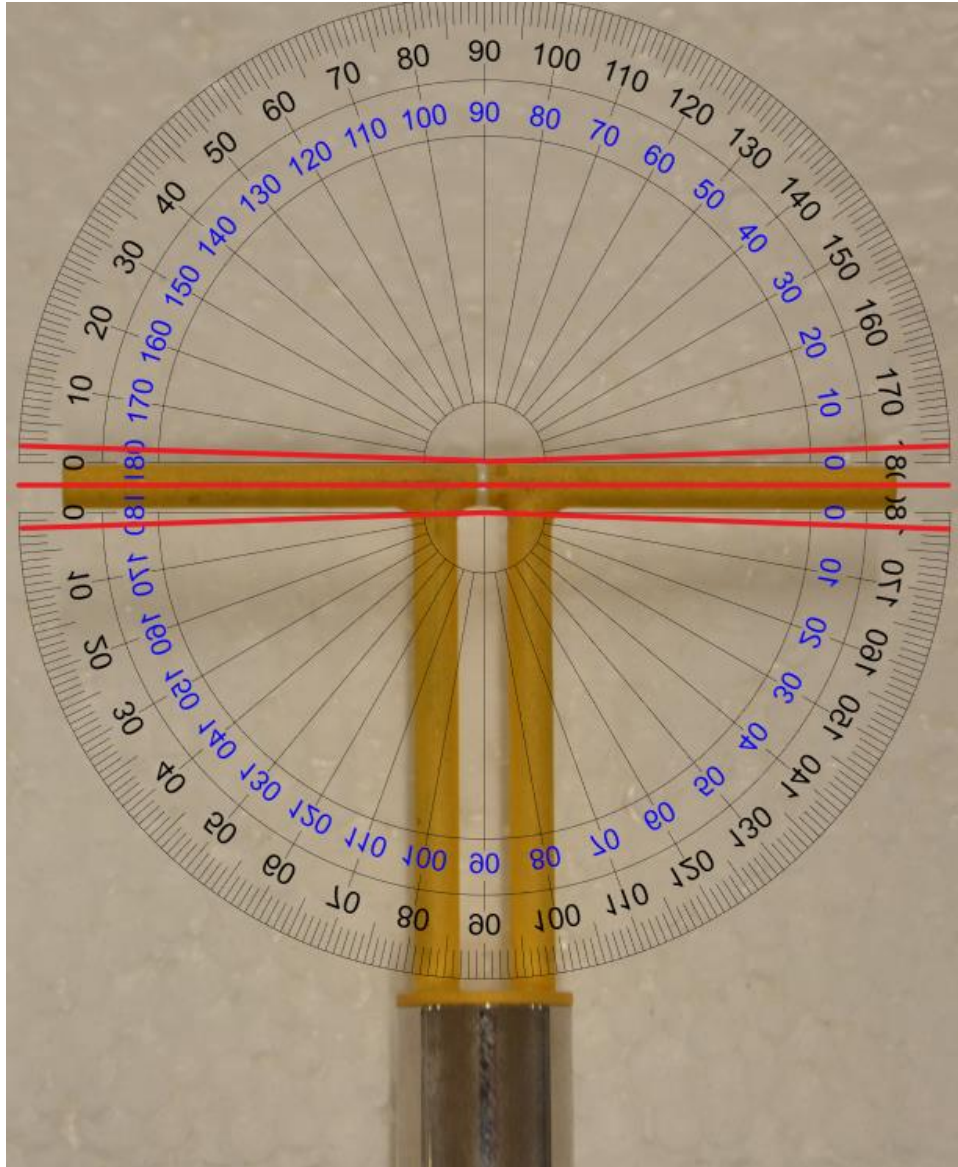
15) Dipole Arms

- The center red line indicates that the arms of the dipole fall within $\pm 2^\circ$

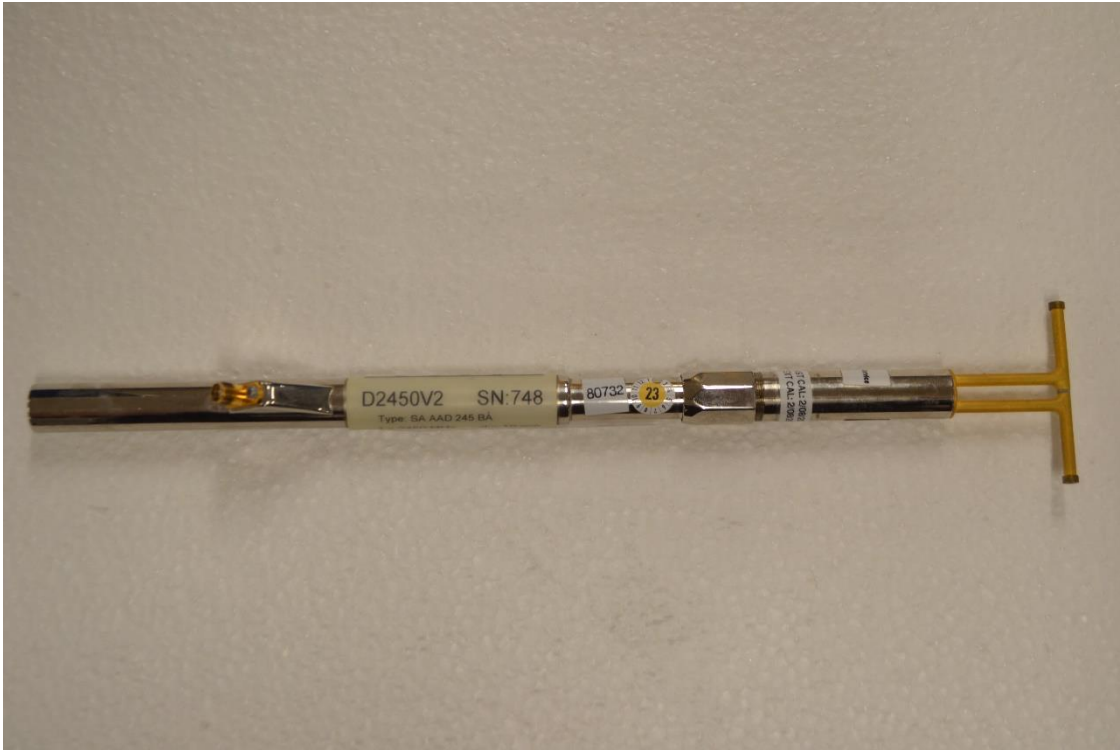
16) Photo of Dipole

- The connector of dipole contains no abnormalities.

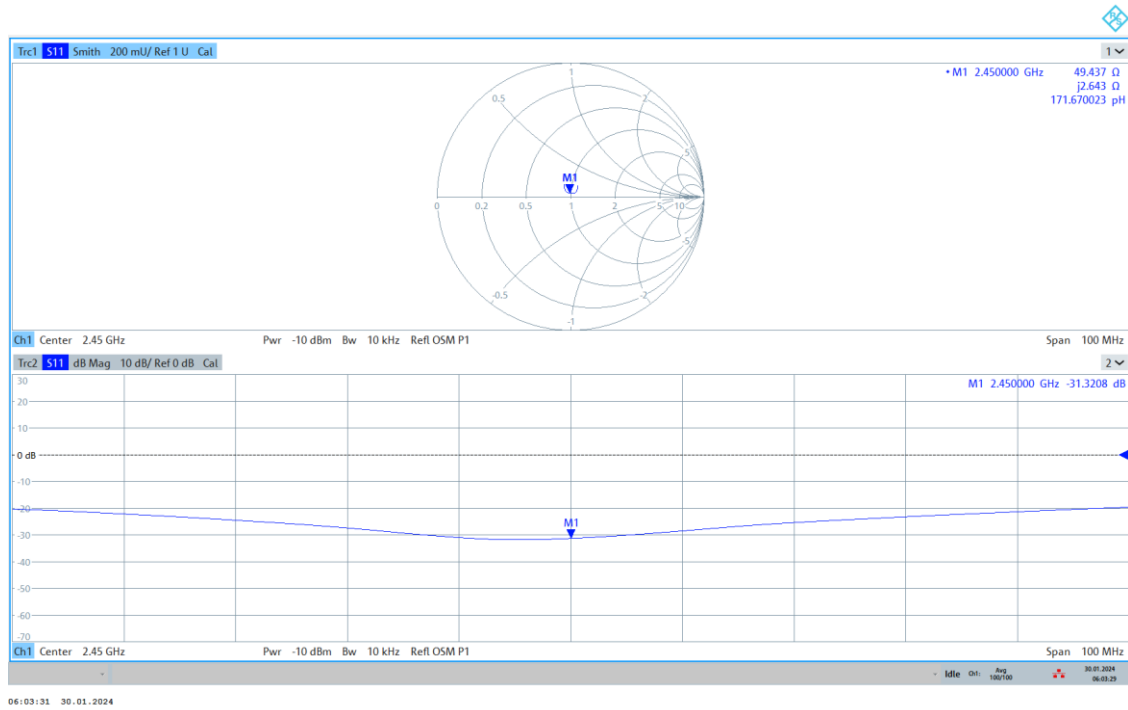
17) Impedance and Return/Loss

- Return/Loss is greater than the -20 dB cutoff and Impedance is within 5 Ω of previous value.

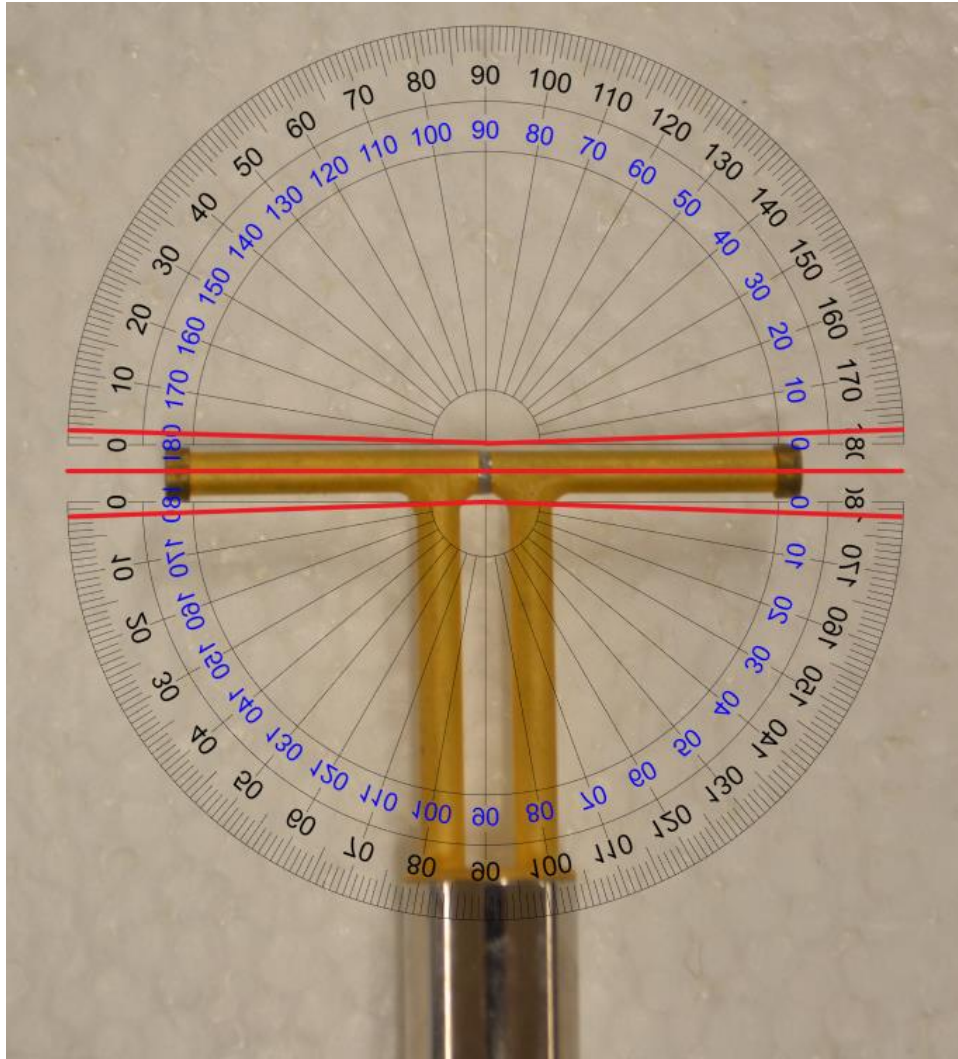
18) Dipole Arms

- The center red line indicates that the arms of the dipole fall within $\pm 2^\circ$

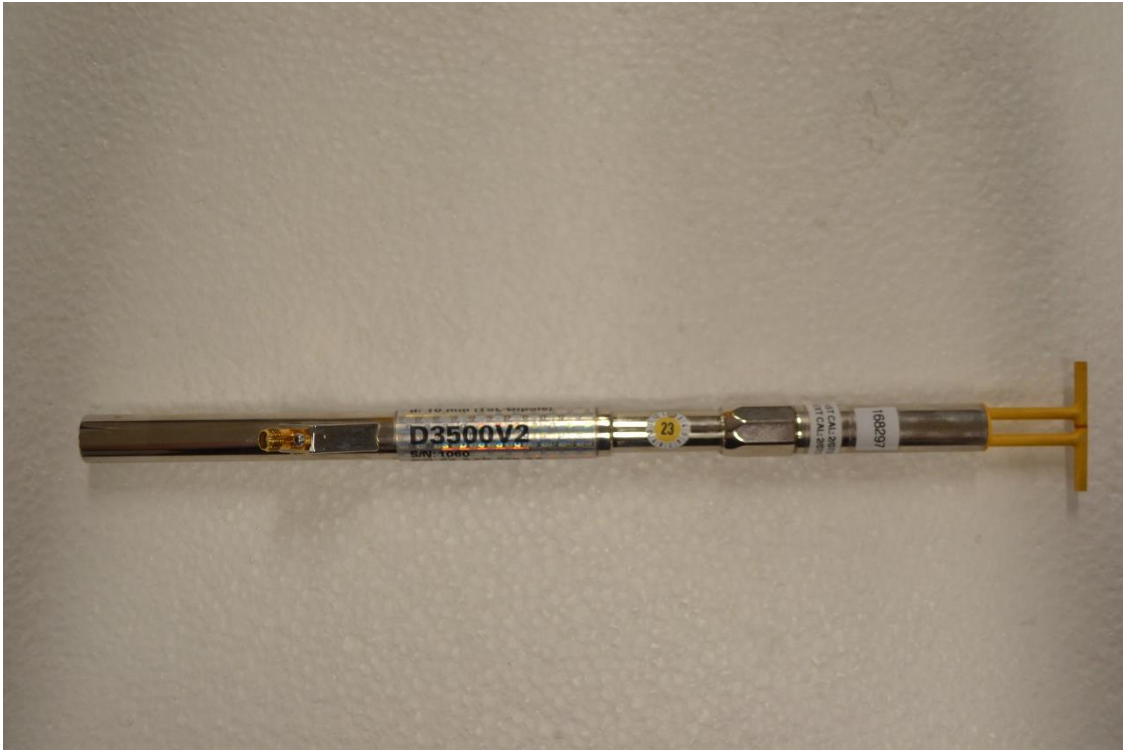
19) Photo of Dipole

- The connector of dipole contains no abnormalities.

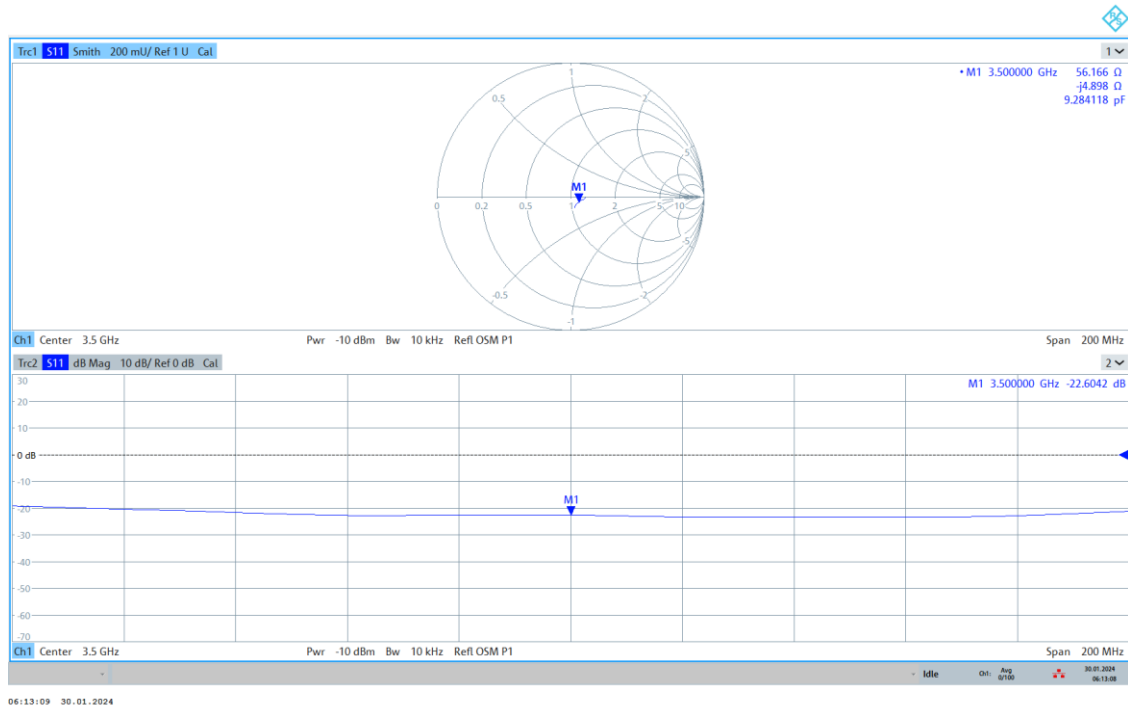
20) Impedance and Return/Loss

- Return/Loss is greater than the -20 dB cutoff and Impedance is within 5 Ω of previous value.

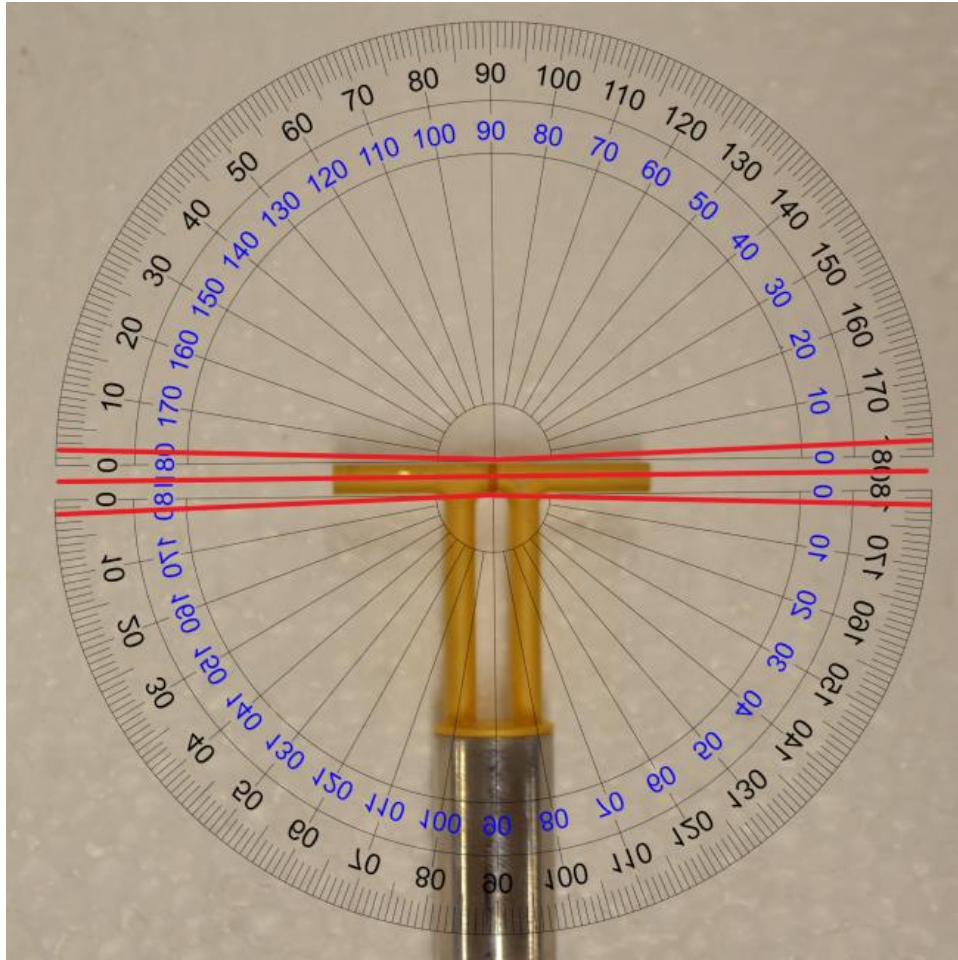
21) Dipole Arms

- The center red line indicates that the arms of the dipole fall within $\pm 2^\circ$
