Conformance test report of an

AIS system

Equipment under test: **McMurdo**

Test Report No.: 734.2/0066/2003/S3220

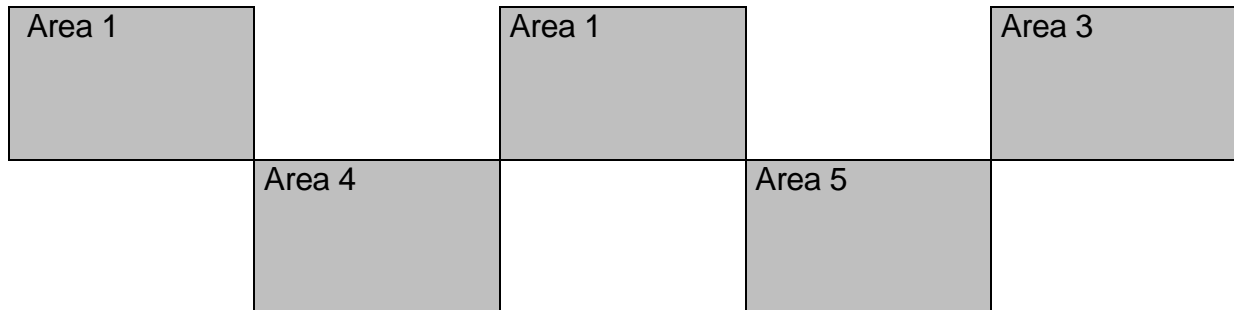
29.10.04	A change of the SW corner of Area 1 (in the picture below) is not accepted (from 51°00 51°05). There is a TXT output from transponder that there are too many corners within a range of 8 Nm <u>Retest 10.11.04 Ba:</u> Change of area is accepted now	Ok
