# Radiated Emission Measurement

Condition : FCC\_part 15 RE-Class C\_Above 1GHz\_PK

EUT : W6M22311-23090

Test Mode : TX 802.11n20 CH1

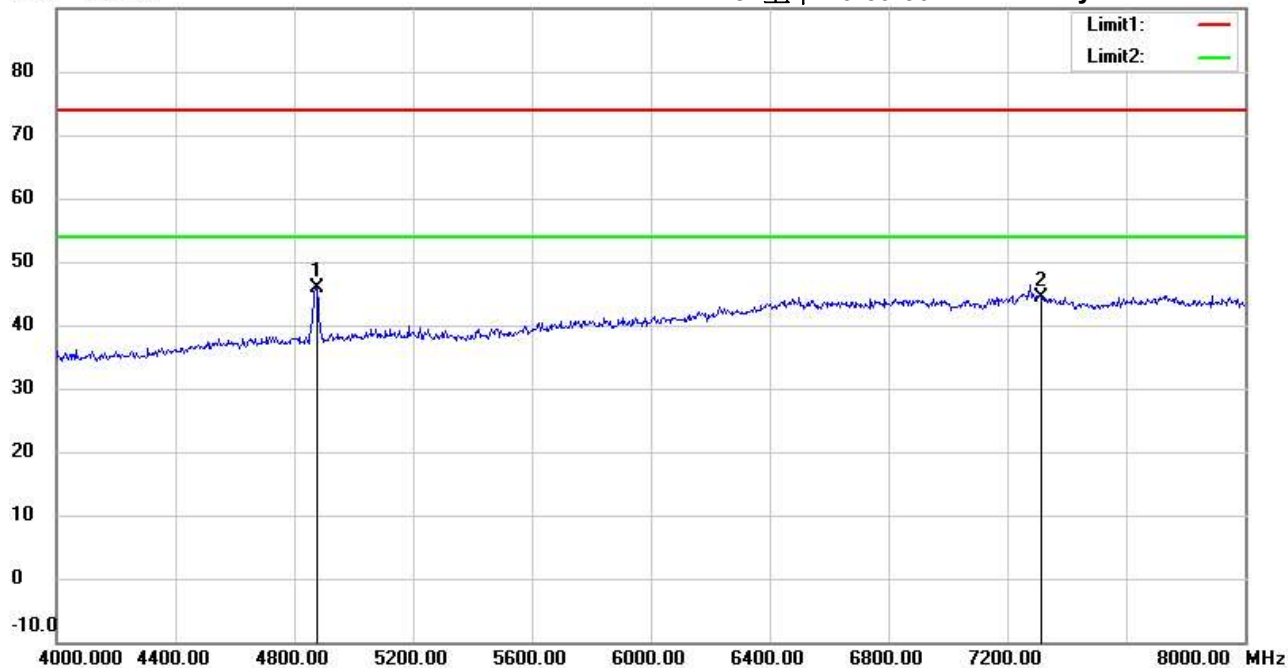
Data : #2

Test Mode : TX 802.11n20 CH6

Polarization: **Horizontal**

| Mk. | Frequency (MHz) | Reading (dBuV) | Detector | Corr. factor (dB/m) | Result (dBuV/m) | Limit (dBuV/m) | Ant.Pos (cm) | Tab.Pos (deg.) | Margin (dB) | Comment |
|---|---|---|---|---|---|---|---|---|---|---|
| * | 4874.000 | 40.76 | peak | 5.21 | 45.97 | 74.00 | 150 | 24 | -28.03 | |
| | 7311.000 | 32.66 | peak | 11.70 | 44.36 | 74.00 | 150 | 274 | -29.64 | |

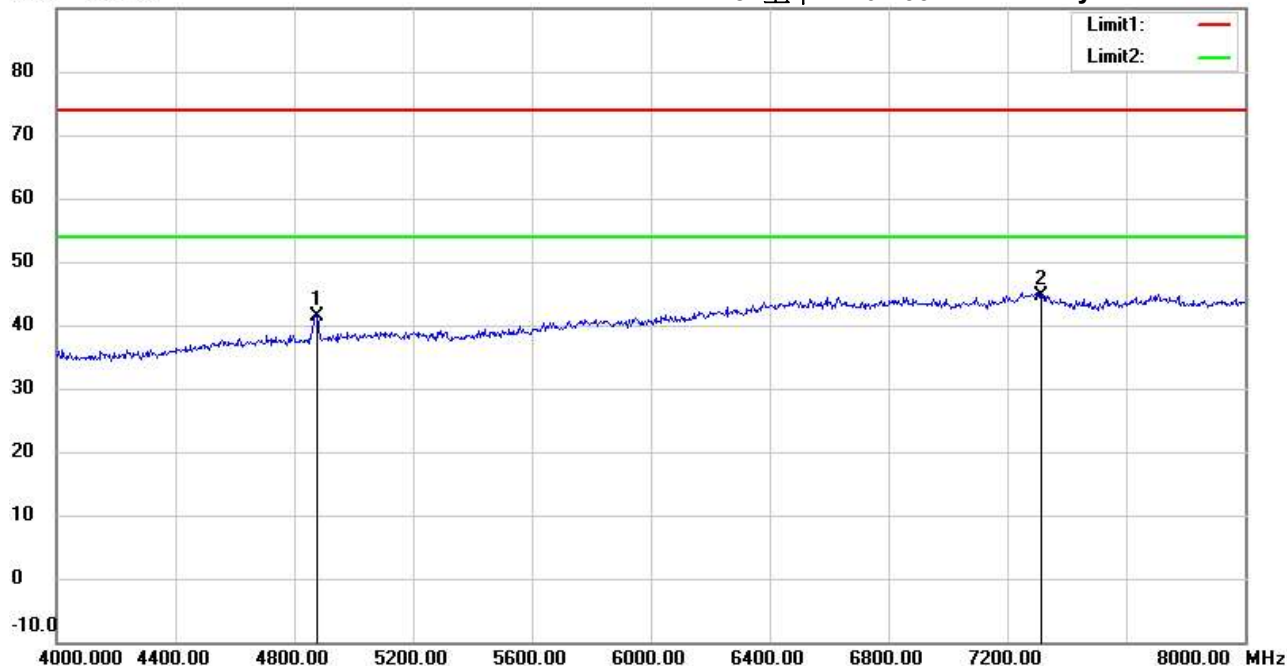
Data : #7

Test Mode : TX 802.11n20 CH6

Polarization: Vertical

| Mk. | Frequency (MHz) | Reading (dBuV) | Detector | Corr. factor (dB/m) | Result (dBuV/m) | Limit (dBuV/m) | Ant.Pos (cm) | Tab.Pos (deg.) | Margin (dB) | Comment |
|---|---|---|---|---|---|---|---|---|---|---|
| | 4874.000 | 36.23 | peak | 5.21 | 41.44 | 74.00 | 150 | 119 | -32.56 | |
| * | 7311.000 | 32.88 | peak | 11.70 | 44.58 | 74.00 | 150 | 285 | -29.42 | |

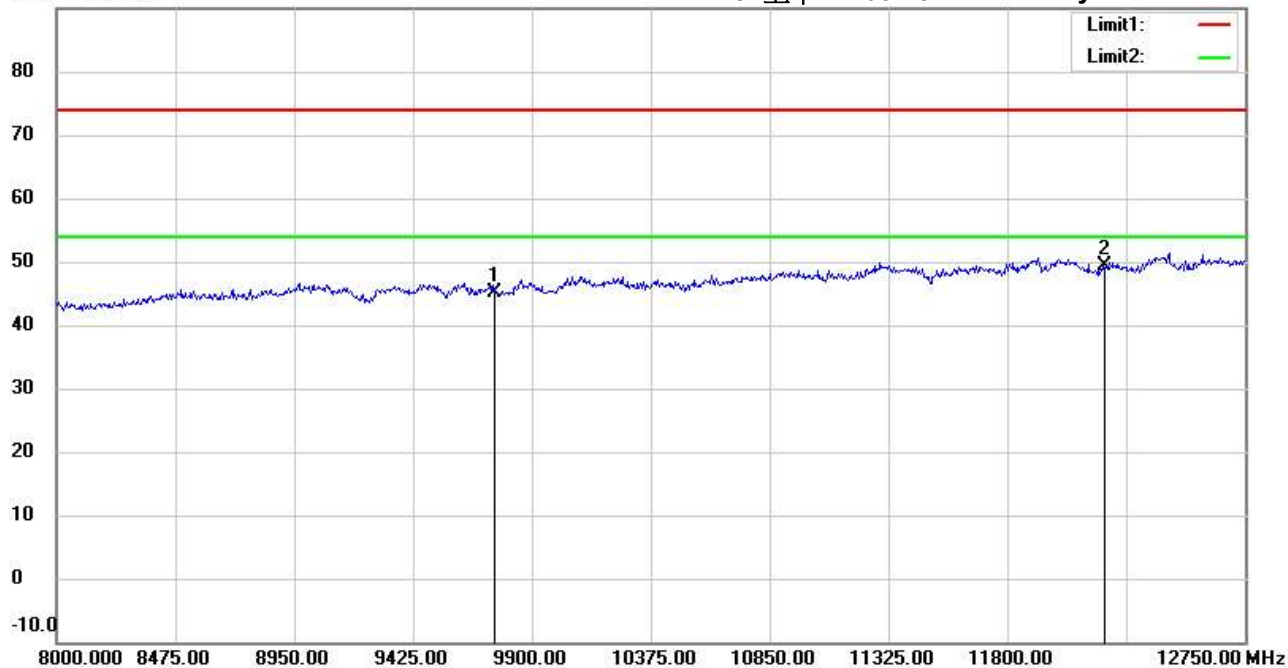
Data : #3

Test Mode : TX 802.11n20 CH6

Polarization: **Horizontal**

| Mk. | Frequency (MHz) | Reading (dBuV) | Detector | Corr. factor (dB/m) | Result (dBuV/m) | Limit (dBuV/m) | Ant.Pos (cm) | Tab.Pos (deg.) | Margin (dB) | Comment |
|---|---|---|---|---|---|---|---|---|---|---|
| | 9748.000 | 31.52 | peak | 13.70 | 45.22 | 74.00 | 150 | 280 | -28.78 | |
| * | 12185.000 | 32.27 | peak | 17.02 | 49.29 | 74.00 | 150 | 178 | -24.71 | |

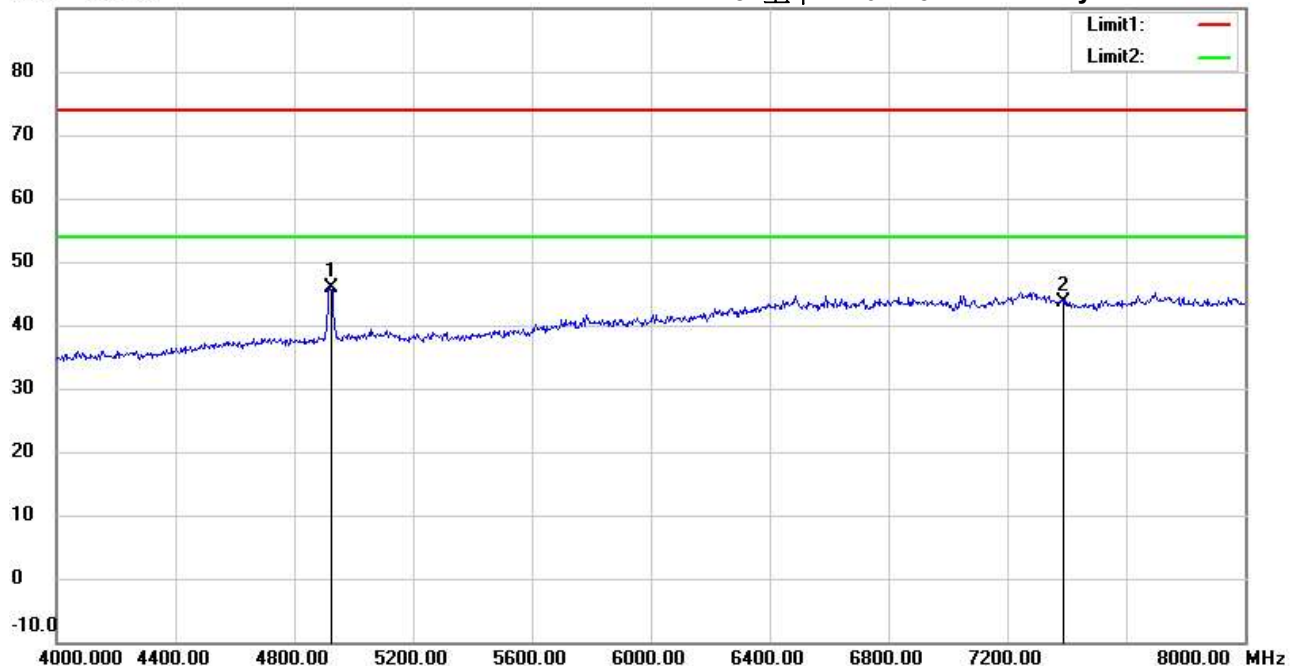
Data :#2

Test Mode : TX 802.11n20 CH11

Polarization: **Horizontal**

| Mk. | Frequency (MHz) | Reading (dBuV) | Detector | Corr. factor (dB/m) | Result (dBuV/m) | Limit (dBuV/m) | Ant.Pos (cm) | Tab.Pos (deg.) | Margin (dB) | Comment |
|---|---|---|---|---|---|---|---|---|---|---|
| * | 4922.000 | 40.63 | peak | 5.37 | 46.00 | 74.00 | 150 | 41 | -28.00 | |
| | 7386.000 | 32.29 | peak | 11.39 | 43.68 | 74.00 | 150 | 344 | -30.32 | |

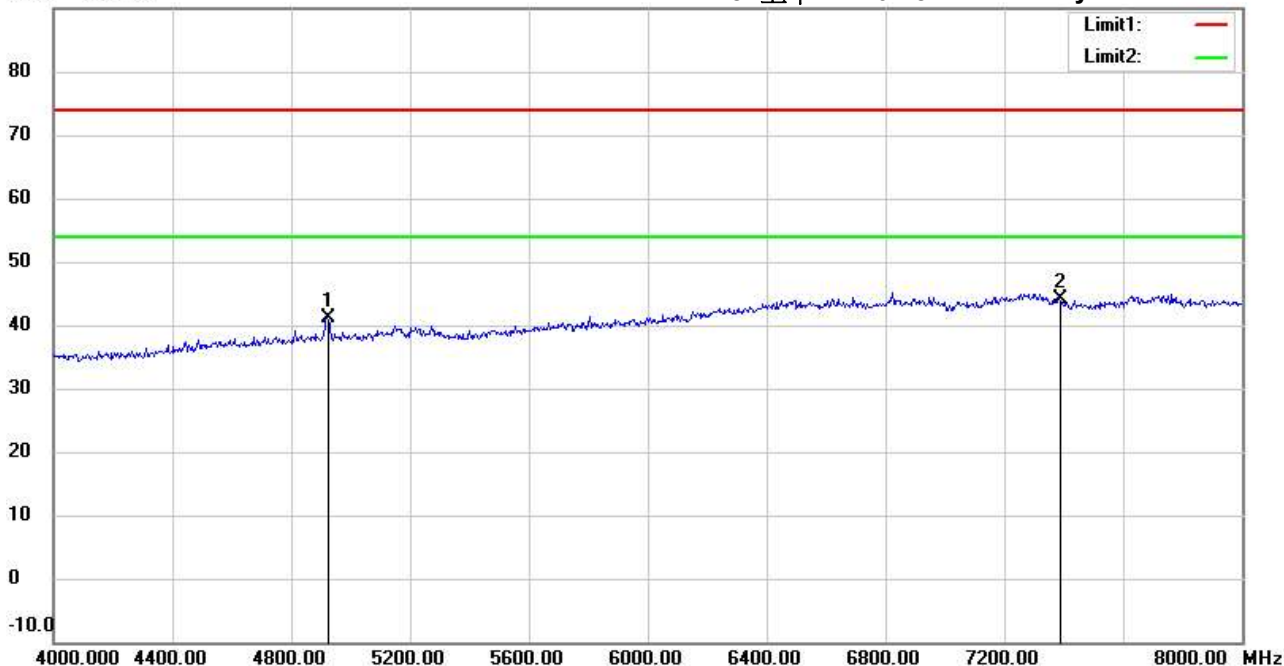
Data : #7

Test Mode : TX 802.11n20 CH11

Polarization: **Vertical**

| Mk. | Frequency (MHz) | Reading (dBuV) | Detector | Corr. factor (dB/m) | Result (dBuV/m) | Limit (dBuV/m) | Ant.Pos (cm) | Tab.Pos (deg.) | Margin (dB) | Comment |
|---|---|---|---|---|---|---|---|---|---|---|
| | 4922.000 | 35.79 | peak | 5.37 | 41.16 | 74.00 | 150 | 112 | -32.84 | |
| * | 7386.000 | 32.77 | peak | 11.39 | 44.16 | 74.00 | 150 | 127 | -29.84 | |

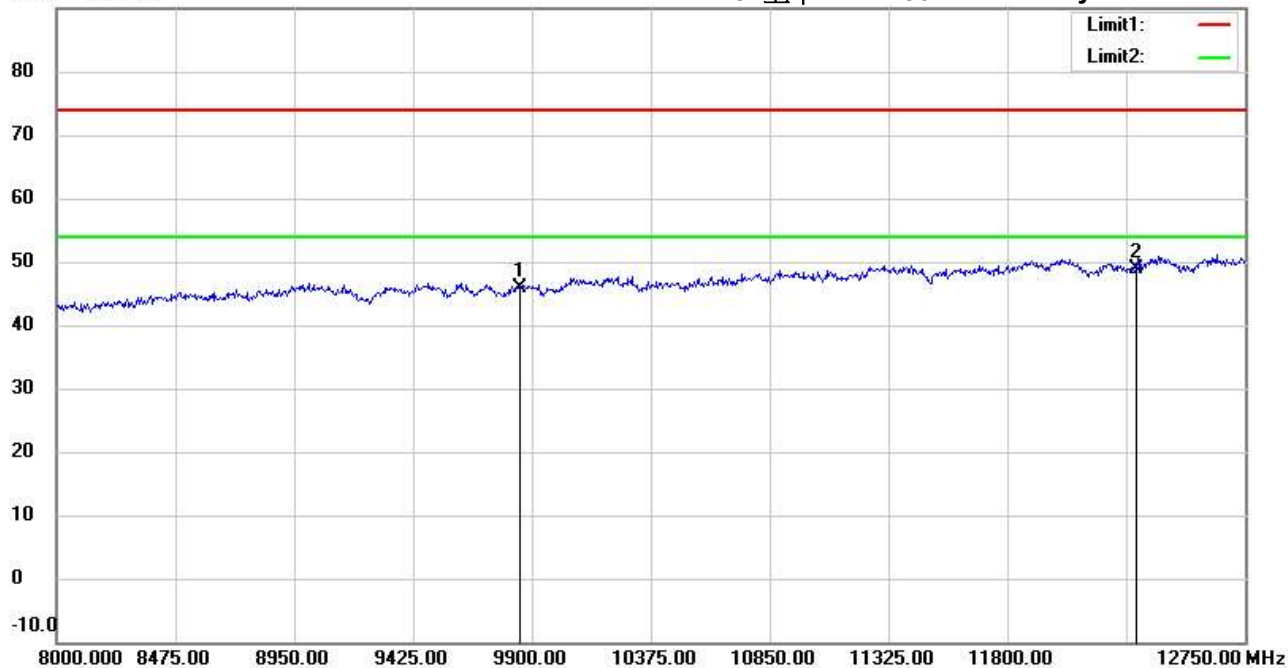
Data : #8

Test Mode : TX 802.11n20 CH11

Polarization: **Vertical**

| Mk. | Frequency (MHz) | Reading (dBuV) | Detector | Corr. factor (dB/m) | Result (dBuV/m) | Limit (dBuV/m) | Ant.Pos (cm) | Tab.Pos (deg.) | Margin (dB) | Comment |
|---|---|---|---|---|---|---|---|---|---|---|
| | 9848.000 | 31.93 | peak | 13.97 | 45.90 | 74.00 | 150 | 249 | -28.10 | |
| * | 12310.000 | 32.19 | peak | 16.62 | 48.81 | 74.00 | 150 | 221 | -25.19 | |

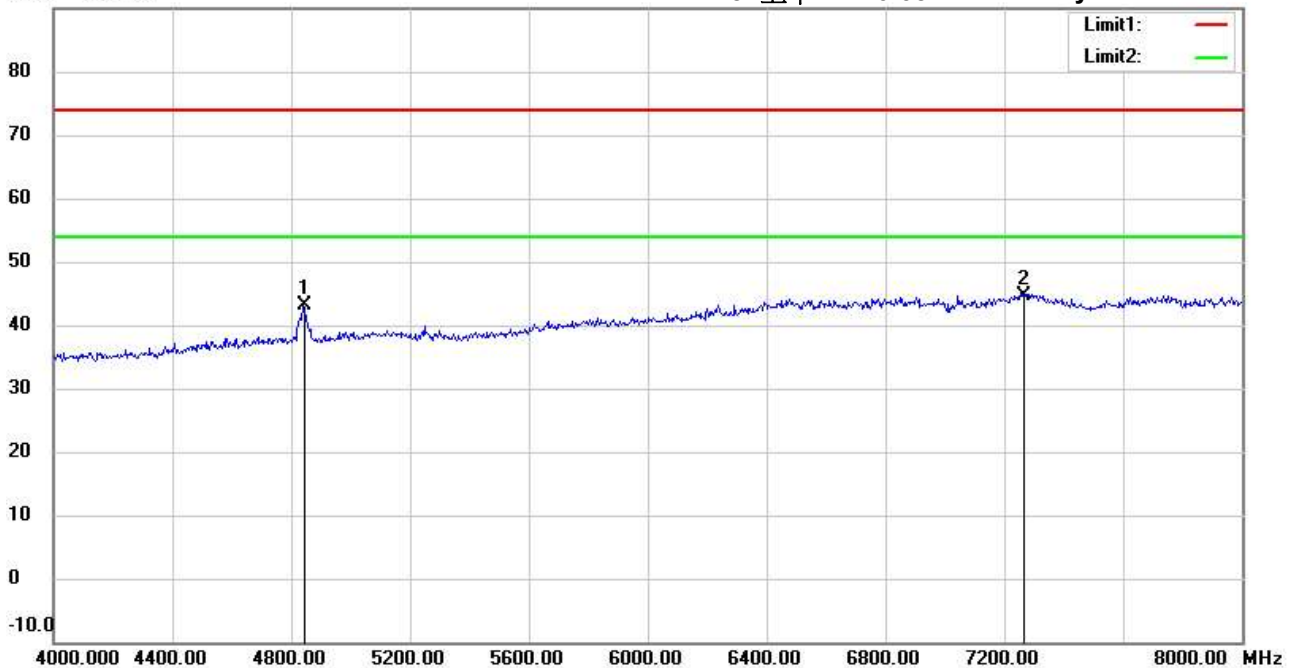
Data :#2

Test Mode : TX 802.11n40 CH1

Polarization: **Horizontal**

| Mk. | Frequency (MHz) | Reading (dBuV) | Detector | Corr. factor (dB/m) | Result (dBuV/m) | Limit (dBuV/m) | Ant.Pos (cm) | Tab.Pos (deg.) | Margin (dB) | Comment |
|---|---|---|---|---|---|---|---|---|---|---|
| | 4842.000 | 37.89 | peak | 5.13 | 43.02 | 74.00 | 150 | 17 | -30.98 | |
| * | 7266.000 | 32.90 | peak | 11.62 | 44.52 | 74.00 | 150 | 359 | -29.48 | |
