### **APPENDIX 3: Photographs of test setup**

#### **Radiated Spurious Emission**

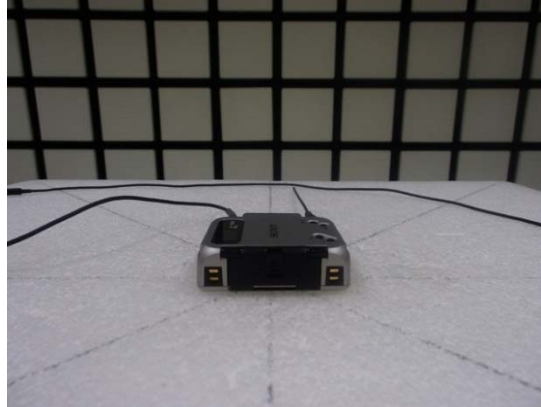
**X-axis**

**Worst Case Position**

(Below 1 GHz Horizontal: X-axis/ Vertical:X-axis)  
(Above 1 GHz Horizontal: X-axis/ Vertical:Y-axis)
