## APPENDIX A: PHOTOGRAPHS OF TEST SETUP

Reference to the test report No. BLA-EMC-202303-A3901

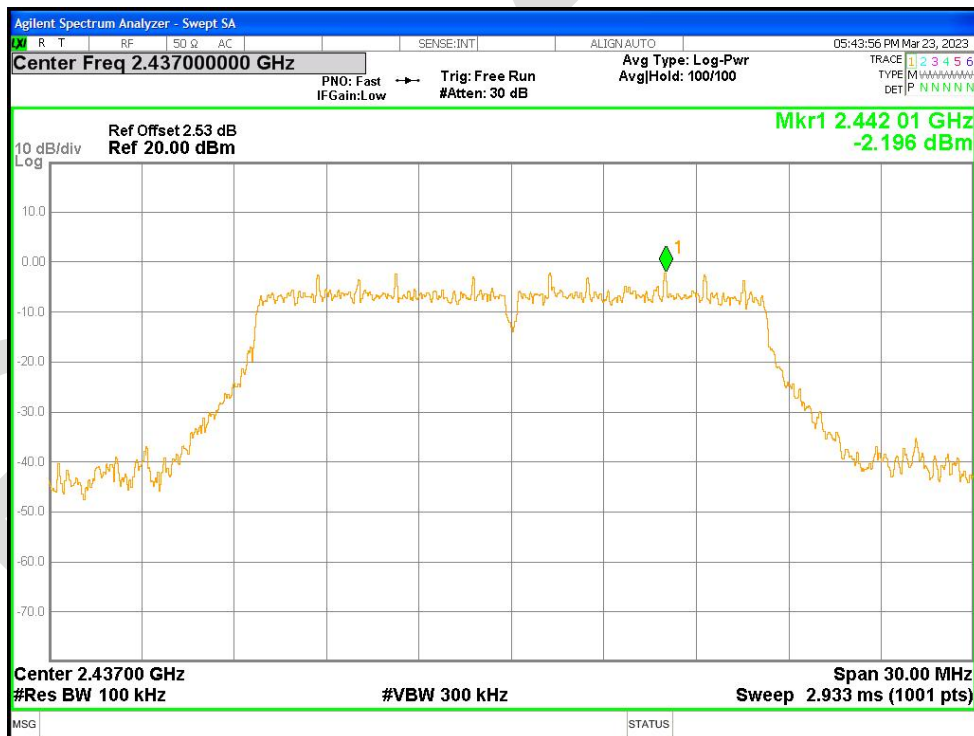
Tx. Spurious NVNT g 2437MHz Ant1 Emission

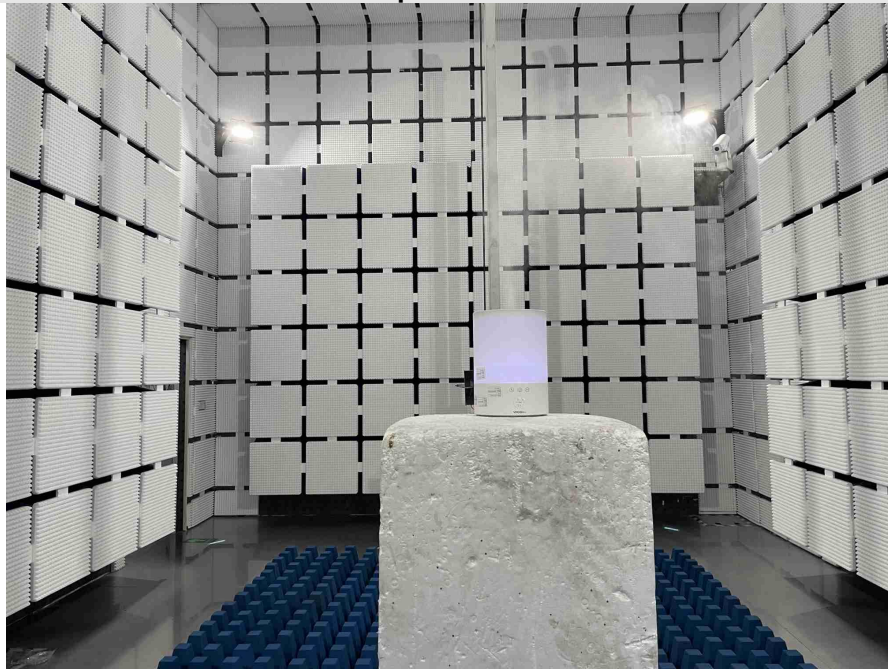
### Radiated Spurious Emissions

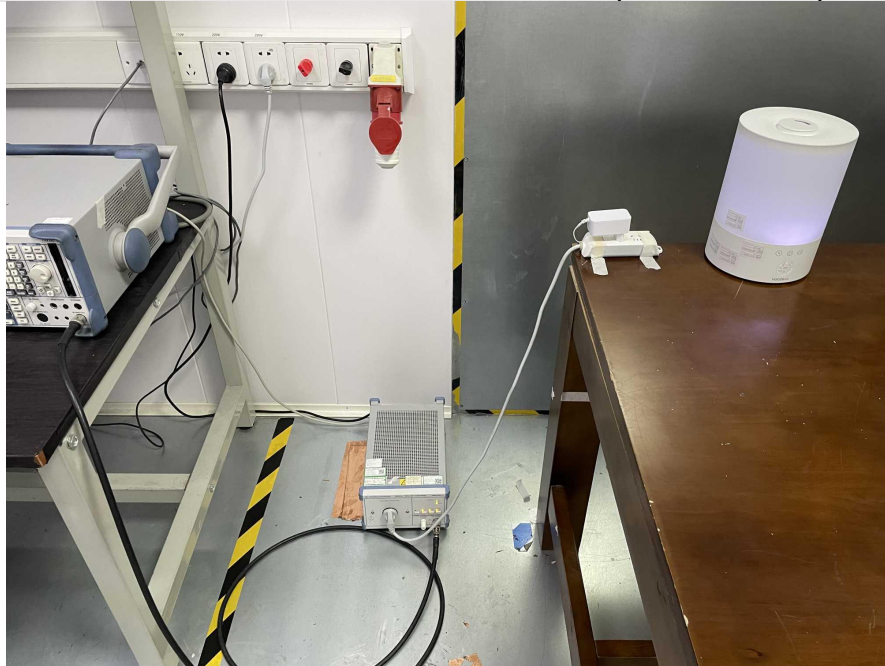
**Conducted Emissions at AC Power Line (150kHz-30MHz)**
