Test Setup Photos

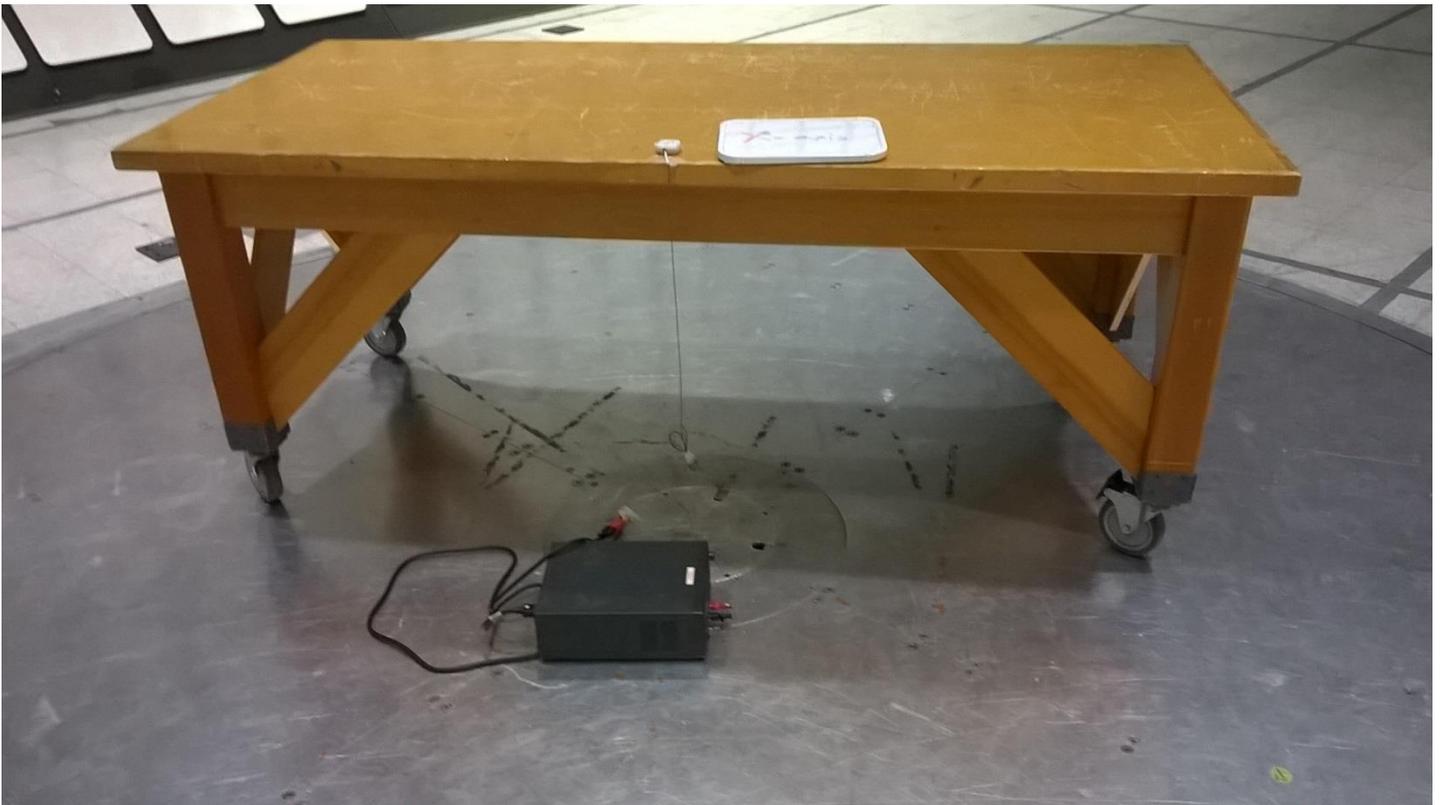
Figure 1 – Radiated Emissions Test Setup, 30MHz – 1GHz

Note: Since the EUT would drain the battery very quickly when transmitting continuously, it was tested with a thin wire run from a DC power supply to the battery input terminals for testing. Some additional preview scan measurements were performed to ensure the additional DC supply wire did not affect the test results. It was found to have no significant effect.

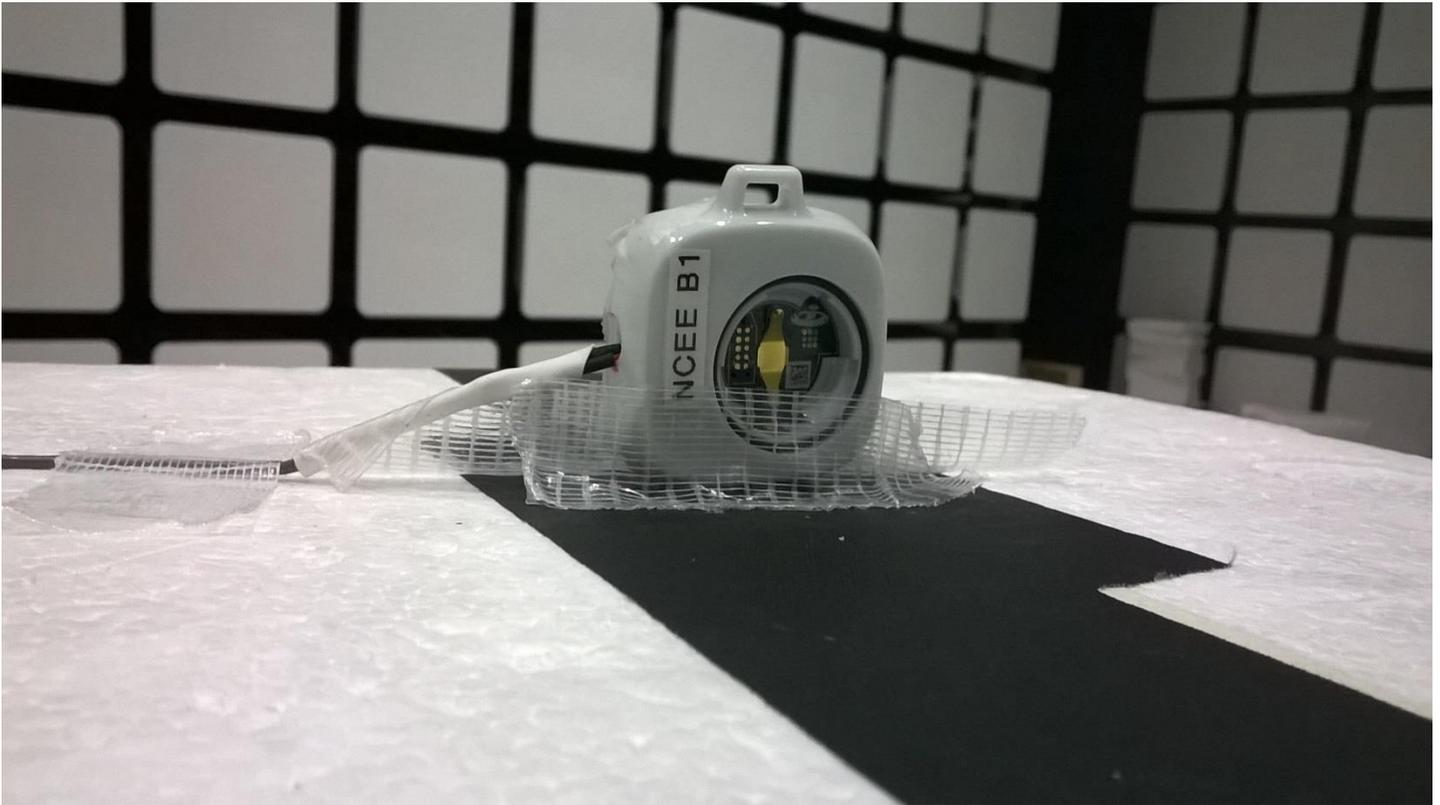
Figure 2 - Radiated Emissions Test Setup, 1 – 19 GHz
