### **APPENDIX 3: Photographs of test setup**

#### **Radiated Spurious Emission**

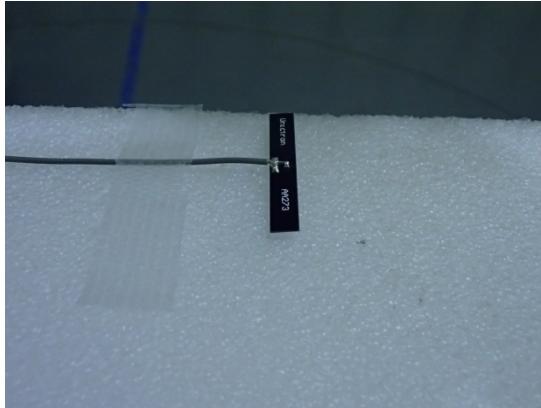
##### X-axis

#### Antenna

### Worst Case Position

Below 1GHz (Hori: Antenna X, Module X / Vert: Antenna X, Module X)

Above 1GHz (Hori: Antenna X, Module X / Vert: Antenna Y, Module X)

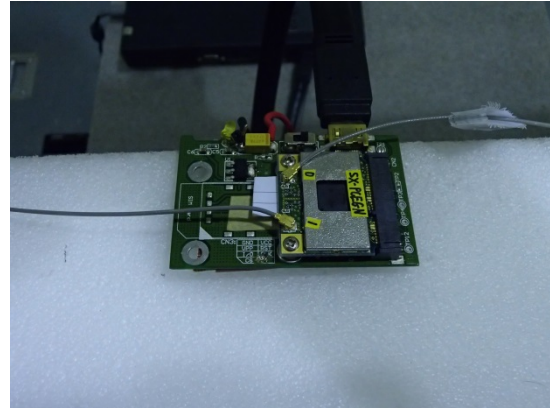
##### X-axis

#### Module
