## Appendix H: Conducted Spurious Emission

### Test Result

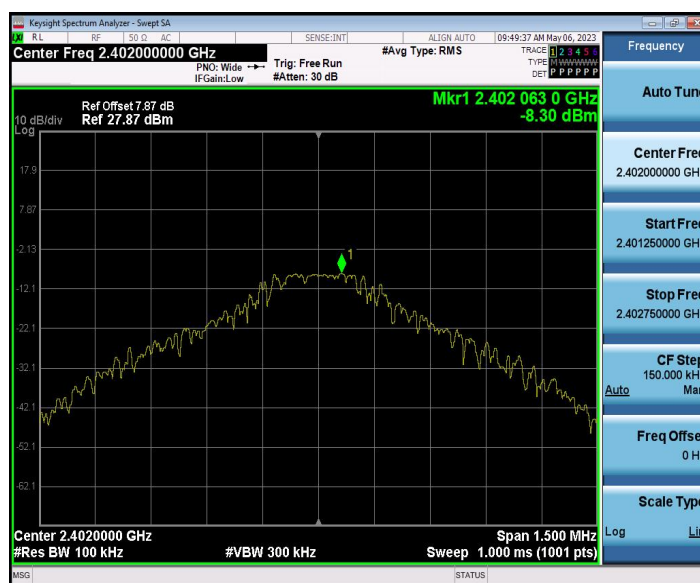
DH5\_Ant1\_2402\_0~Reference

| TestMode | Antenna | Channel | FreqRange [MHz] | RefLevel [dBm] | Result [dBm] | Limit [dBm] | Verdict |
|---|---|---|---|---|---|---|---|
| DH5 | Ant1 | 2402 | Reference | -8.30 | -8.30 | --- | PASS |

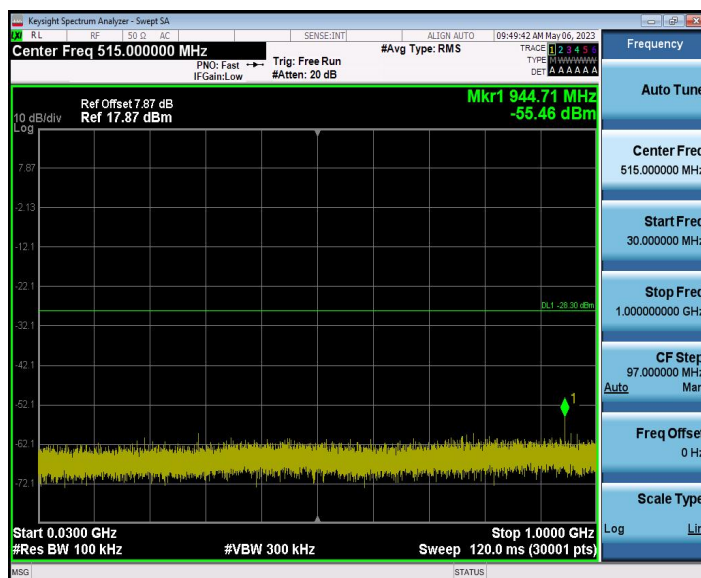
DH5\_Ant1\_2402\_30~1000

| TestMode | Antenna | Channel | FreqRange [MHz] | RefLevel [dBm] | Result [dBm] | Limit [dBm] | Verdict |
|---|---|---|---|---|---|---|---|
| | | | 30~1000 | -8.30 | -55.46 | ≤-28.3 | PASS |

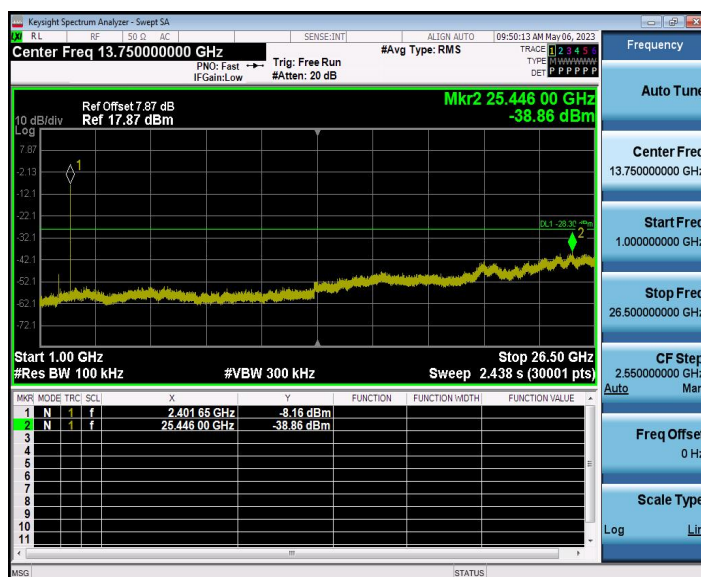
DH5\_Ant1\_2402\_1000~26500

| TestMode | Antenna | Channel | FreqRange [MHz] | RefLevel [dBm] | Result [dBm] | Limit [dBm] | Verdict |
|---|---|---|---|---|---|---|---|
| | | | 1000~26500 | -8.30 | -38.87 | ≤-28.3 | PASS |

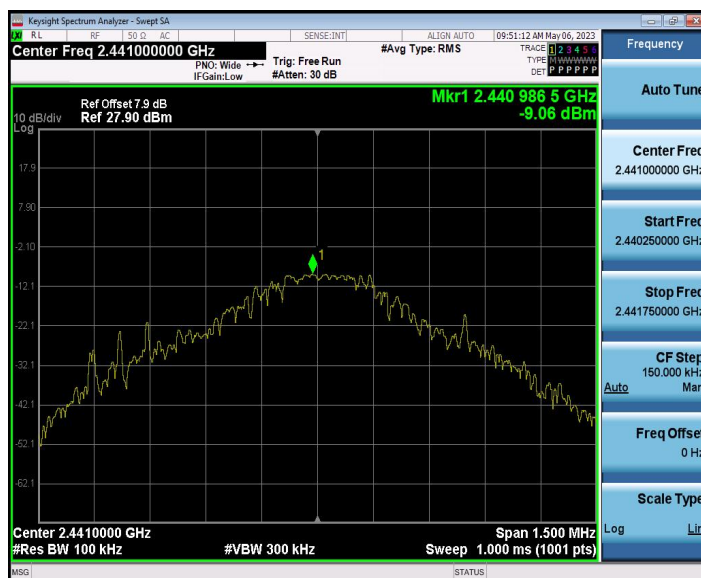
DH5\_Ant1\_2441\_0~Reference

| TestMode | Antenna | Channel | FreqRange [MHz] | RefLevel [dBm] | Result [dBm] | Limit [dBm] | Verdict |
|---|---|---|---|---|---|---|---|
| | | 2441 | Reference | -9.06 | -9.06 | --- | PASS |

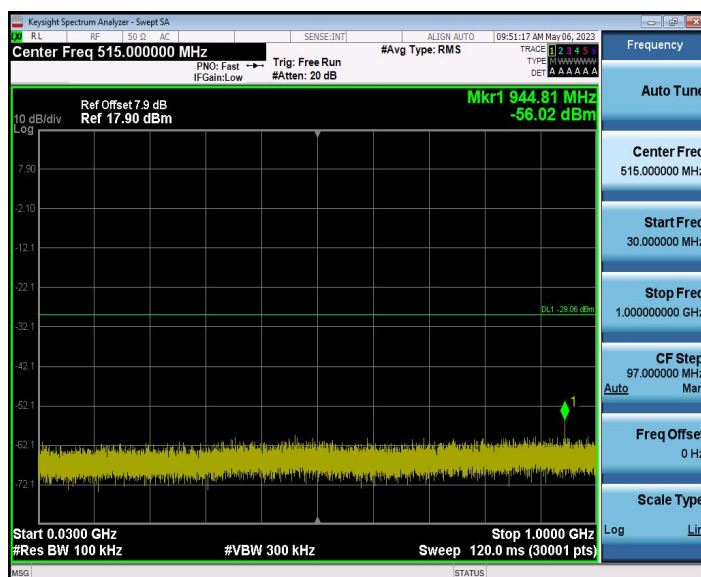
DH5\_Ant1\_2441\_30~1000

| TestMode | Antenna | Channel | FreqRange [MHz] | RefLevel [dBm] | Result [dBm] | Limit [dBm] | Verdict |
|---|---|---|---|---|---|---|---|
| | | | 30~1000 | -9.06 | -56.02 | ≤-29.06 | PASS |

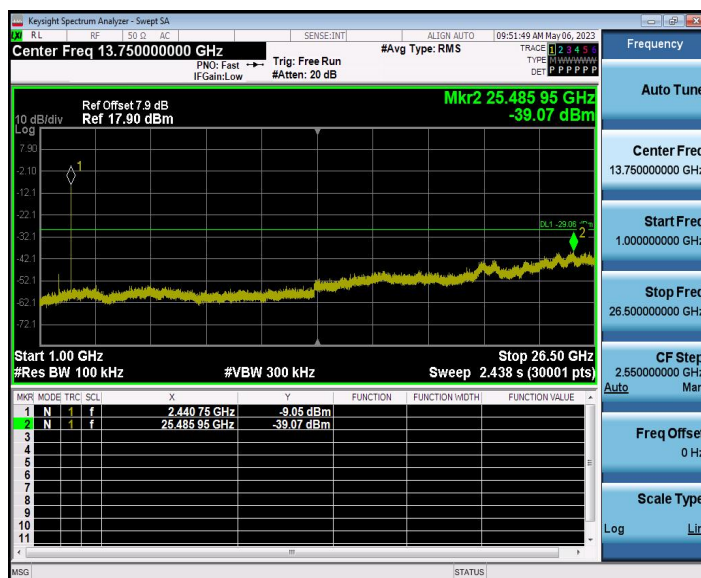
DH5\_Ant1\_2441\_1000~26500

| TestMode | Antenna | Channel | FreqRange [MHz] | RefLevel [dBm] | Result [dBm] | Limit [dBm] | Verdict |
|---|---|---|---|---|---|---|---|
| | | | 1000~26500 | -9.06 | -39.07 | ≤-29.06 | PASS |

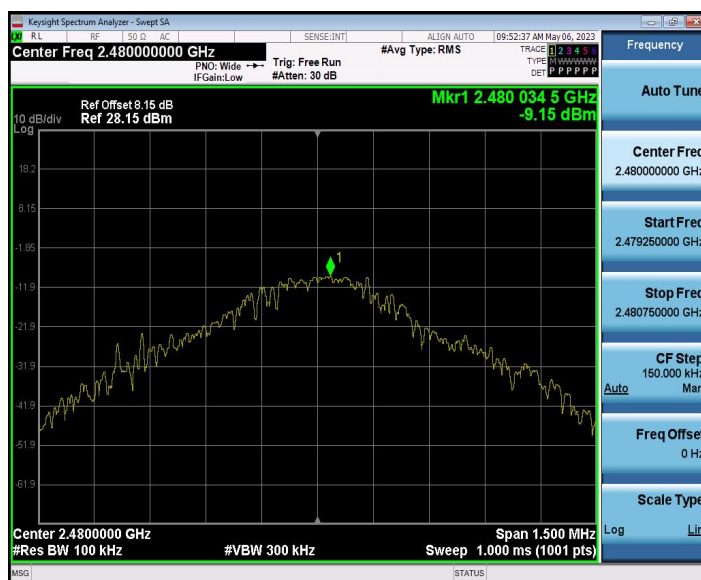
DH5\_Ant1\_2480\_0~Reference

| TestMode | Antenna | Channel | FreqRange [MHz] | RefLevel [dBm] | Result [dBm] | Limit [dBm] | Verdict |
|---|---|---|---|---|---|---|---|
| | | 2480 | Reference | -9.15 | -9.15 | --- | PASS |

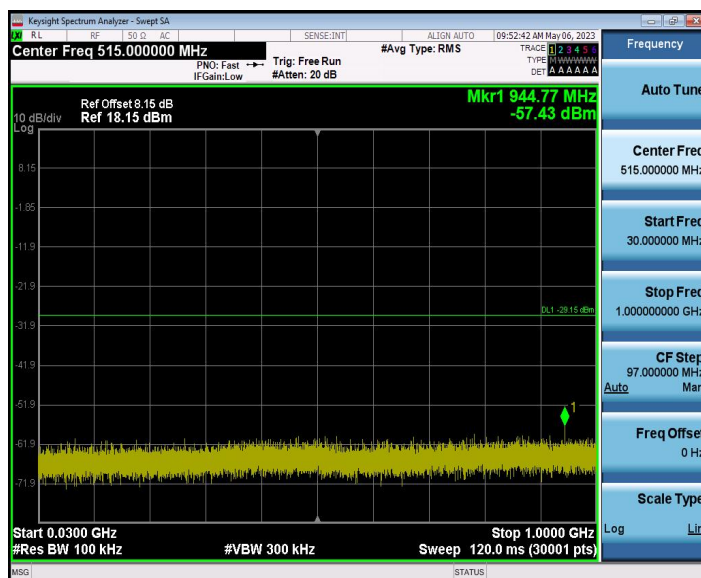
DH5\_Ant1\_2480\_30~1000

| TestMode | Antenna | Channel | FreqRange [MHz] | RefLevel [dBm] | Result [dBm] | Limit [dBm] | Verdict |
|---|---|---|---|---|---|---|---|
| | | | 30~1000 | -9.15 | -57.43 | ≤-29.15 | PASS |

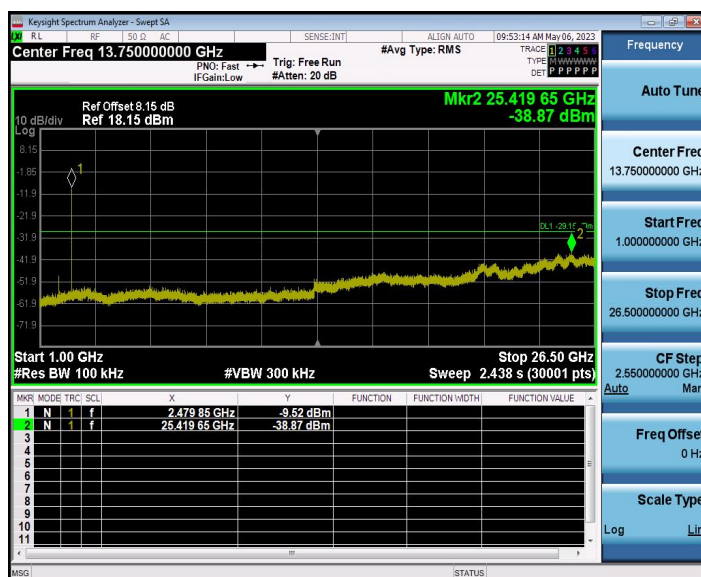
### DH5\_Ant1\_2480\_1000~26500

| TestMode | Antenna | Channel | FreqRange [MHz] | RefLevel [dBm] | Result [dBm] | Limit [dBm] | Verdict |
|---|---|---|---|---|---|---|---|
| | | | 1000~26500 | -9.15 | -38.87 | ≤-29.15 | PASS |

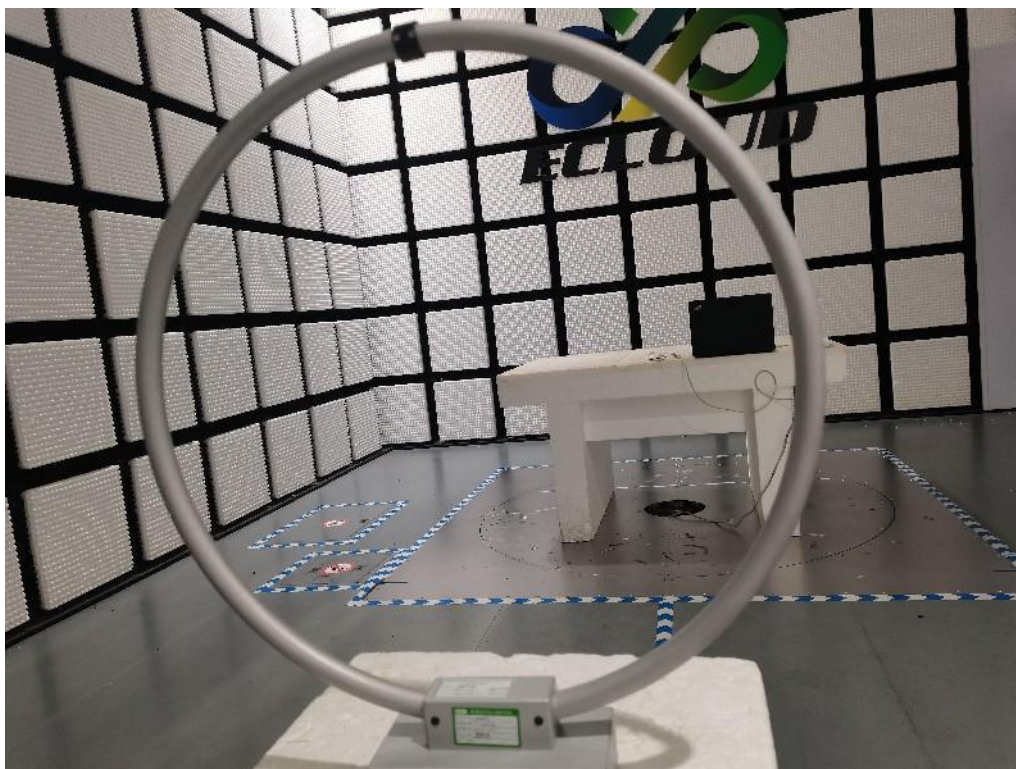
Fig. 1 Radiated emission setup photo(Below 30MHz)

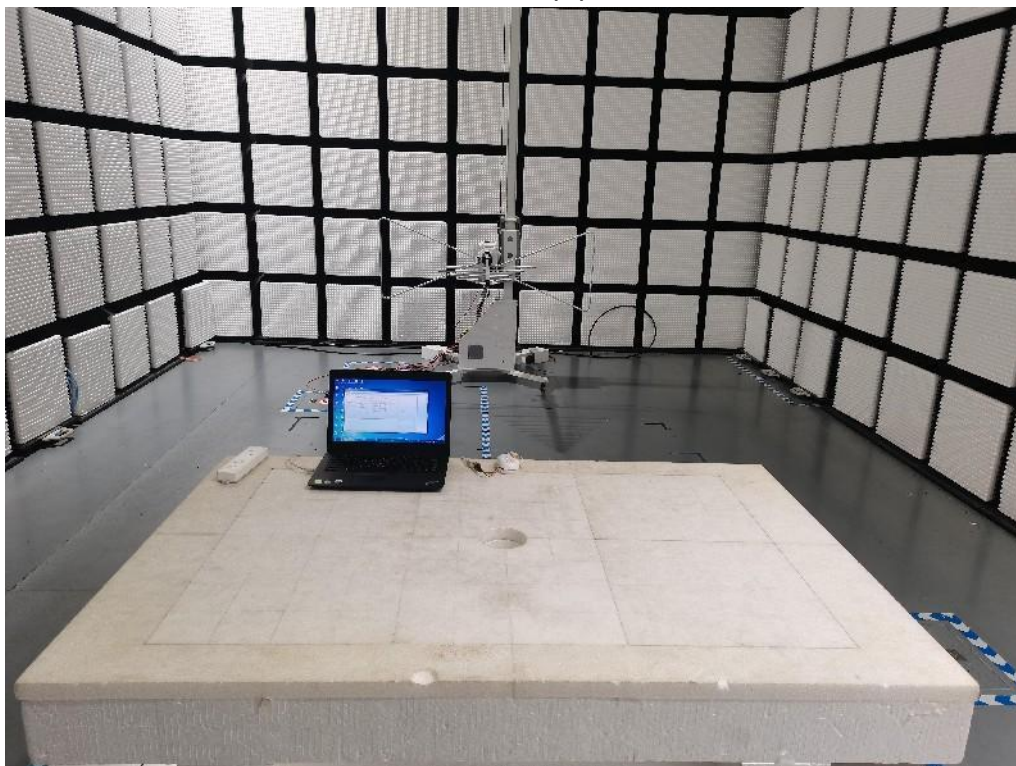
Fig. 2 Radiated emission setup photo(30MHz-1GHz)

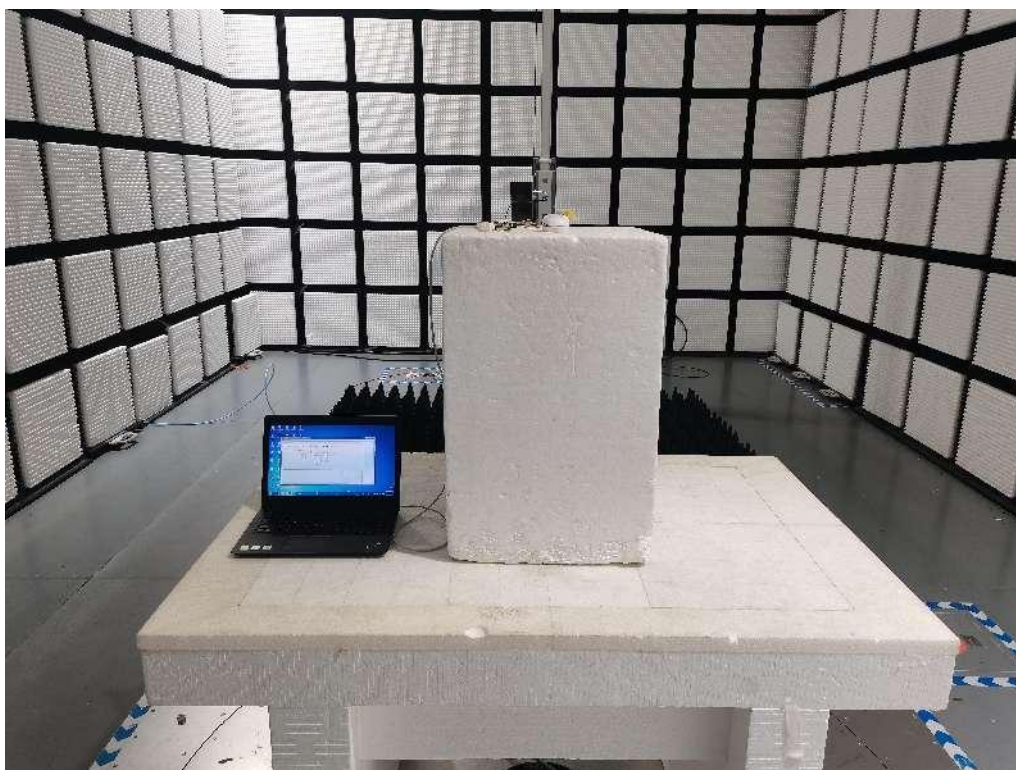
Fig. 3 Radiated emission setup photo(Above 1GHz)

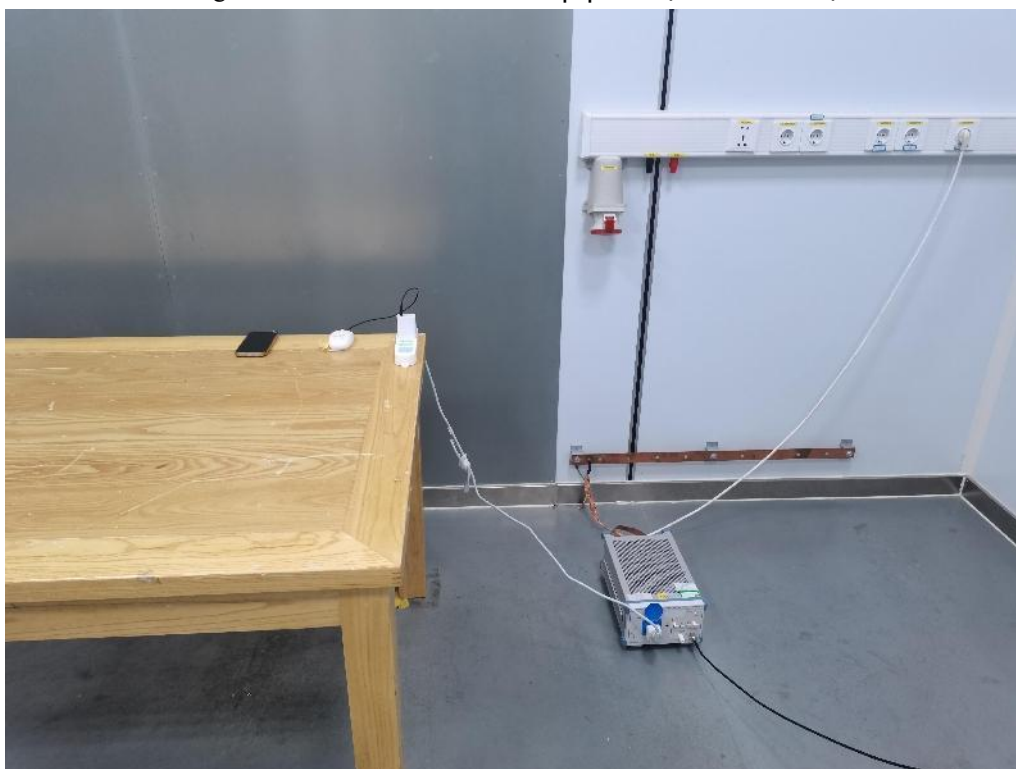
Fig. 4 Power line conducted emission setup photo
