## Appendix C: photographs of EUT

Reference to the test report no. BLA-EMC-202404-A5601

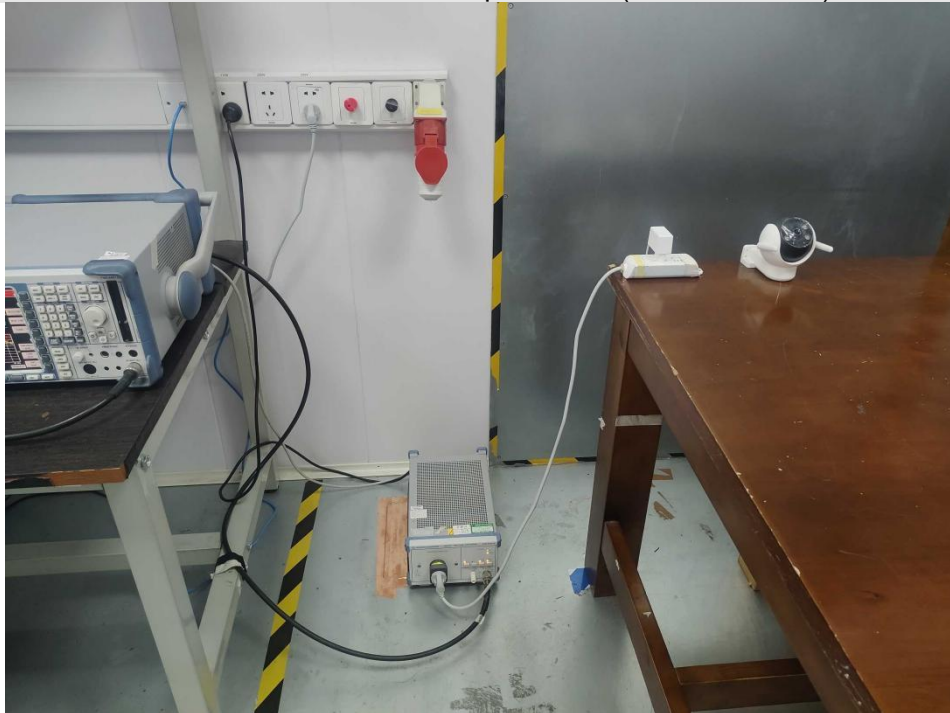
### Conducted emissions at AC power line (150kHz-30MHz)

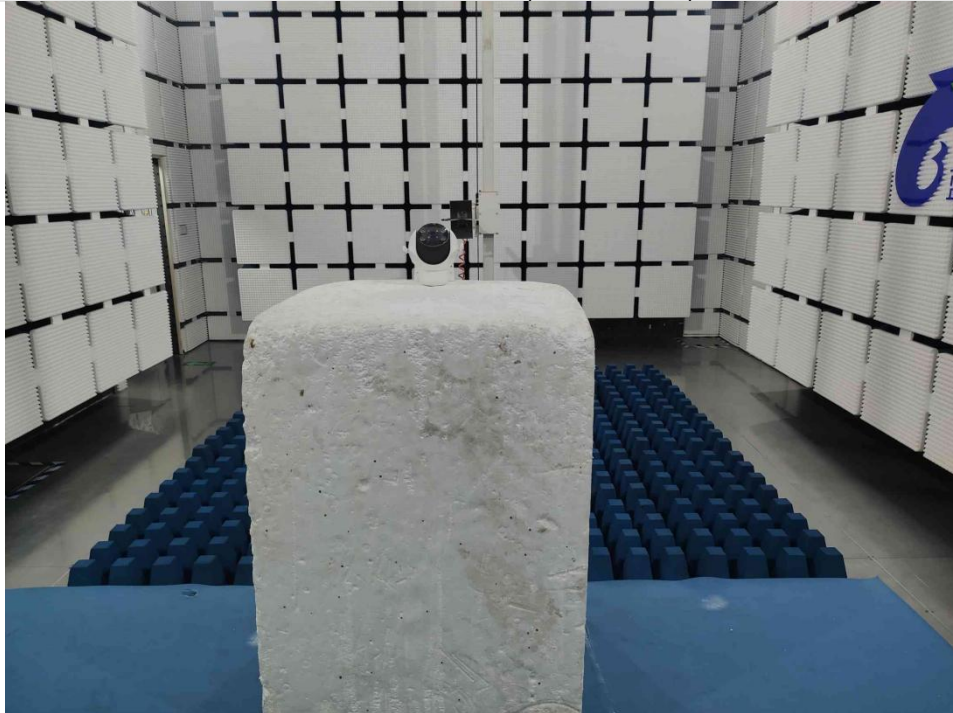
Radiated Emissions (above 1GHz)
