## Appendix G: Band edge measurements

## Appendix H: Conducted Spurious Emission Test Result

13. TEST SETUP PHOTO

14. EUT PHOTO

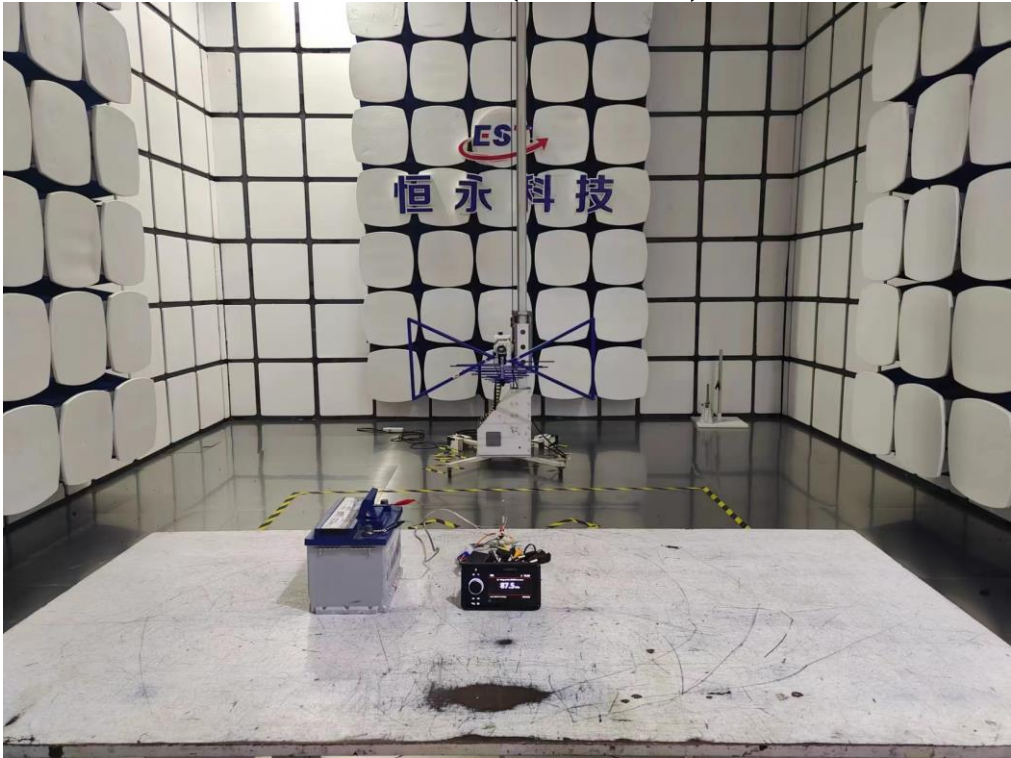
Radiated Test (Below 1GHz)

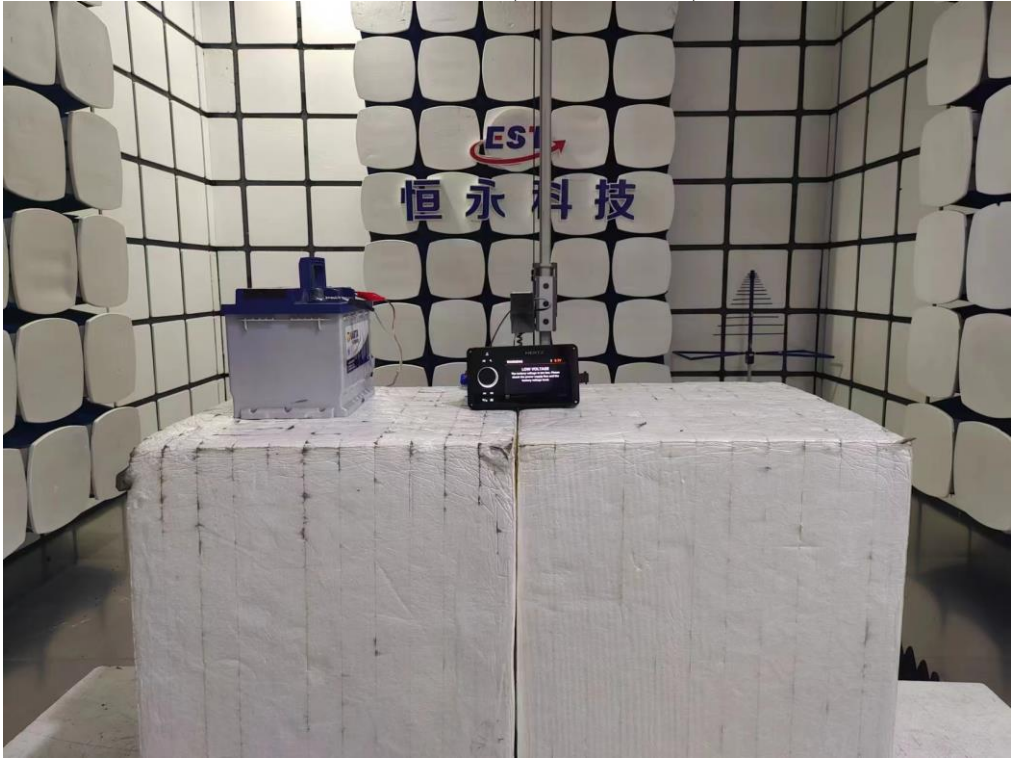
Radiated Test (Above 1GHz)
