## Appendix B: photographs of test setup

## Appendix C: photographs of EUT

Reference to the test report no. BLA-EMC-202503-A00201

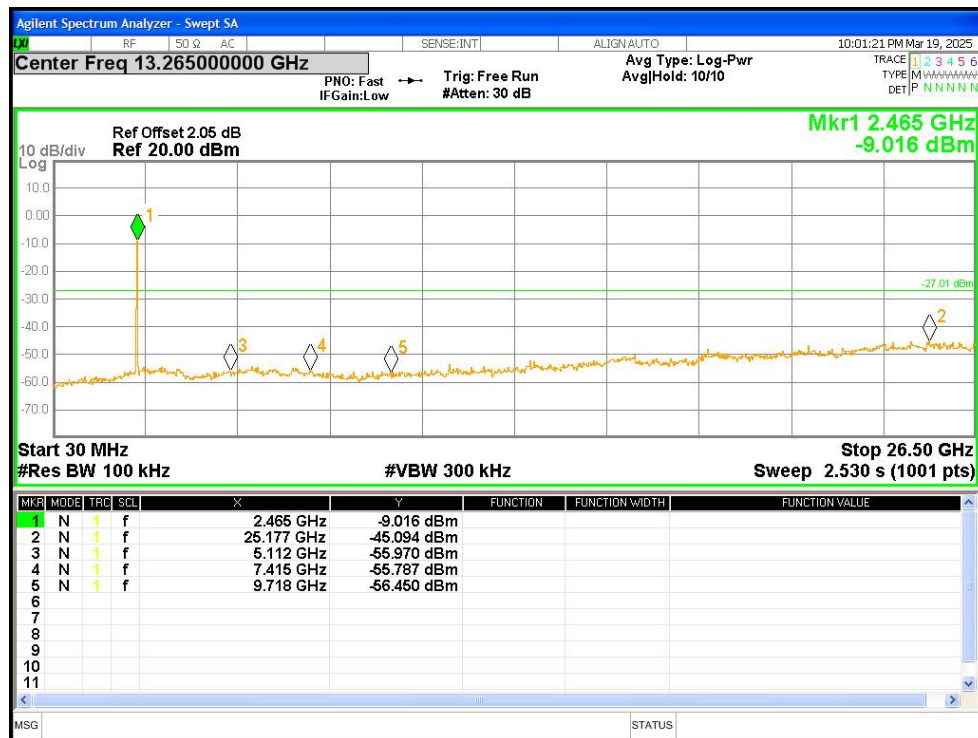
Tx. Spurious NVNT n40 2422MHz Ant1 Ref

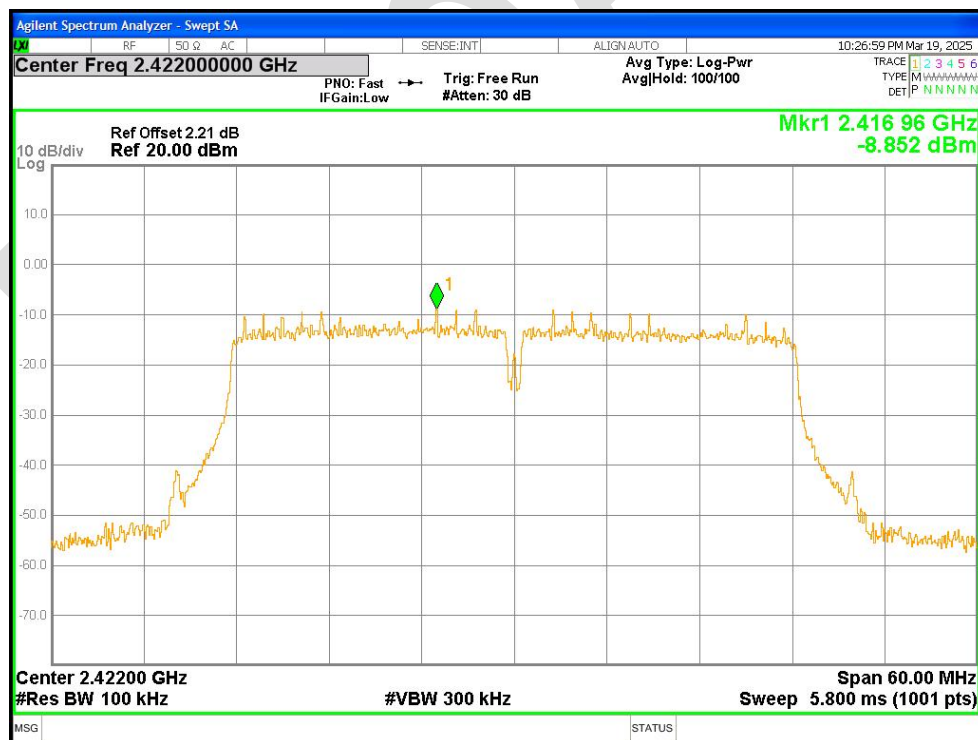
Tx. Spurious NVNT n40 2422MHz Ant1 Emission

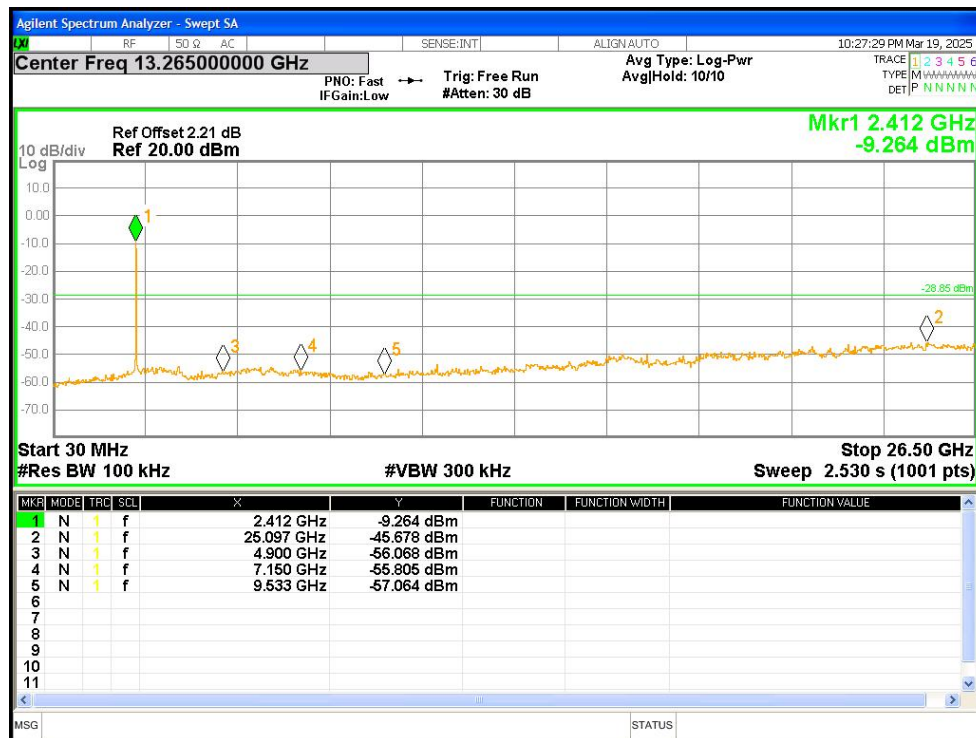
Tx. Spurious NVNT n40 2437MHz Ant1 Ref

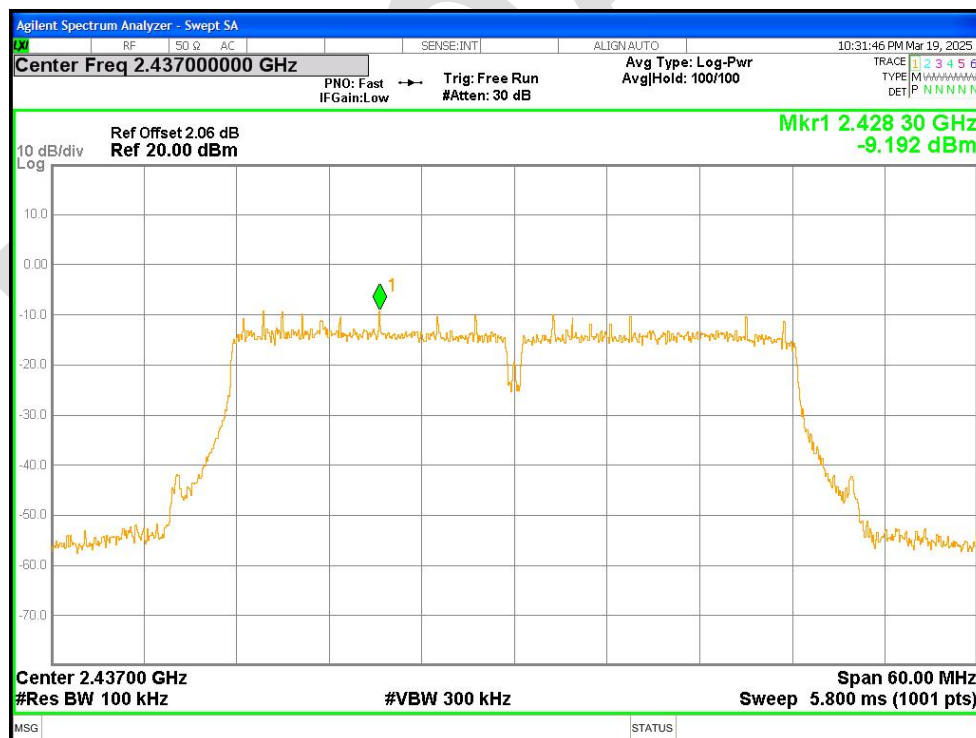
Tx. Spurious NVNT n40 2437MHz Ant1 Emission

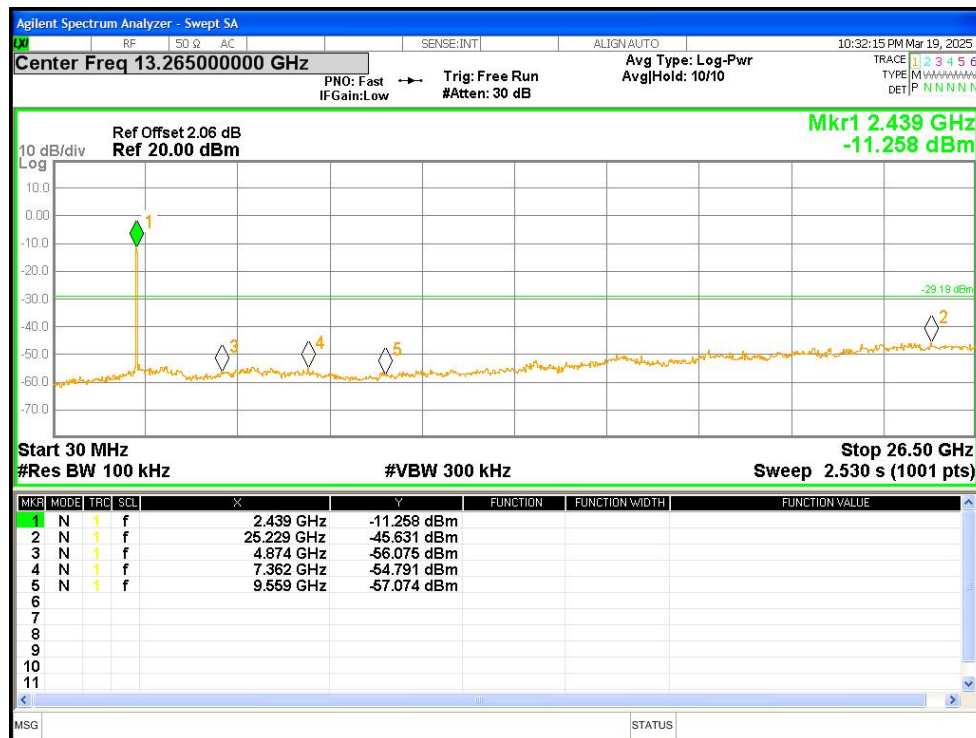
Tx. Spurious NVNT n40 2452MHz Ant1 Ref

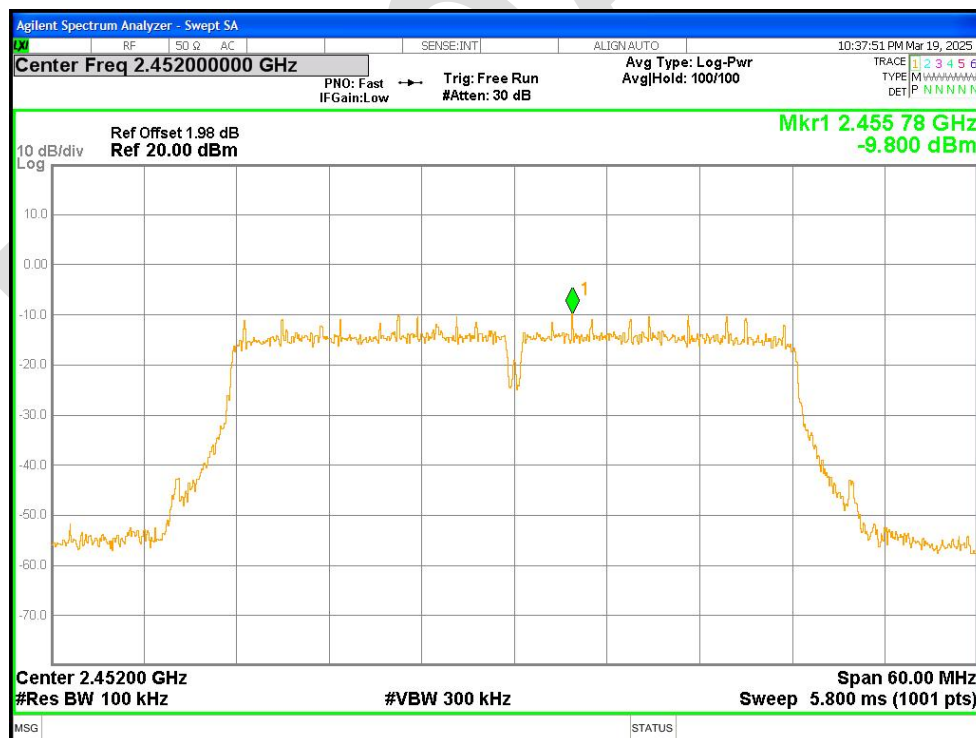
Tx. Spurious NVNT n40 2452MHz Ant1 Emission

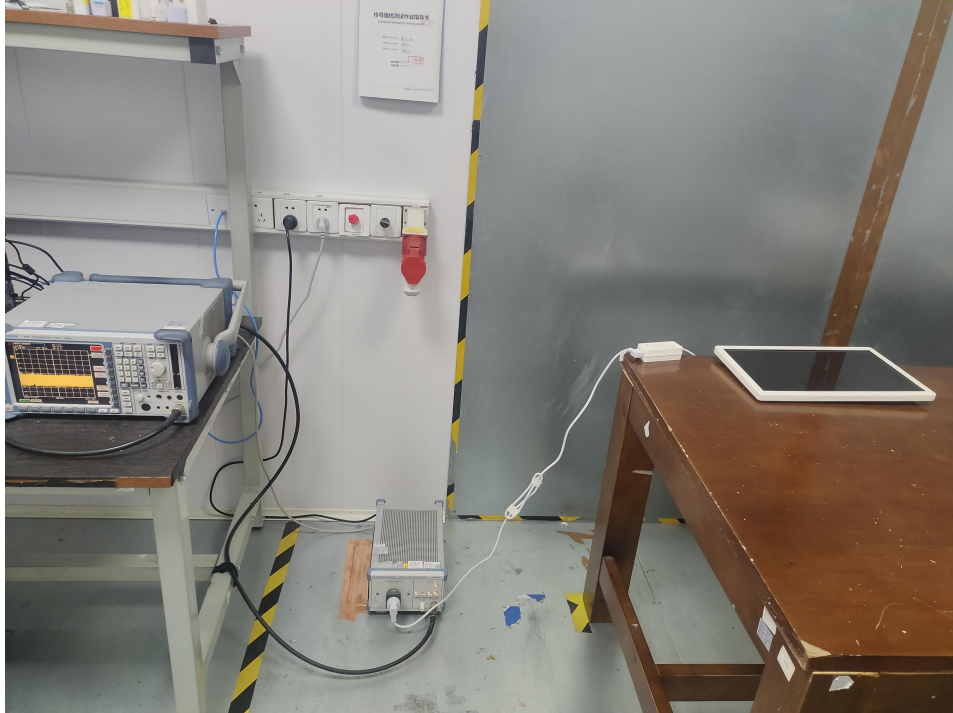
Conducted emissions at AC power line (150 kHz-30 MHz)

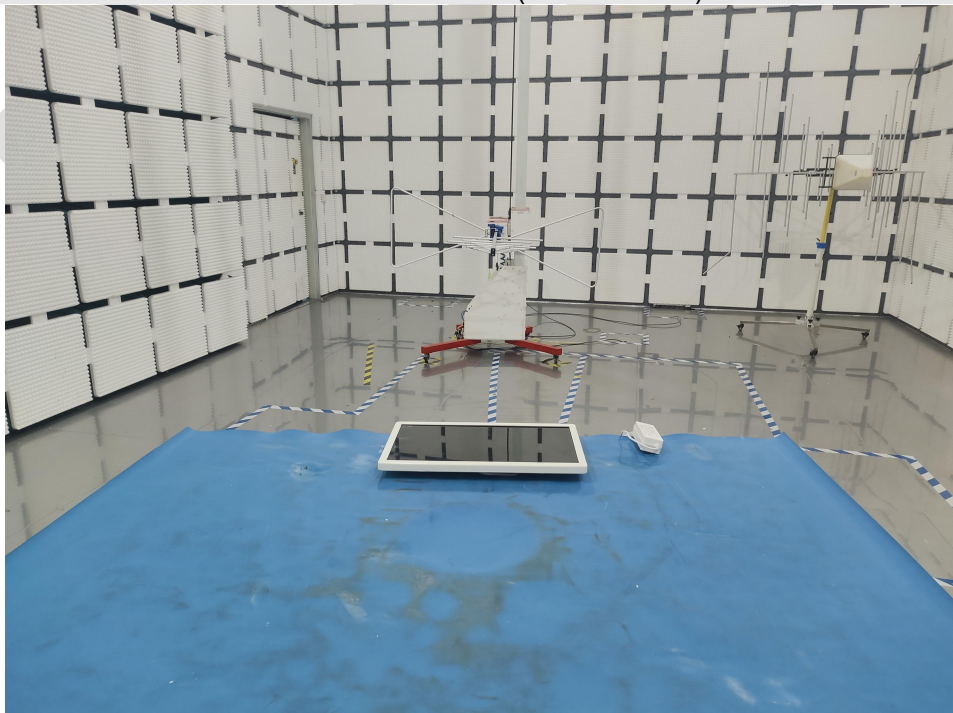
Radiated Emissions (30MHz-1GHz)

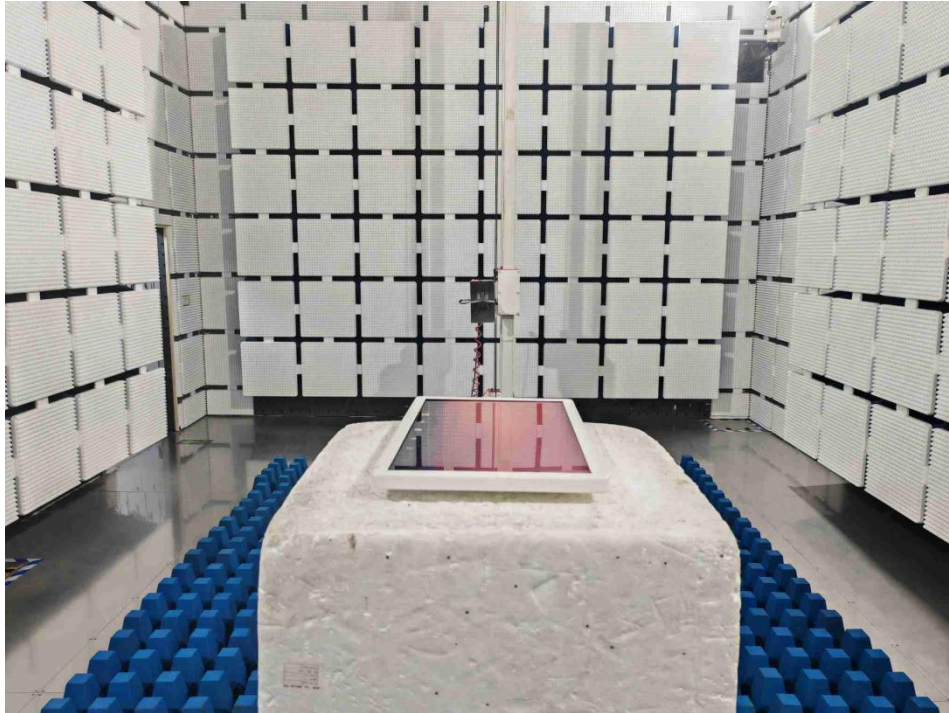
Radiated Emissions (above 1GHz)
