8) Internal Photos

Figure 1: Picture of **top** of part 101941 DT-RFIO-Module (US). Only the lids are removed from the two shield boxes to the right. ANT1 and 2 are indicated. ANT2 extends onto the bent part of the board, as indicated in Figure 2.

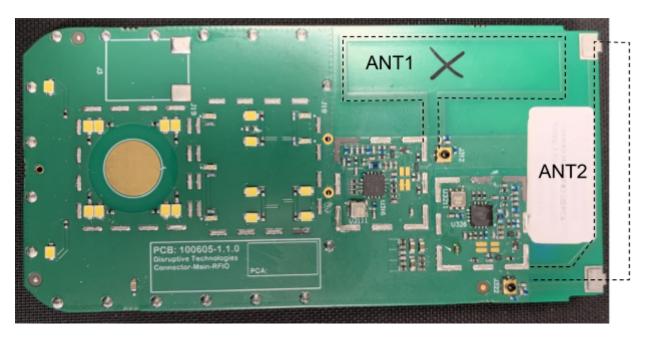
Figure 2: Picture of **top** of part 101941 DT-RFIO-Module (US). All shields are removed. ANT1 and 2 are indicated. ANT2 extends onto the bent part of the board, as indicated by the dotted line.

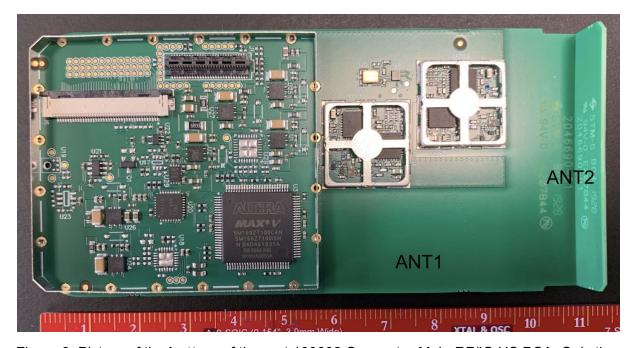
Figure 3: Picture of the **bottom** of the part 100602 Connector-Main-RF/IO US PCA. Only the lids are removed from the two shield boxes. The traces of the antennas go on the other side of the PCB.

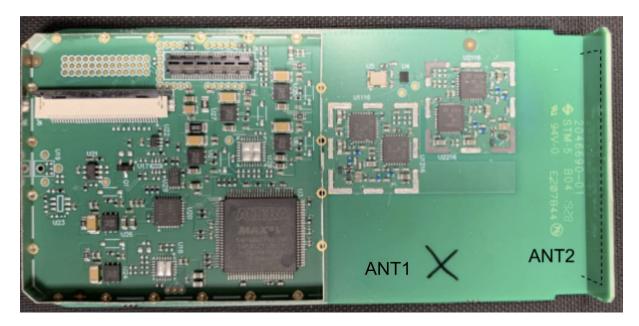
Figure 4: Picture of the **bottom** of the part 100602 Connector-Main-RF/IO US PCA. The shields are completely removed from the shield boxes and the extension of ANT2 onto the bent part of the board is indicated by the dotted line. The traces of the antennas go on the other side of the PCB.
