### **APPENDIX 3: Photographs of test setup**

#### **Radiated Spurious Emission**

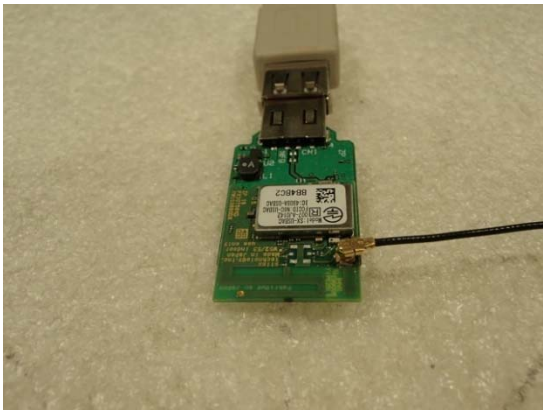
Module  
X-axis

Worst Case Position
