### **APPENDIX 3: Photographs of test setup**

#### **Radiated Spurious Emission**

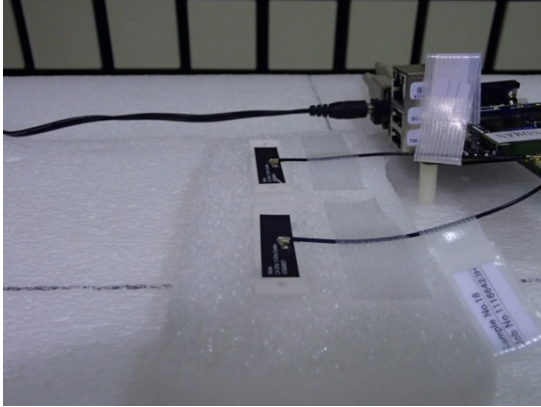
### Worst Case Position

**Molex Antenna**  
(Horizontal: X-axis/ Vertical: Z-axis)  
**X-axis**

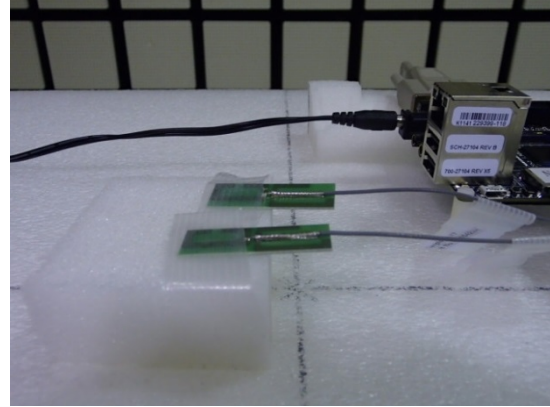
**Laird Antenna**  
(Horizontal: X-axis/ Vertical: Z-axis)  
**X-axis**

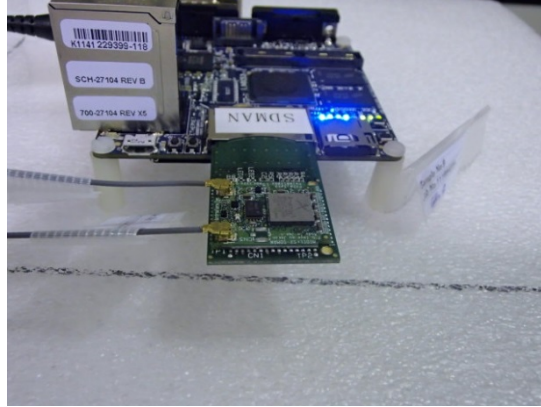
### Worst Case Position

**Module**  
(Horizontal: X-axis/ Vertical: X-axis)  
**X-axis**
