## Appendix 2

### Photodocumentation

Test report reference:  
M/EMV-01/260

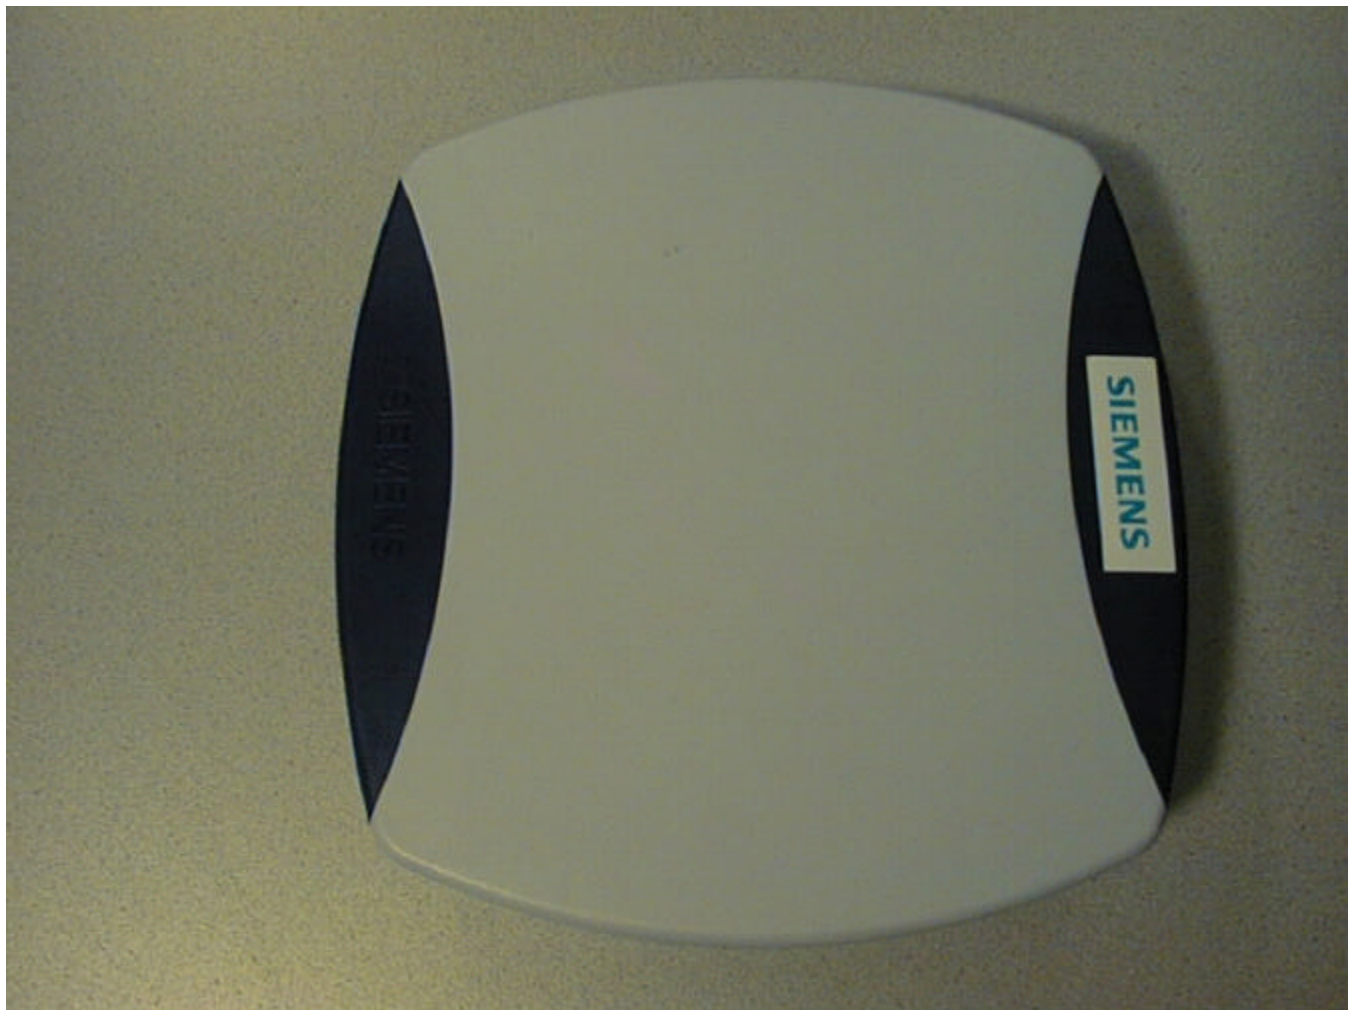
Description: Top view

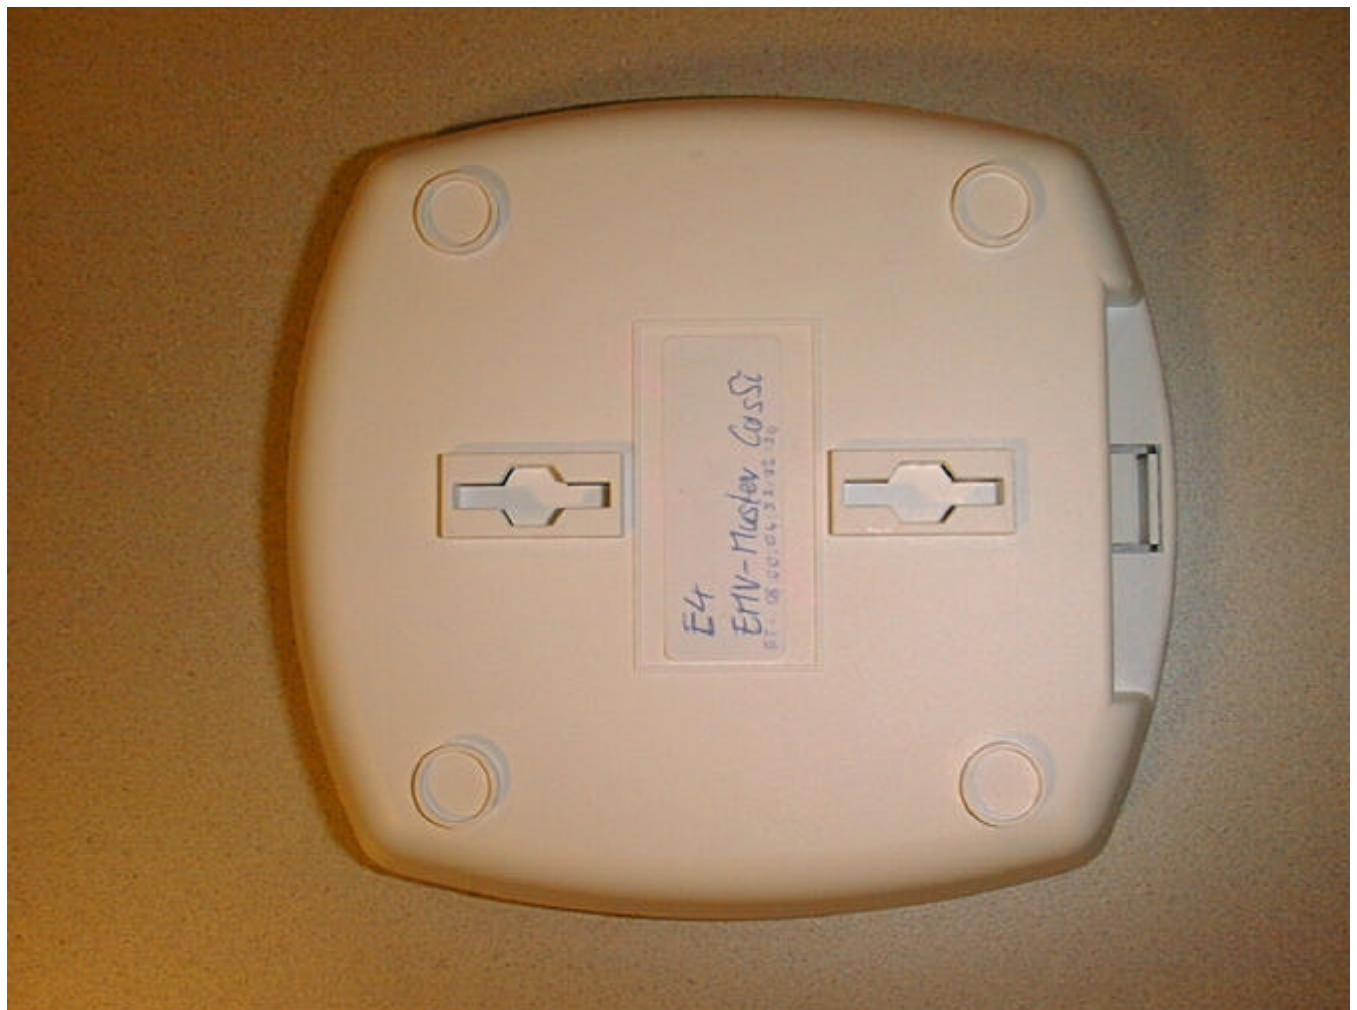
Description: Bottom view

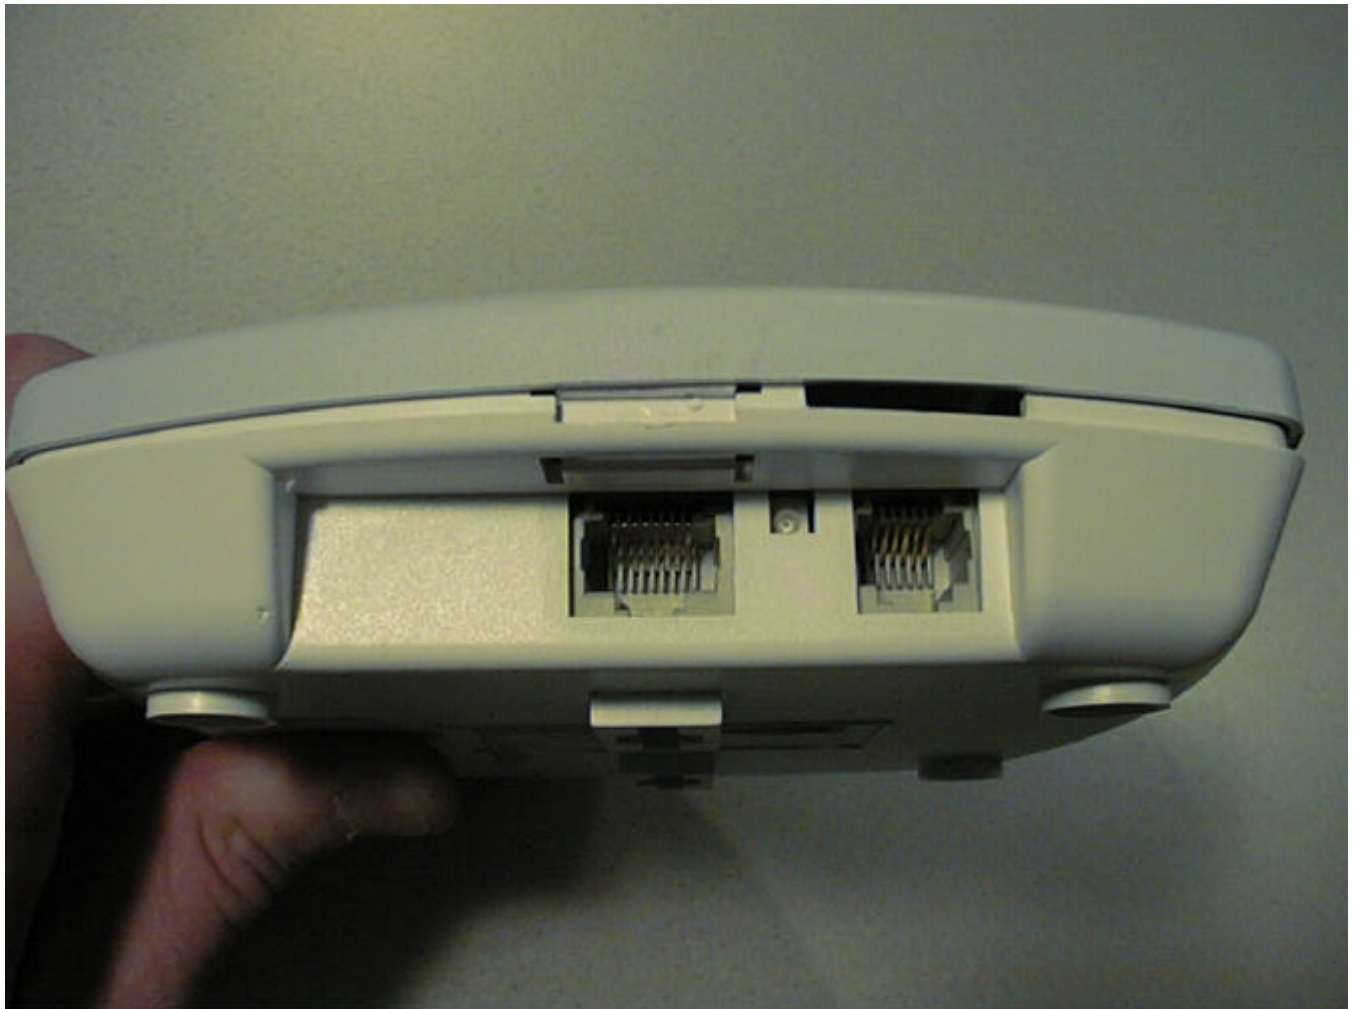
Description: View of connectors

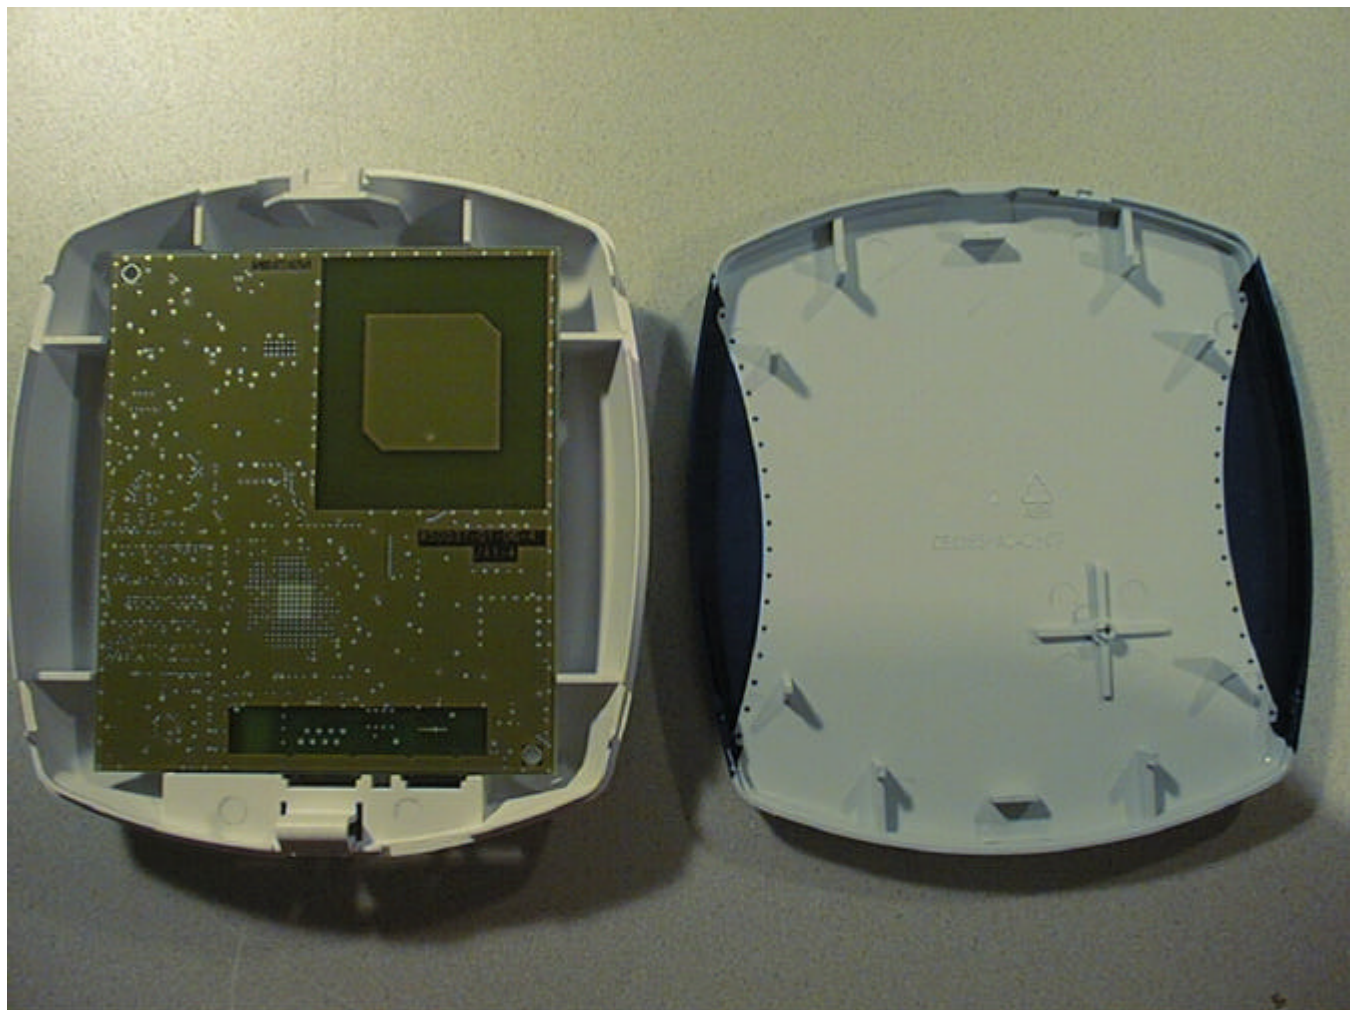
Description: Case opened

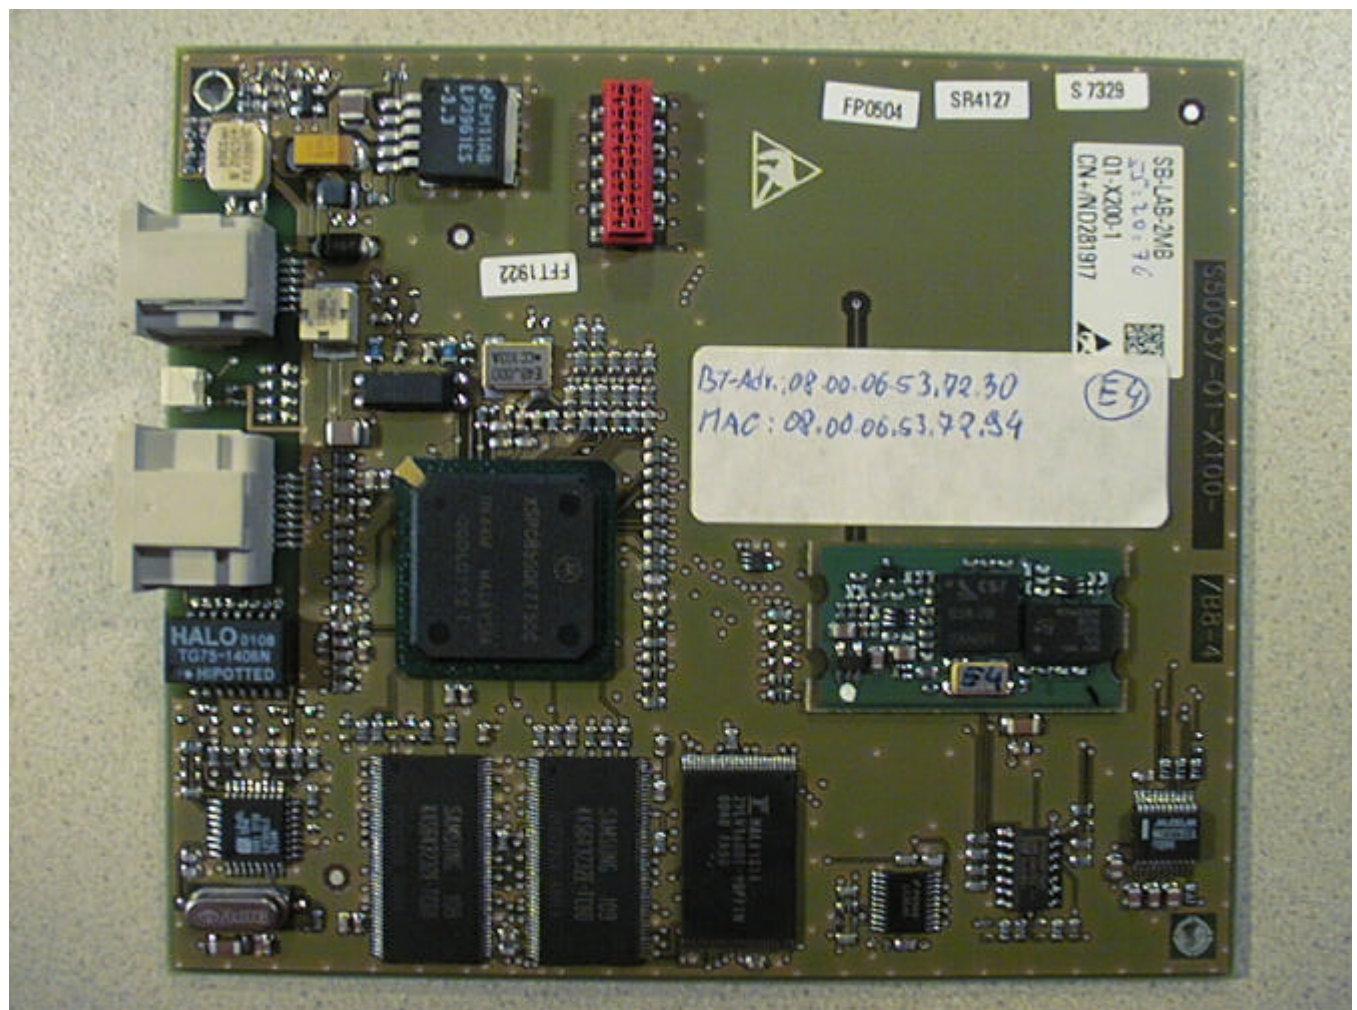
Description: PCB view #1

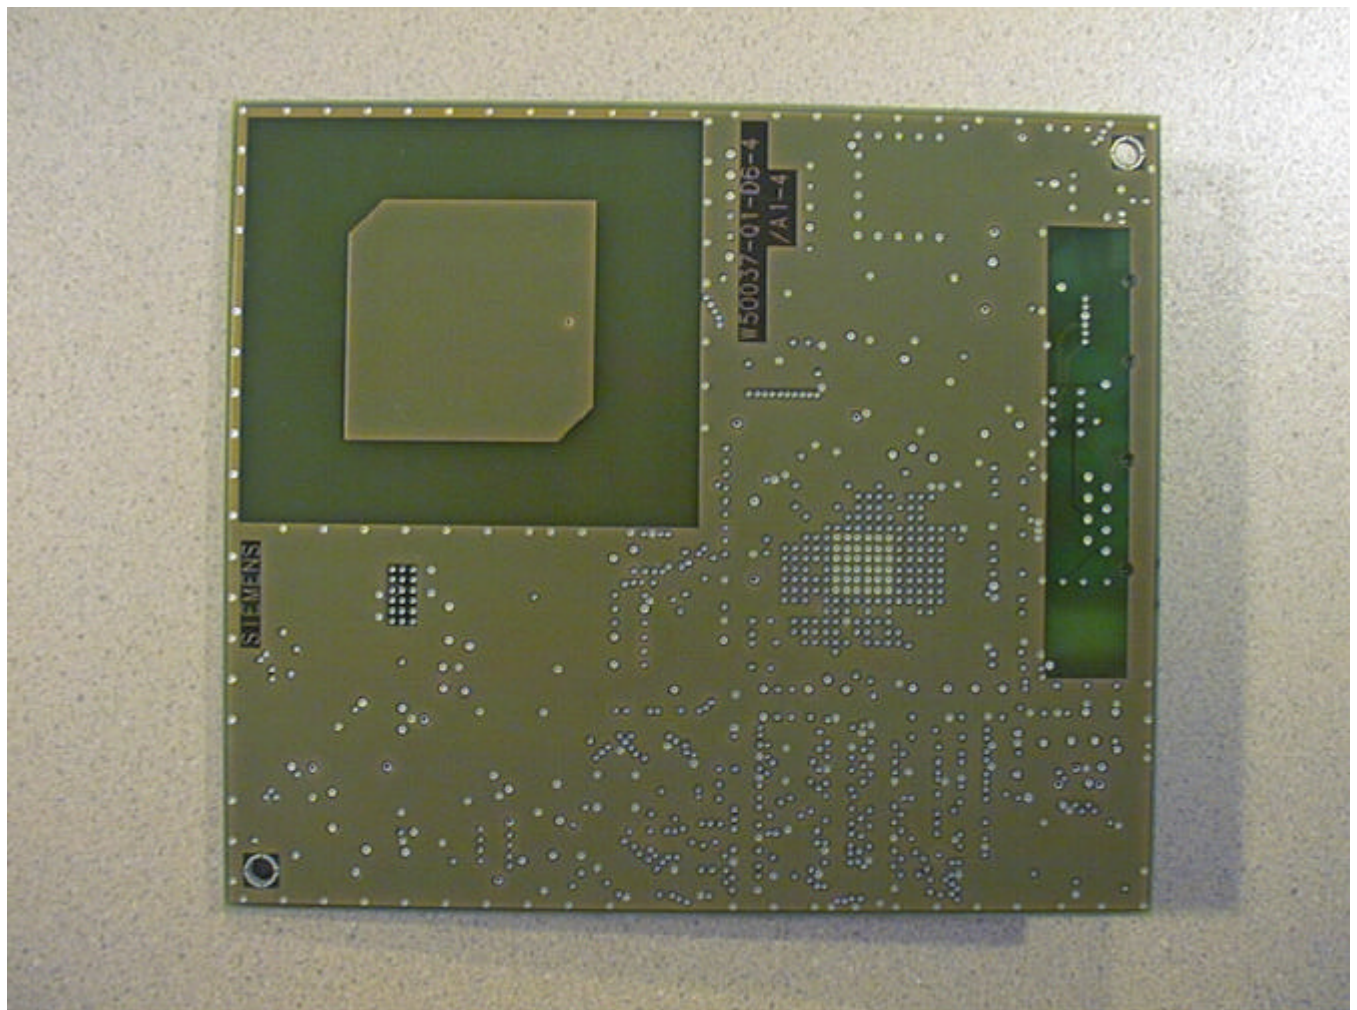
Description: PCB view #2

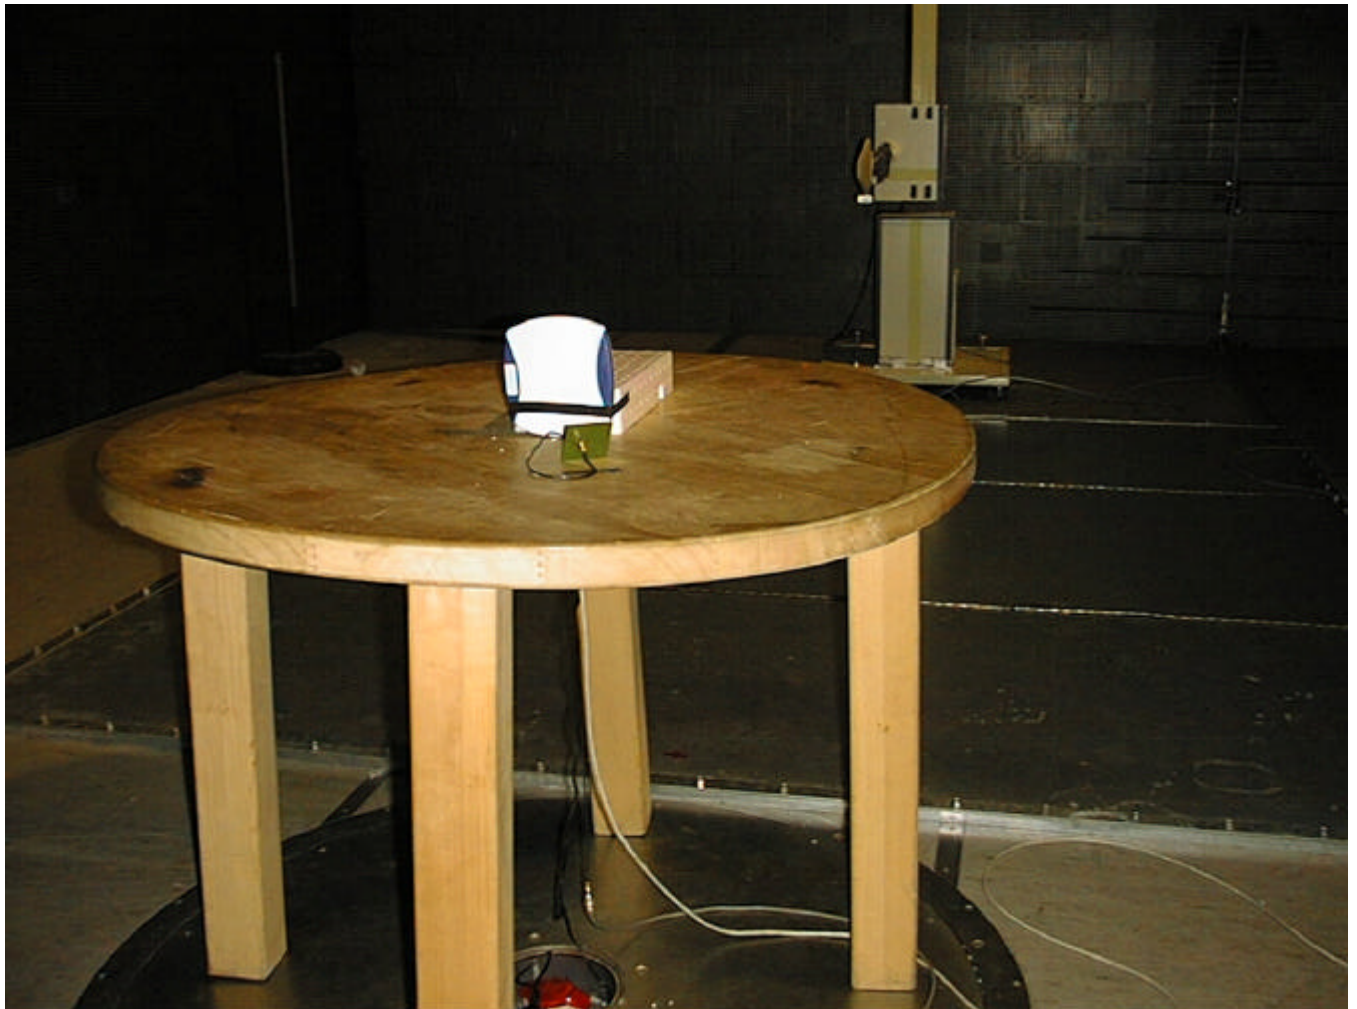
Description: Test setup radiated emissions 30  
MHz to 2 GHz

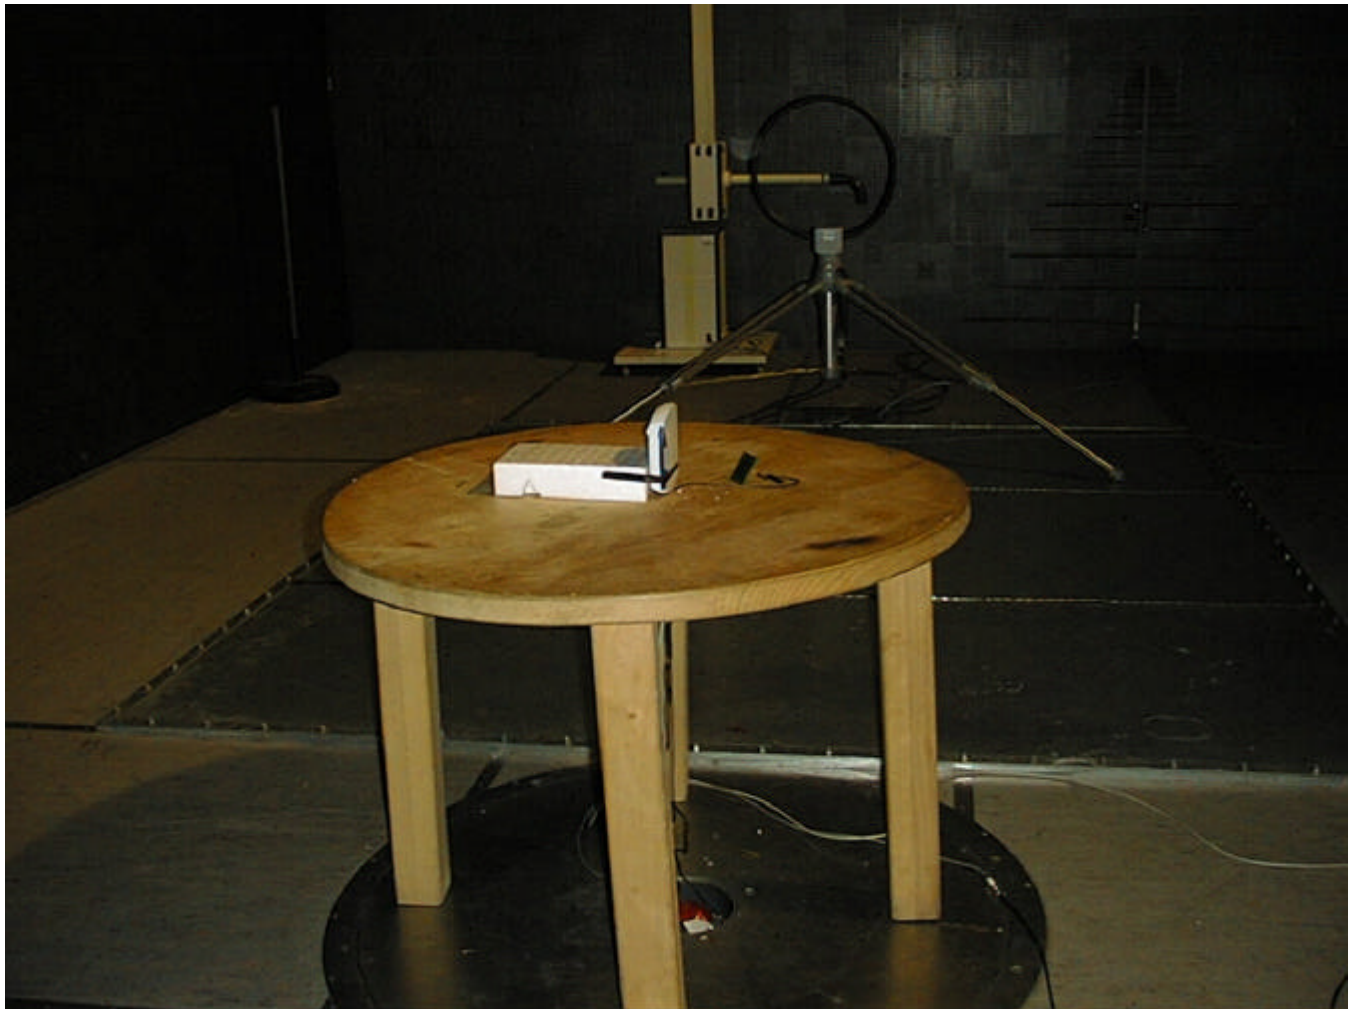
Description: Test setup radiated emissions below  
30 MHz

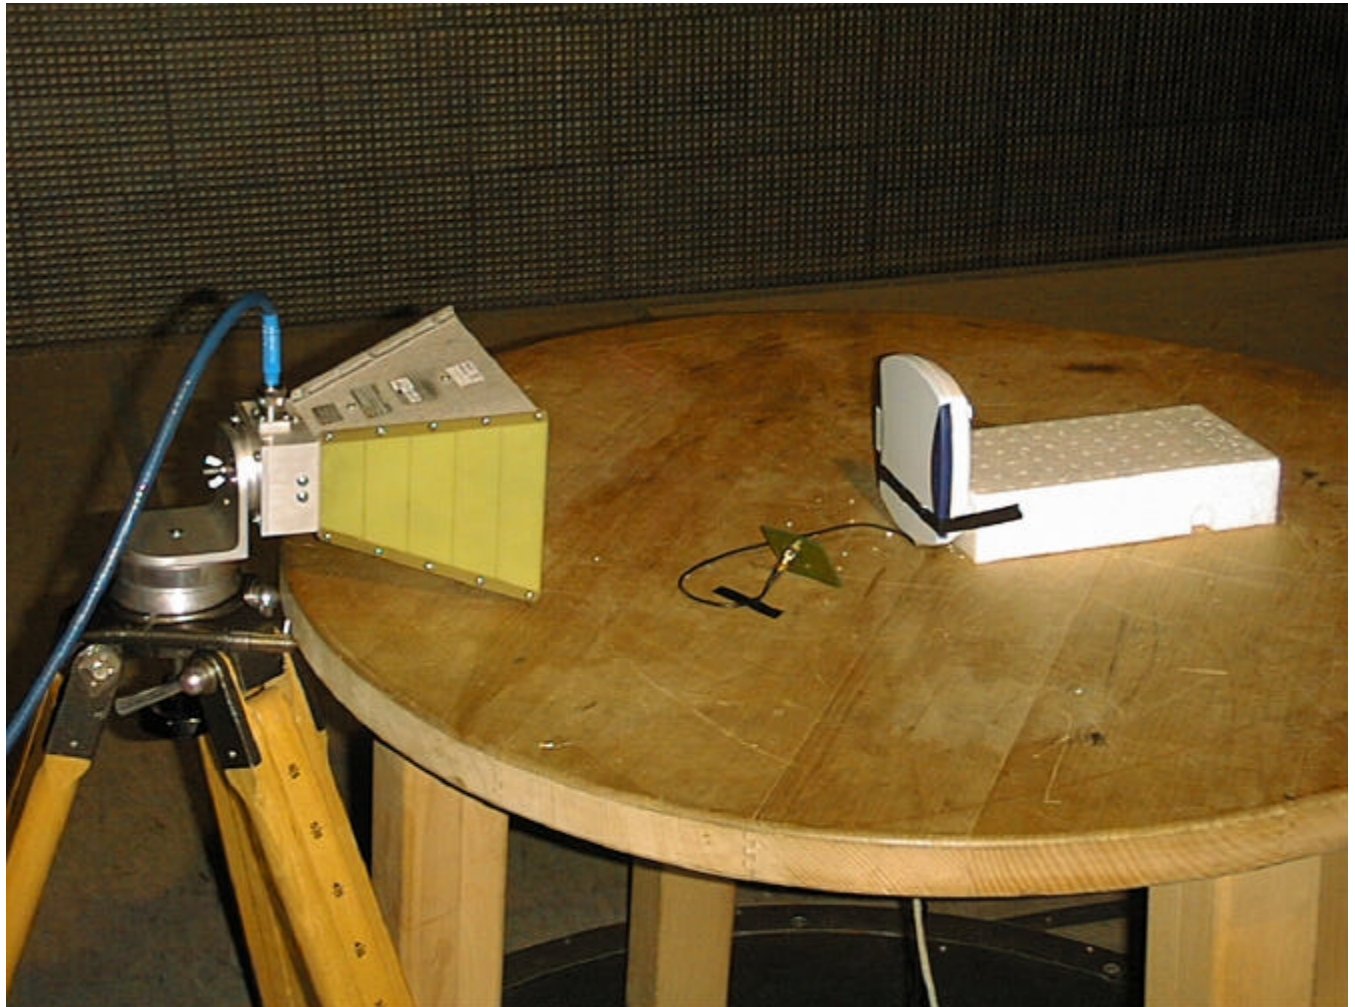
Description: Test setup radiated emissions above 2 GHz\*

\* The measurement distance was reduced because no emissions were found in 1m distance, but there were no emissions found with the smaller distance too.

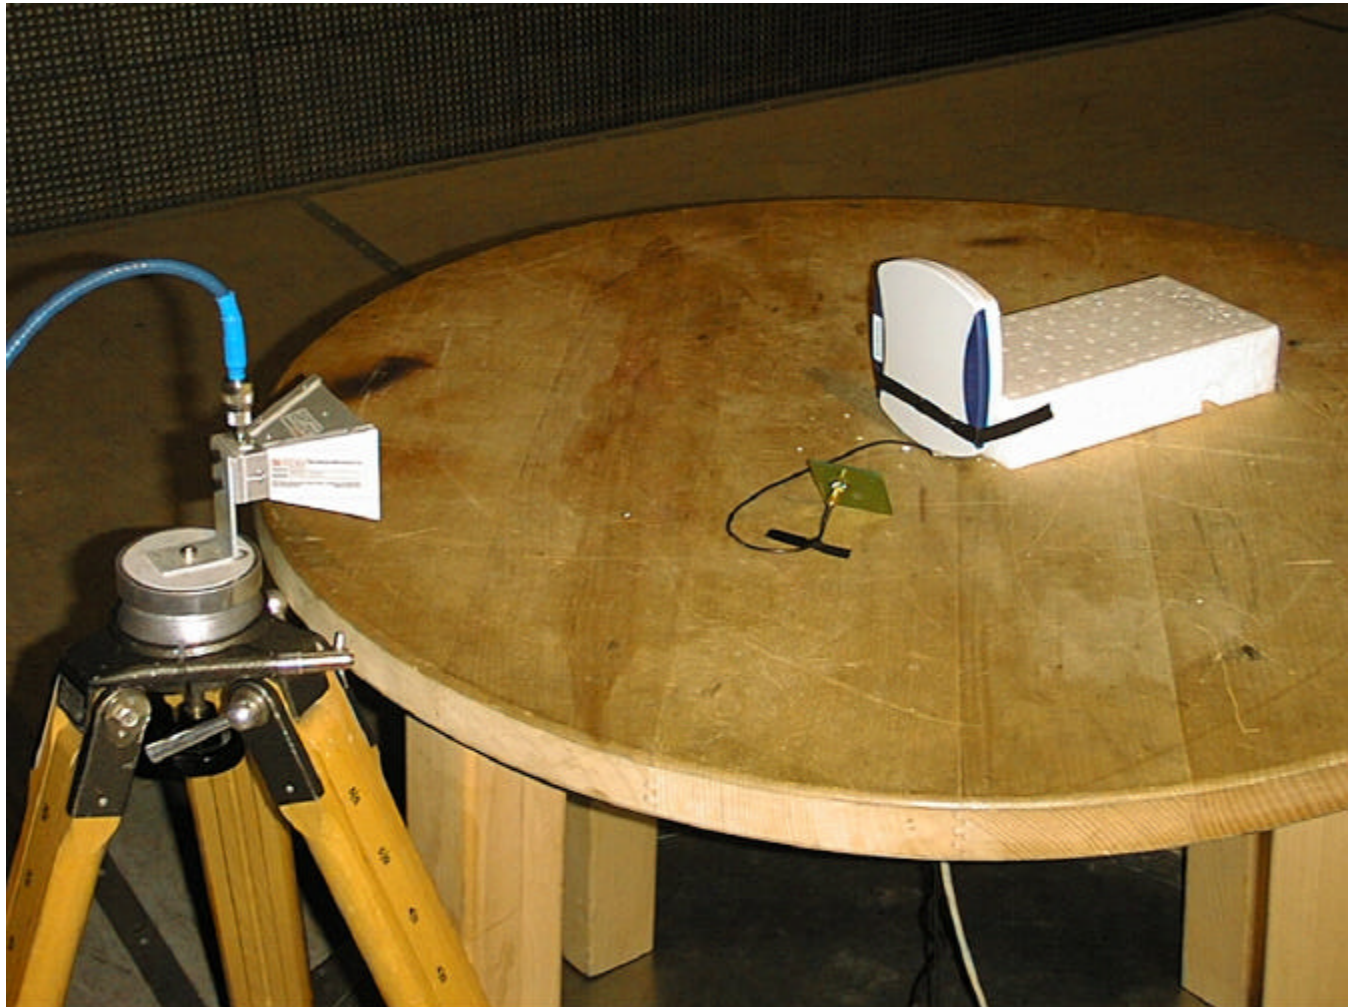
Description: Test setup radiated emissions above 18 GHz\*

\* The measurement distance was reduced because no emissions were found in 1m distance, but there were no emissions found with the smaller distance too.
