## APPENDIX A: PHOTOGRAPHS OF TEST SETUP

Reference to the test report No. BLA-EMC-202303-A10001

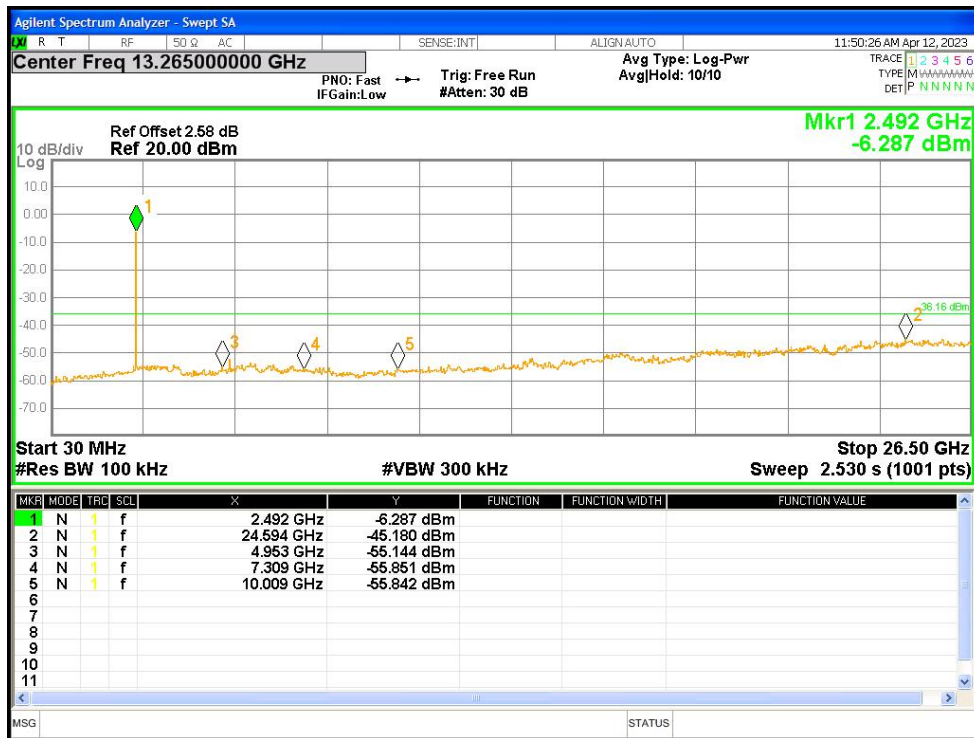
Tx. Spurious NVNT BLE 2M 2402MHz Ant1 Ref

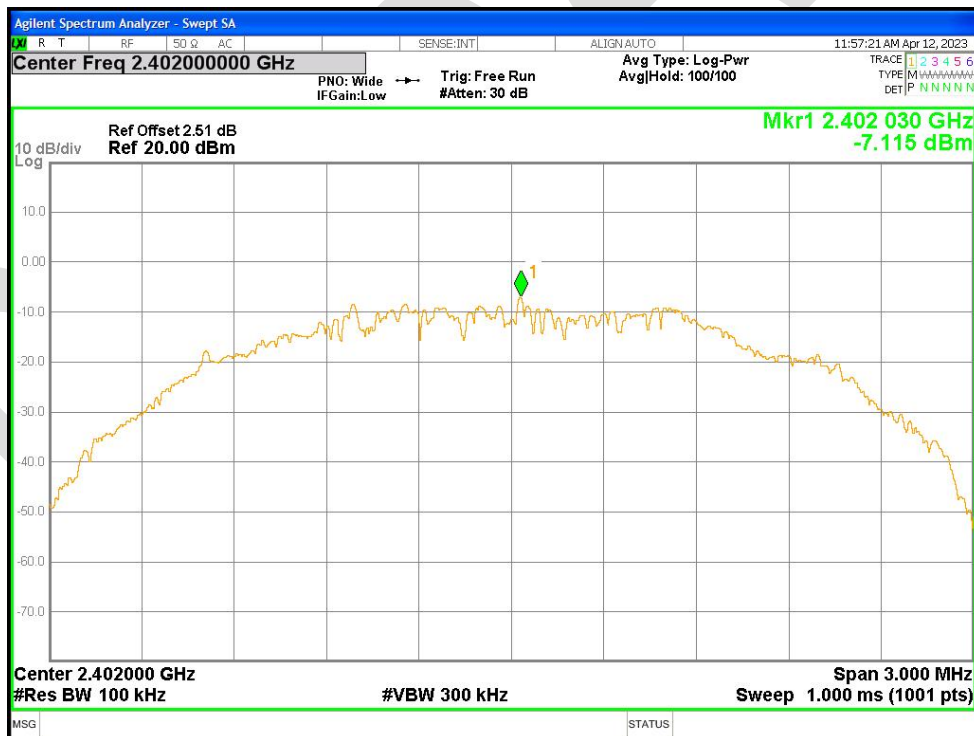
Tx. Spurious NVNT BLE 2M 2402MHz Ant1 Emission

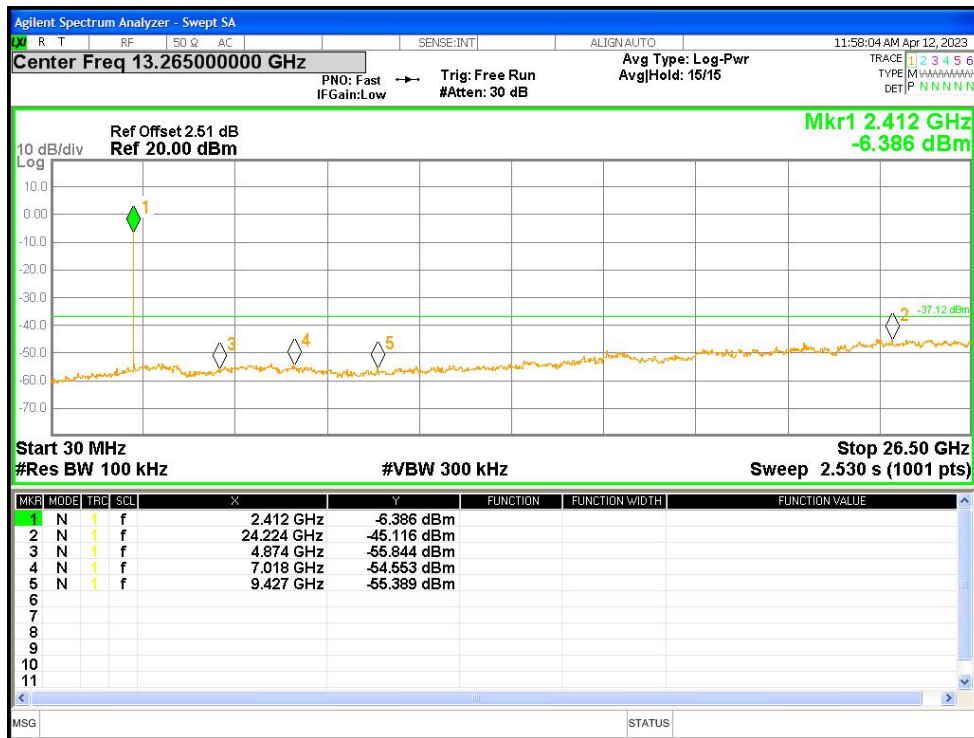
Tx. Spurious NVNT BLE 2M 2442MHz Ant1 Ref

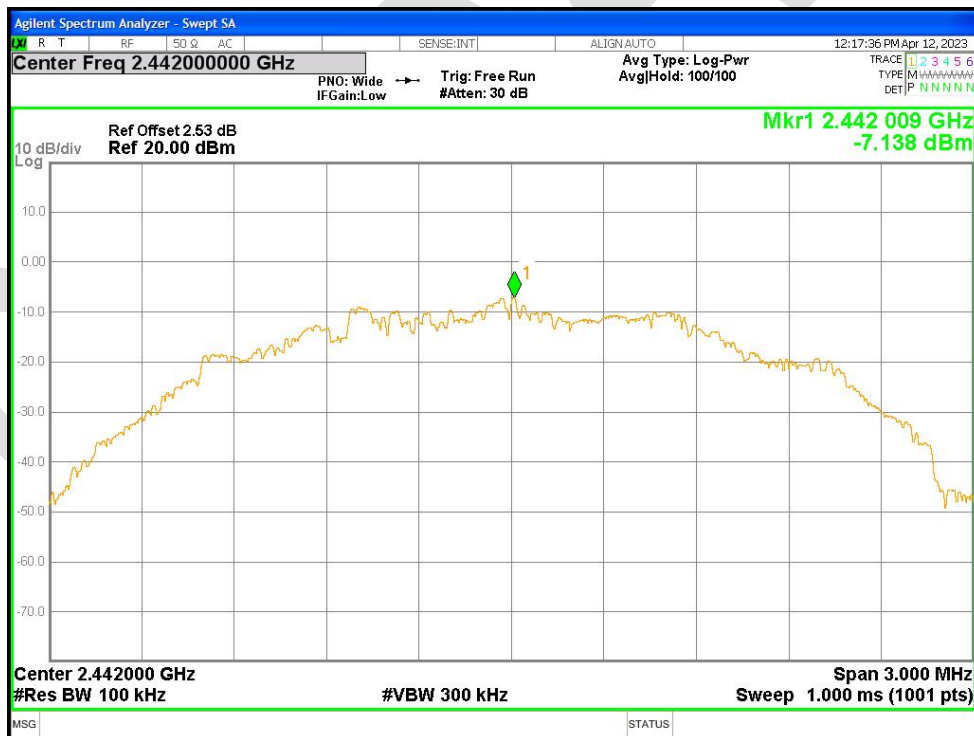
Tx. Spurious NVNT BLE 2M 2442MHz Ant1 Emission

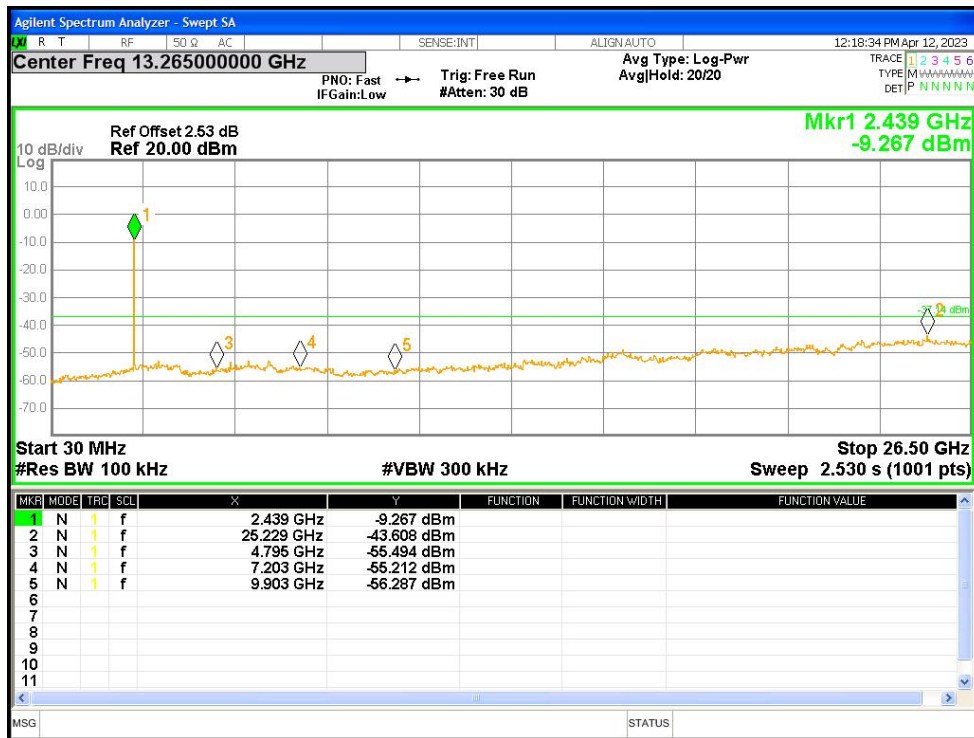
Tx. Spurious NVNT BLE 2M 2480MHz Ant1 Ref

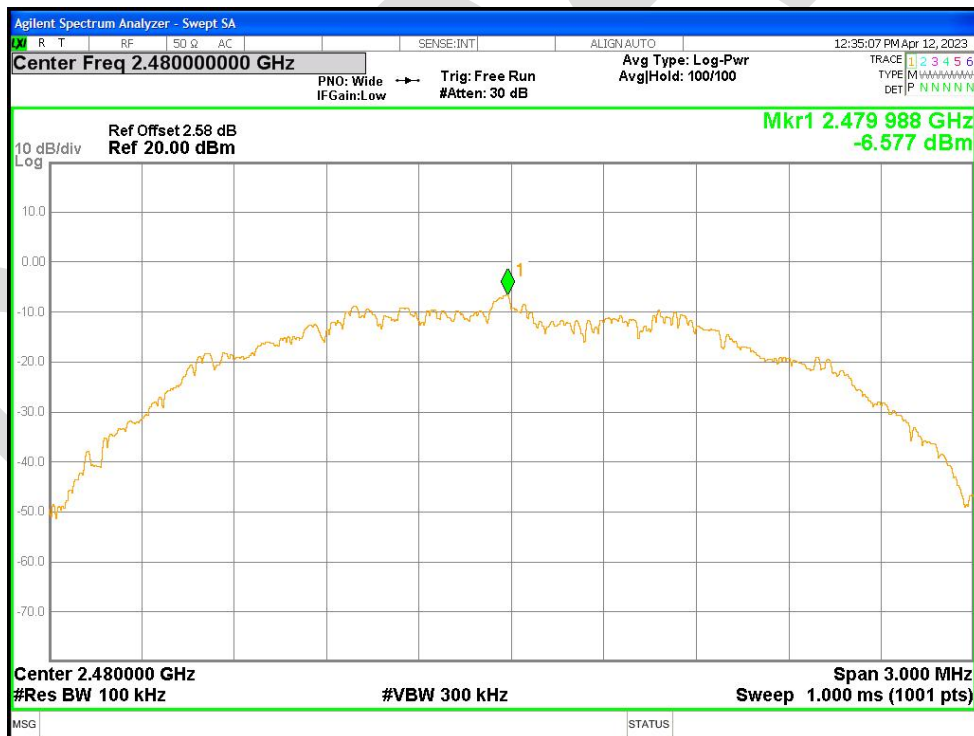
Tx. Spurious NVNT BLE 2M 2480MHz Ant1 Emission

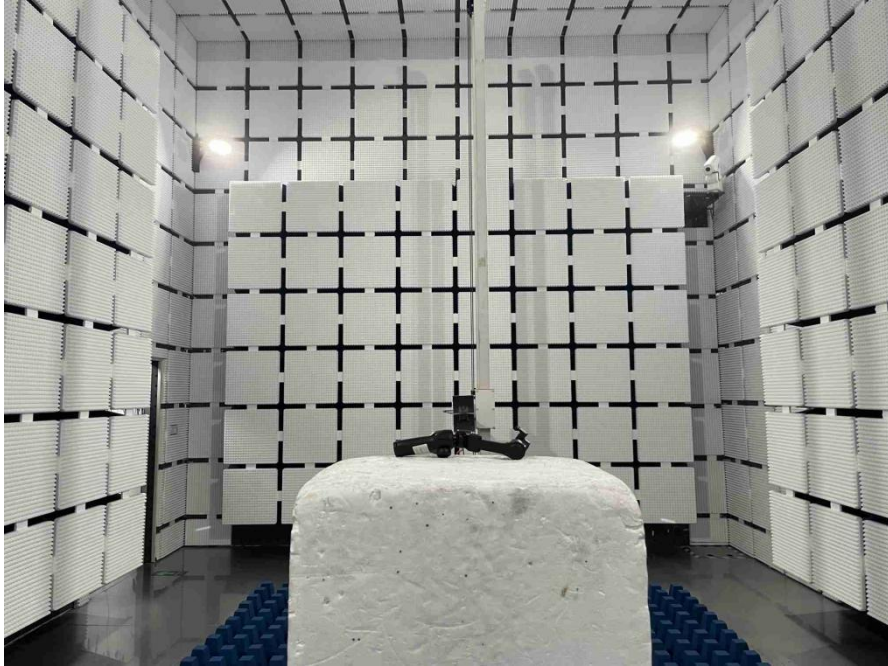
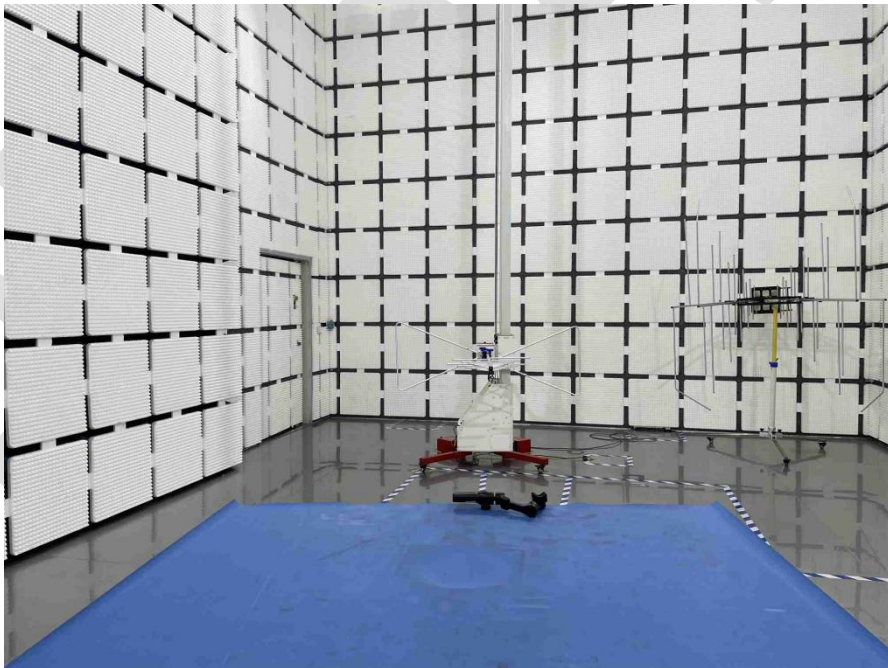
### Radiated Spurious Emissions

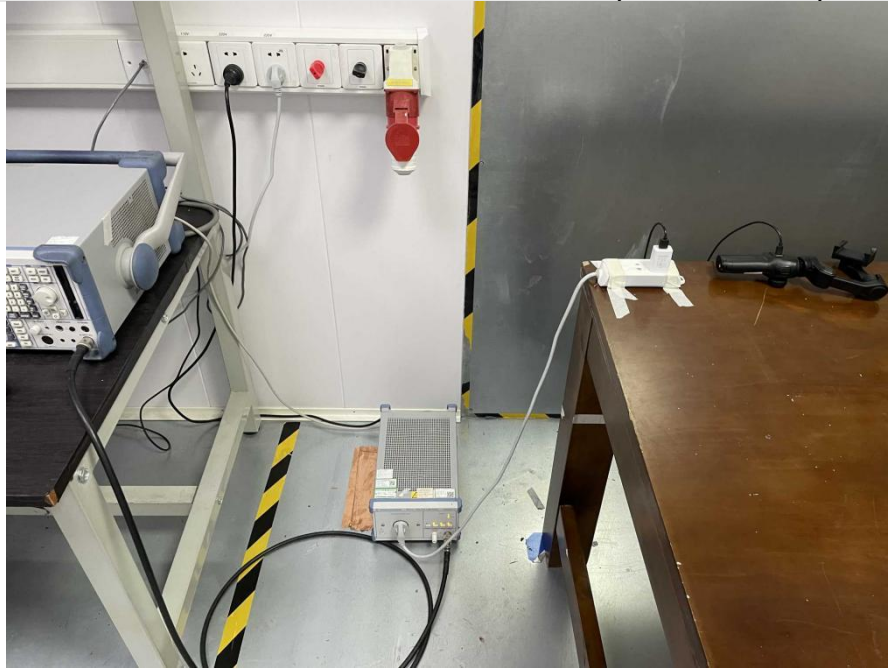
**Conducted Emissions at AC Power Line (150kHz-30MHz)**
