Report No.: EED32Q80426701 Page 32 of 39

9 PHOTOGRAPHS OF TEST SETUP

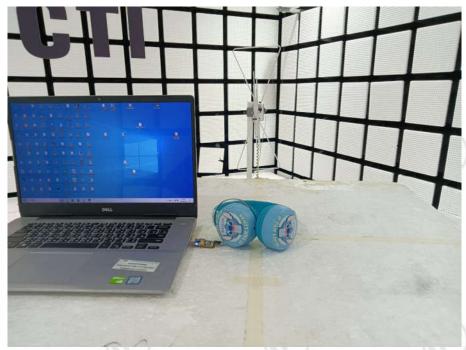
Radiated spurious emission Test Setup-1(Below 1GHz)

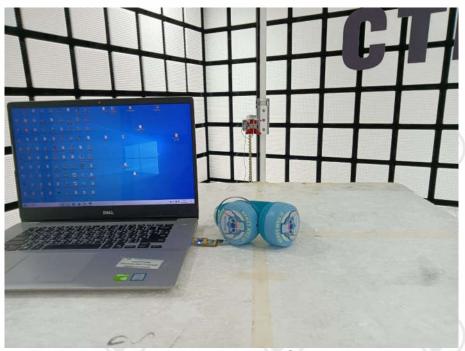
Radiated spurious emission Test Setup-2(Above 1GHz)

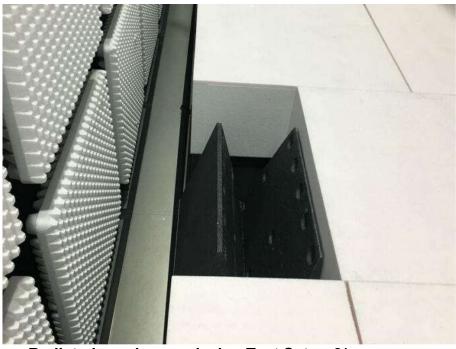
Radiated spurious emission Test Setup-3(Above 1GHz) There are absorbing materials under the ground.

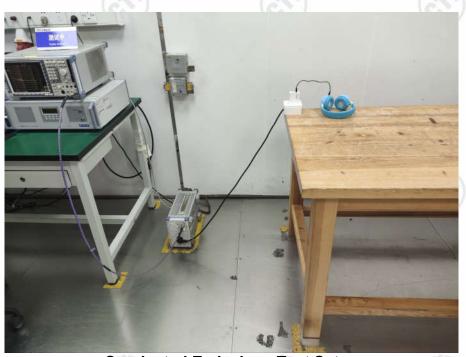
Conducted Emissions Test Setup
