### **APPENDIX 3: Photographs of test setup**

#### **Radiated Spurious Emission**

### Antenna Terminal Conducted Tests

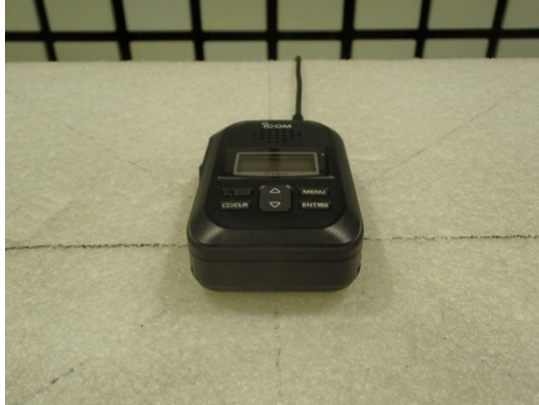
**X-axis**

**Worst Case Position**

**Below 1 GHz (Horizontal: X-axis/ Vertical: X-axis)**

**Above 1 GHz (Horizontal: X-axis/ Vertical: Y-axis)**
