# Radiated Emission Measurement

Condition : FCC\_part 15E RE\_Above 1GHz\_PK

EUT : W6M22311-23090

Test Mode : TX 802.11n20 CH44

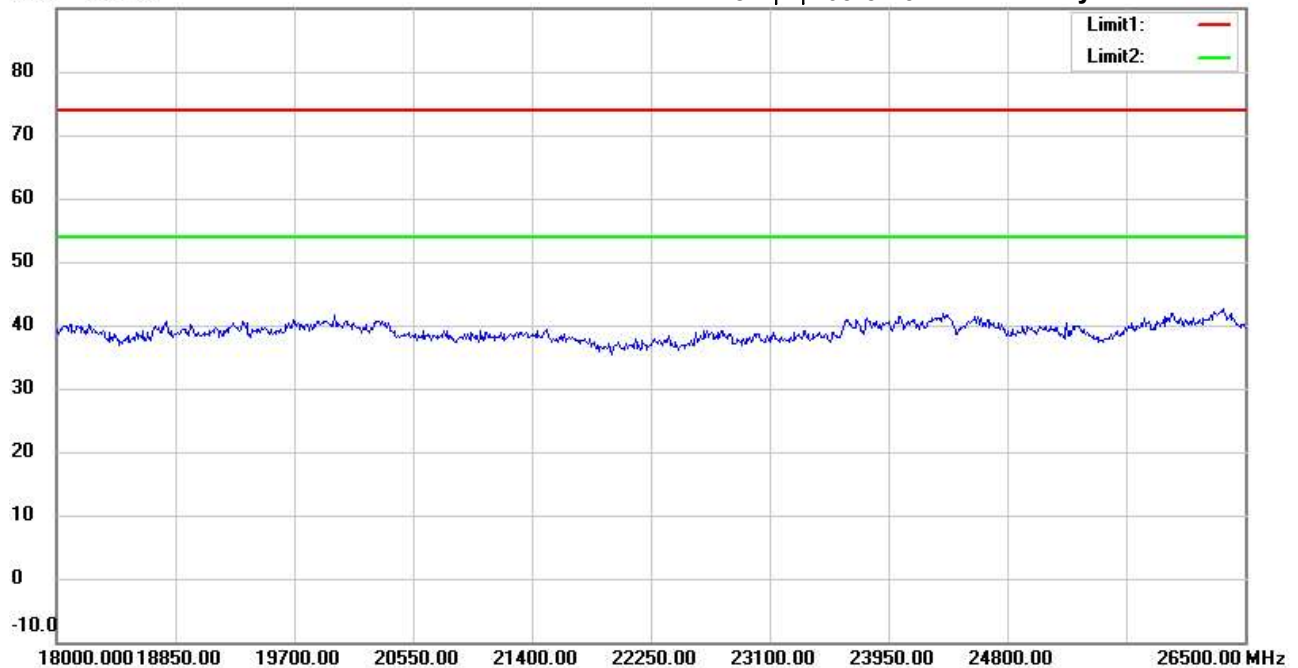
Polarization: **Horizontal**

Distance: 3m

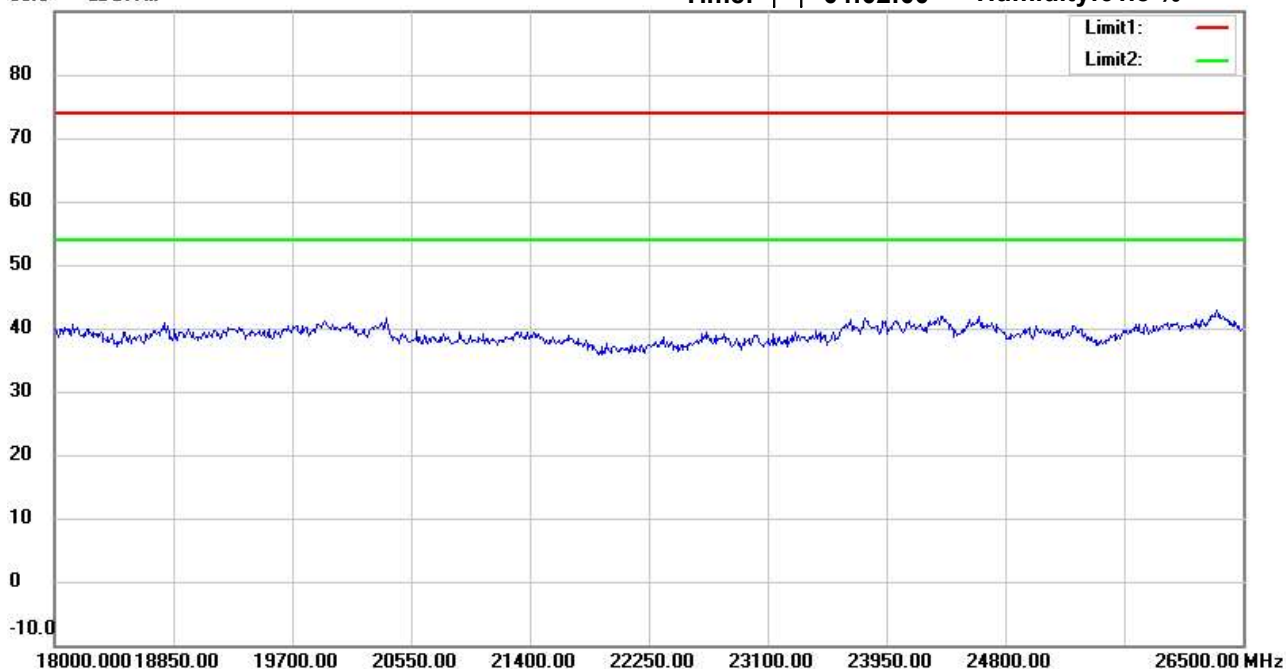
Condition : FCC\_part 15E RE\_Above 1GHz\_PK

Test Mode : TX 802.11n20 CH44

Polarization: **Vertical**

Distance: 3m

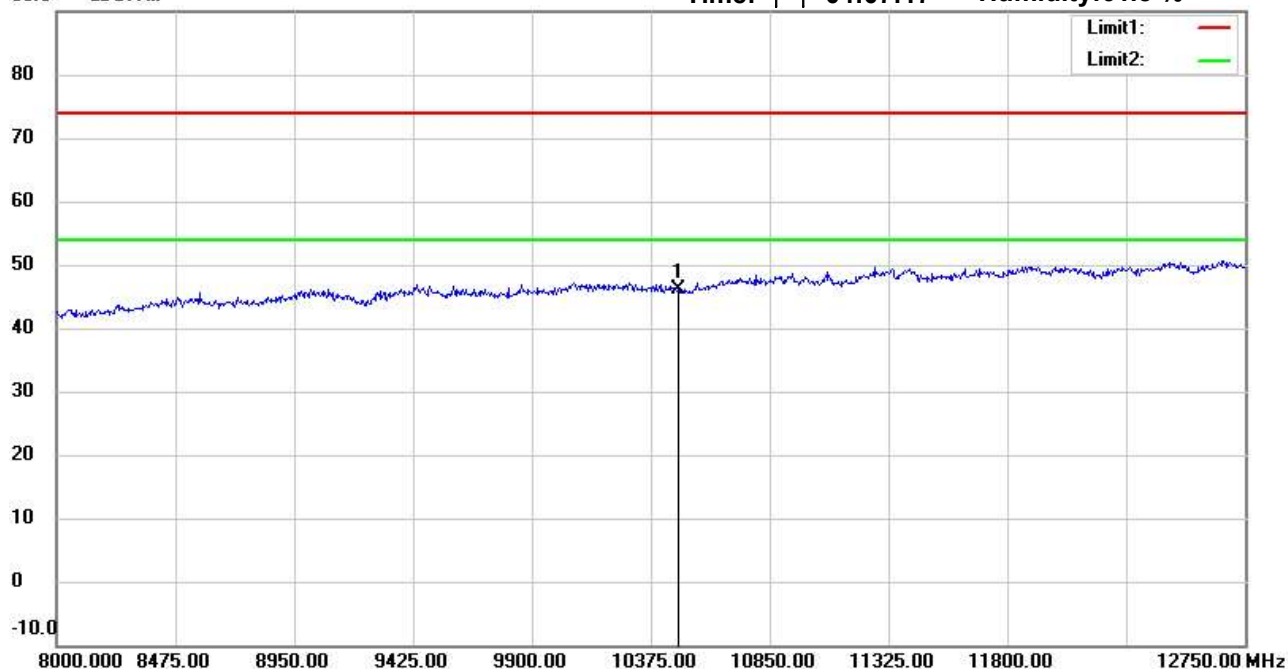
Condition : FCC\_part 15E RE\_Above 1GHz\_PK

Test Mode : TX 802.11n20 CH48

Polarization: **Horizontal**

| Mk. | Frequency (MHz) | Reading (dBuV) | Detector | Corr. factor (dB/m) | Result (dBuV/m) | Limit (dBuV/m) | Ant.Pos (cm) | Tab.Pos (deg.) | Margin (dB) | Comment |
|---|---|---|---|---|---|---|---|---|---|---|
| * | 10480.000 | 32.10 | peak | 14.08 | 46.18 | 74.00 | 150 | 45 | -27.82 | |

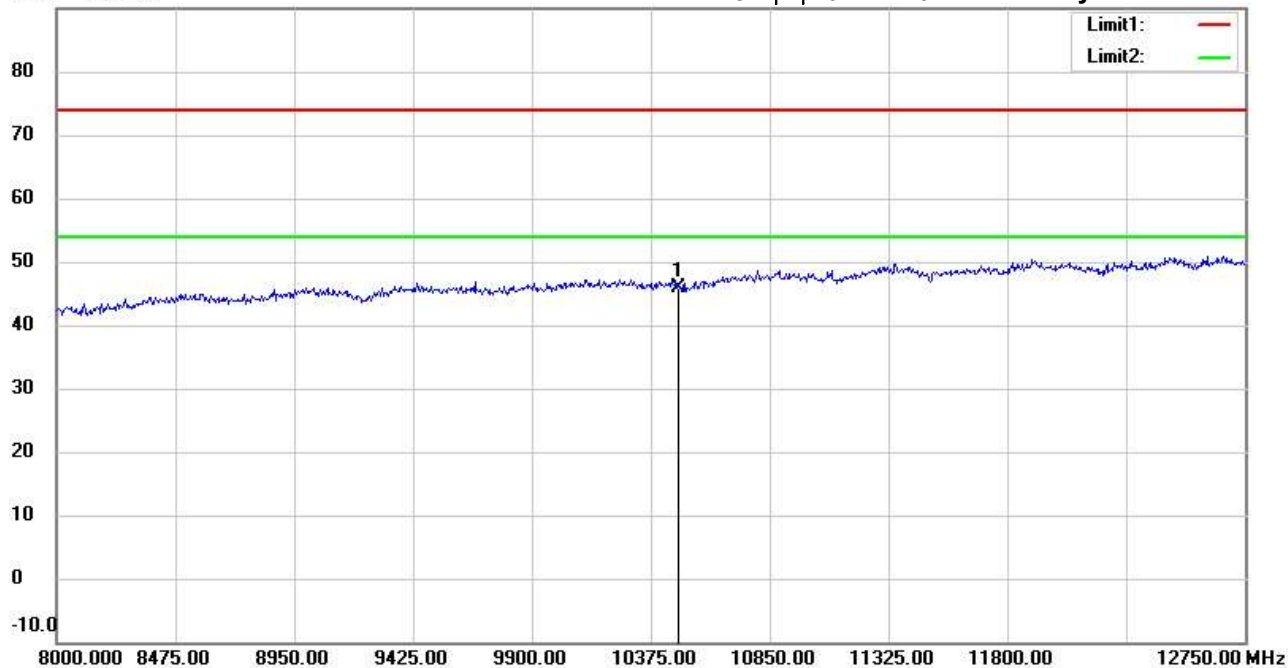
Condition : FCC\_part 15E RE\_Above 1GHz\_PK

Test Mode : TX 802.11n20 CH48

Polarization: **Vertical**

| Mk. | Frequency (MHz) | Reading (dBuV) | Detector | Corr. factor (dB/m) | Result (dBuV/m) | Limit (dBuV/m) | Ant.Pos (cm) | Tab.Pos (deg.) | Margin (dB) | Comment |
|---|---|---|---|---|---|---|---|---|---|---|
| * | 10480.000 | 31.87 | peak | 14.08 | 45.95 | 74.00 | 150 | 10 | -28.05 | |

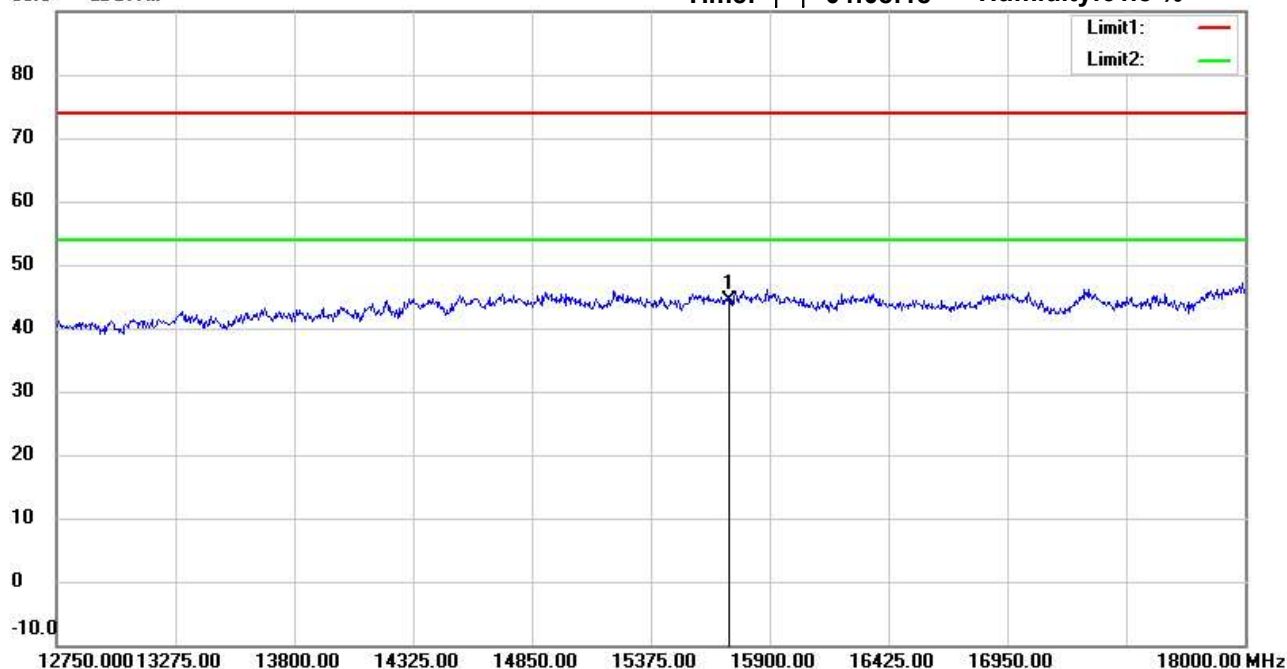
Condition : FCC\_part 15E RE\_Above 1GHz\_PK

Test Mode : TX 802.11n20 CH48

Polarization: **Horizontal**

| Mk. | Frequency (MHz) | Reading (dBuV) | Detector | Corr. factor (dB/m) | Result (dBuV/m) | Limit (dBuV/m) | Ant.Pos (cm) | Tab.Pos (deg.) | Margin (dB) | Comment |
|---|---|---|---|---|---|---|---|---|---|---|
| * | 15720.000 | 21.19 | peak | 23.09 | 44.28 | 74.00 | 150 | 285 | -29.72 | |

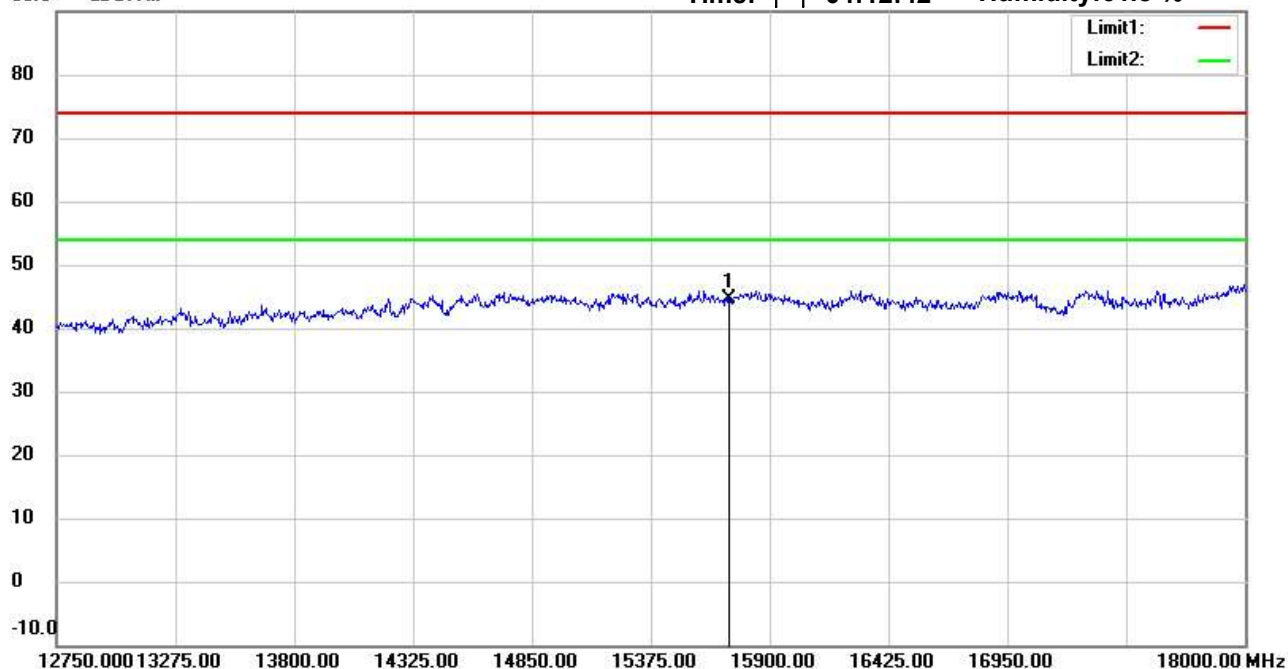
Condition : FCC\_part 15E RE\_Above 1GHz\_PK

Test Mode : TX 802.11n20 CH48

Polarization: Vertical

| Mk. | Frequency (MHz) | Reading (dBuV) | Detector | Corr. factor (dB/m) | Result (dBuV/m) | Limit (dBuV/m) | Ant.Pos (cm) | Tab.Pos (deg.) | Margin (dB) | Comment |
|---|---|---|---|---|---|---|---|---|---|---|
| * | 15720.000 | 21.45 | peak | 23.09 | 44.54 | 74.00 | 150 | 285 | -29.46 | |

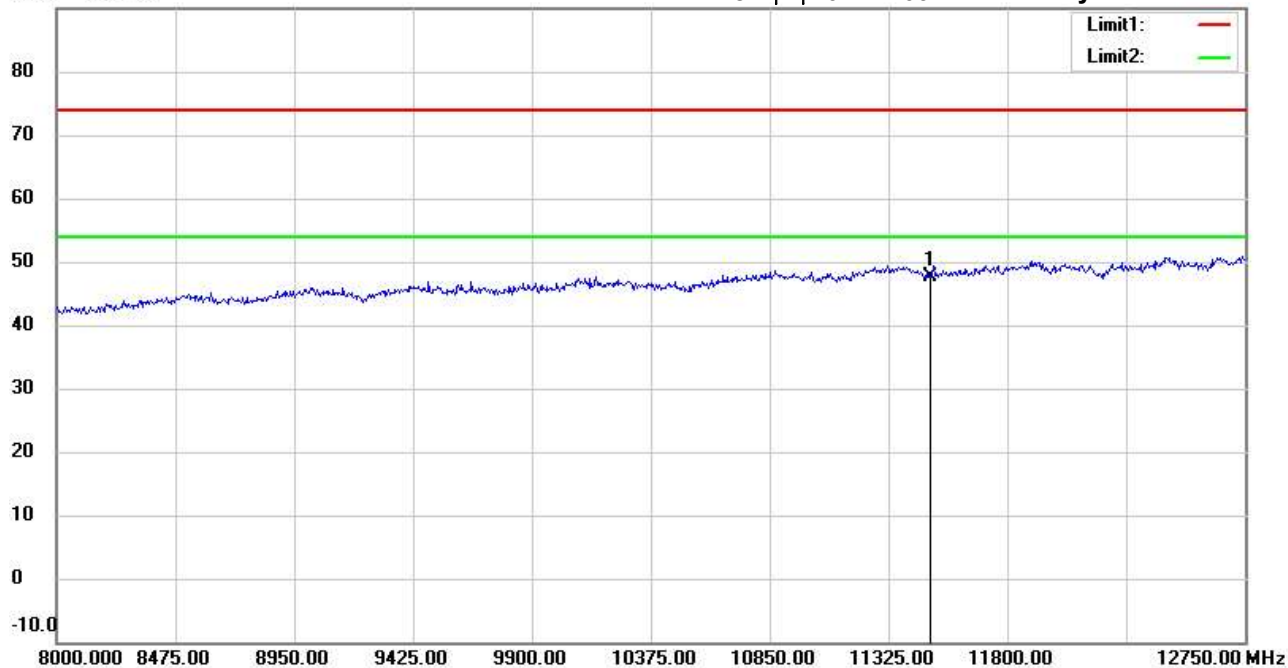
Condition : FCC\_part 15E RE\_Above 1GHz\_PK

Test Mode : TX 802.11n20 CH149

Polarization: **Horizontal**

| Mk. | Frequency (MHz) | Reading (dBuV) | Detector | Corr. factor (dB/m) | Result (dBuV/m) | Limit (dBuV/m) | Ant.Pos (cm) | Tab.Pos (deg.) | Margin (dB) | Comment |
|---|---|---|---|---|---|---|---|---|---|---|
| * | 11490.000 | 31.11 | peak | 16.42 | 47.53 | 74.00 | 150 | 165 | -26.47 | |

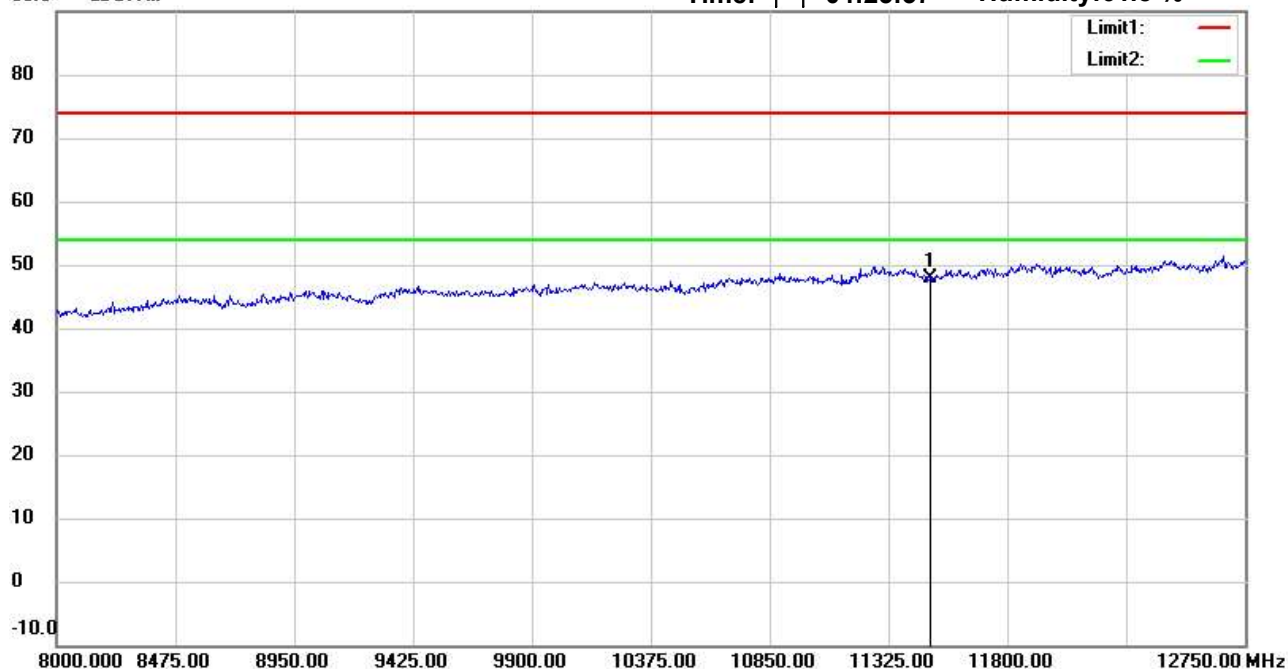
Condition : FCC\_part 15E RE\_Above 1GHz\_PK

Test Mode : TX 802.11n20 CH149

Polarization: Vertical

| Mk. | Frequency (MHz) | Reading (dBuV) | Detector | Corr. factor (dB/m) | Result (dBuV/m) | Limit (dBuV/m) | Ant.Pos (cm) | Tab.Pos (deg.) | Margin (dB) | Comment |
|---|---|---|---|---|---|---|---|---|---|---|
| * | 11490.000 | 31.42 | peak | 16.42 | 47.84 | 74.00 | 150 | 55 | -26.16 | |

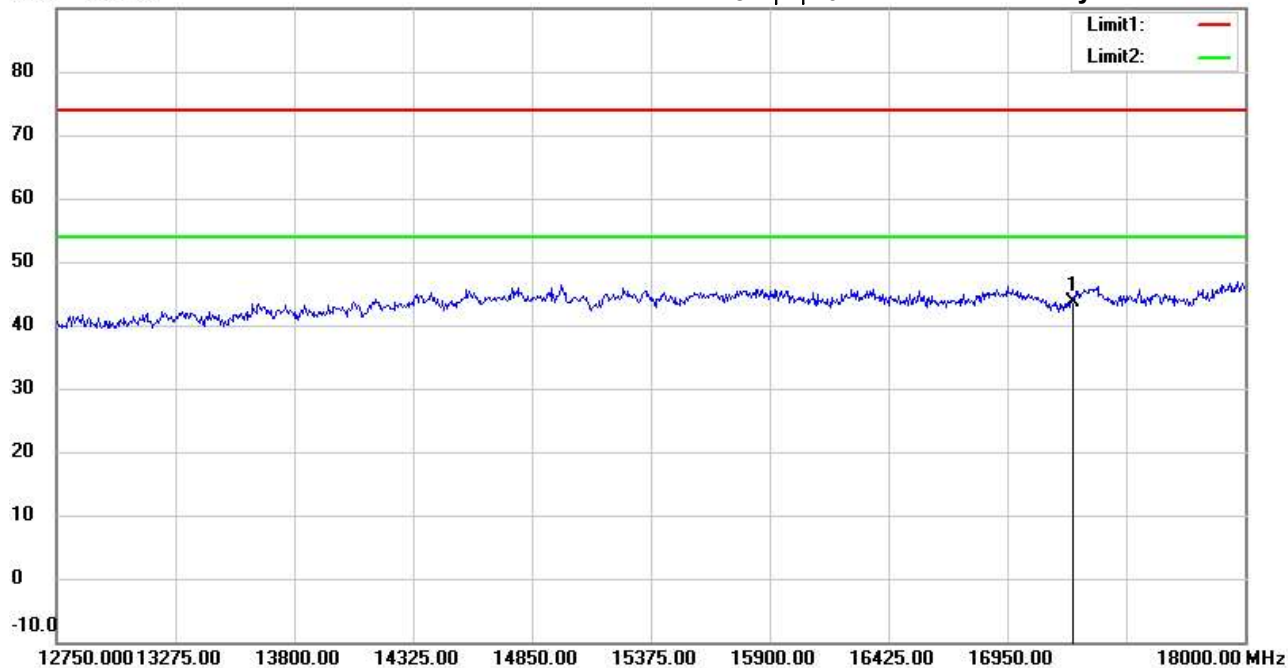
Condition : FCC\_part 15E RE\_Above 1GHz\_PK

Test Mode : TX 802.11n20 CH149

Polarization: **Horizontal**

| Mk. | Frequency (MHz) | Reading (dBuV) | Detector | Corr. factor (dB/m) | Result (dBuV/m) | Limit (dBuV/m) | Ant.Pos (cm) | Tab.Pos (deg.) | Margin (dB) | Comment |
|---|---|---|---|---|---|---|---|---|---|---|
| * | 17235.000 | 19.92 | peak | 23.74 | 43.66 | 74.00 | 150 | 84 | -30.34 | |

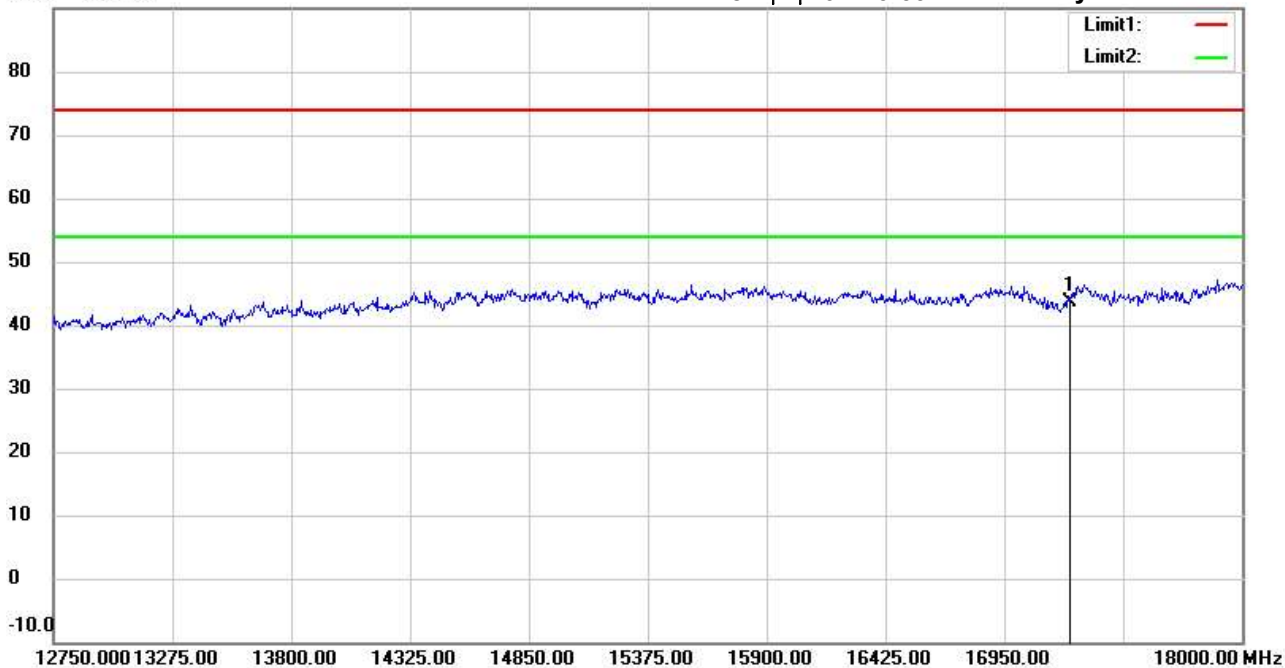
Condition : FCC\_part 15E RE\_Above 1GHz\_PK

Test Mode : TX 802.11n20 CH149

Polarization: Vertical

| Mk. | Frequency (MHz) | Reading (dBuV) | Detector | Corr. factor (dB/m) | Result (dBuV/m) | Limit (dBuV/m) | Ant.Pos (cm) | Tab.Pos (deg.) | Margin (dB) | Comment |
|---|---|---|---|---|---|---|---|---|---|---|
| * | 17235.000 | 19.80 | peak | 23.74 | 43.54 | 74.00 | 150 | 223 | -30.46 | |
