Report No.: CR230851060-00

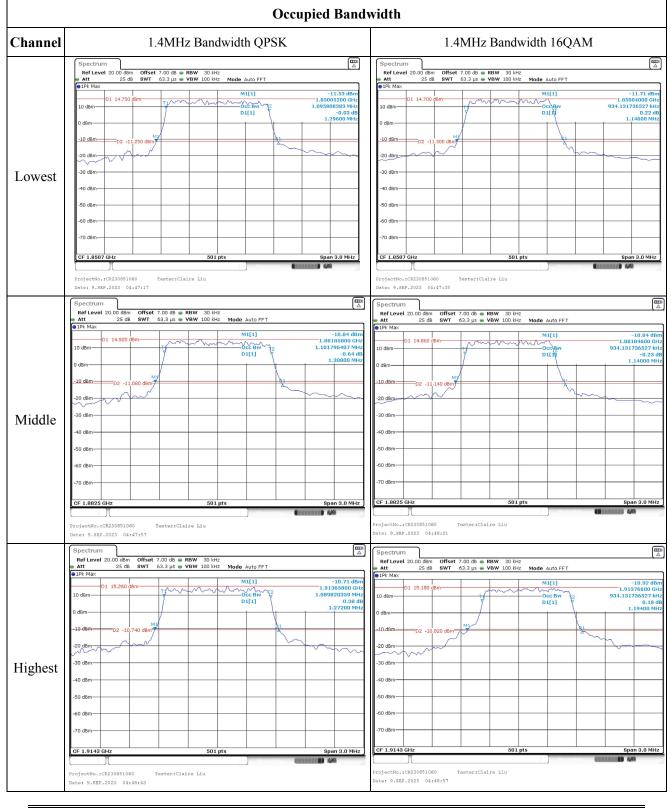
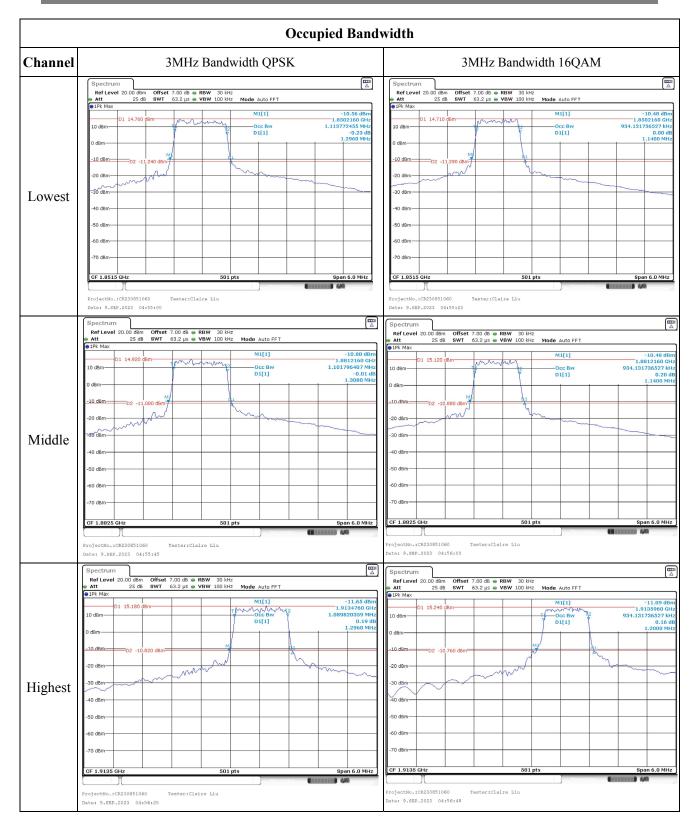
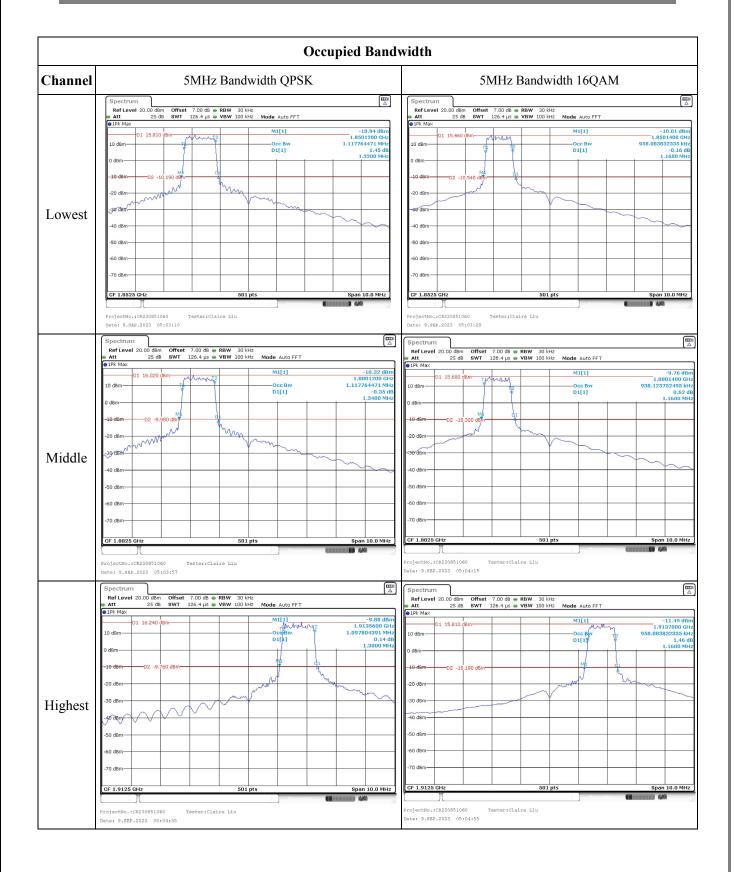
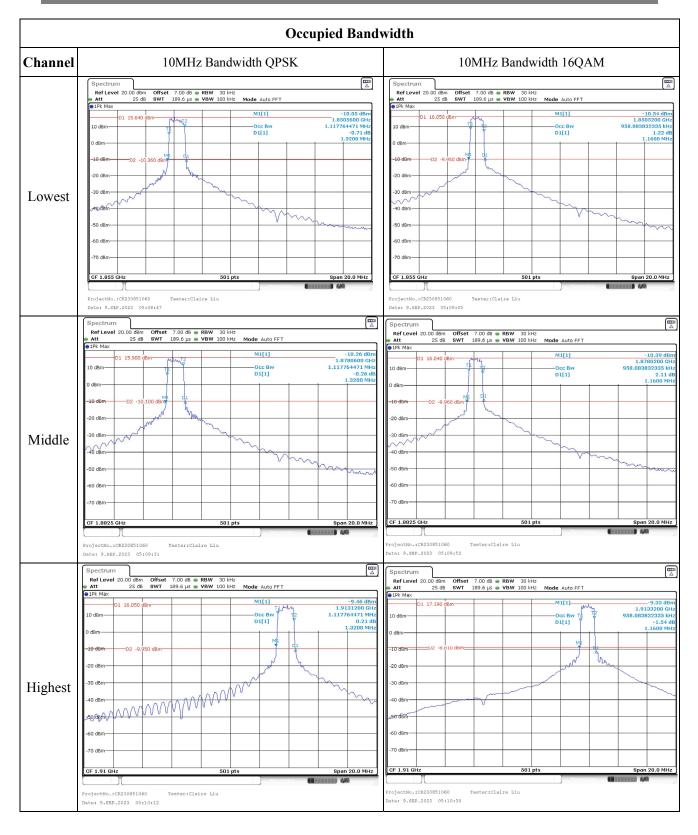
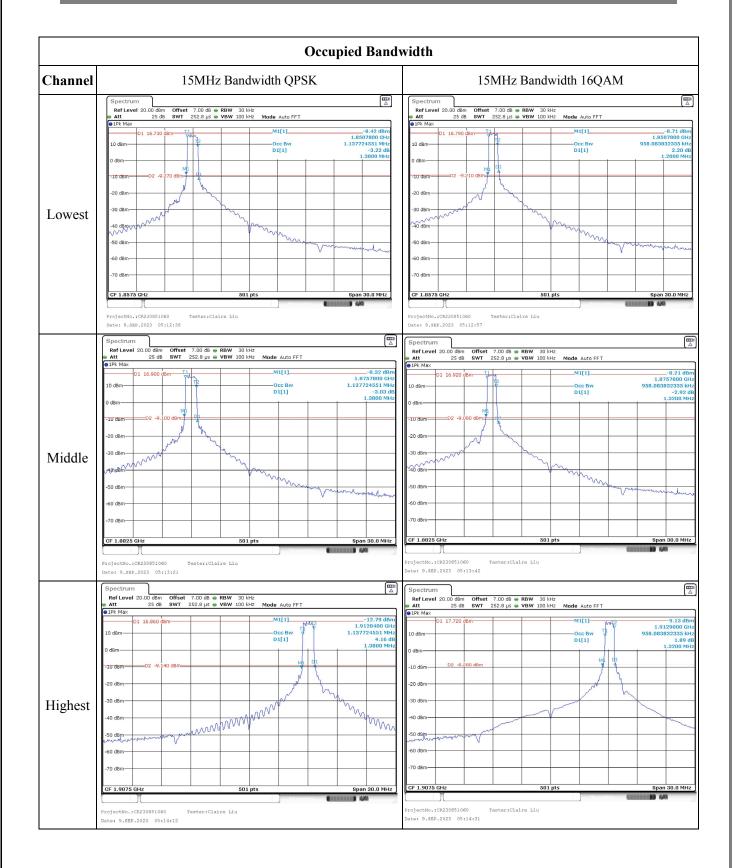
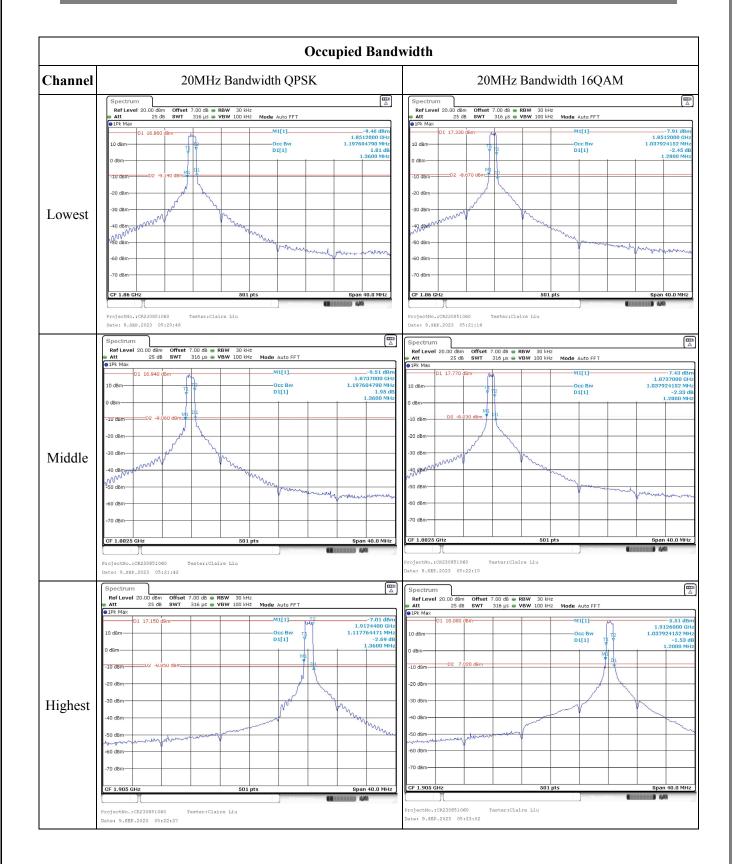
Test Plots(Note: The 7dB is the Insertion loss of the RF cable, Power Splitter and DC Block, which was offset into the Spectrum Analyzer):
