### **APPENDIX 3: Photographs of test setup**

#### **Radiated Spurious Emission**

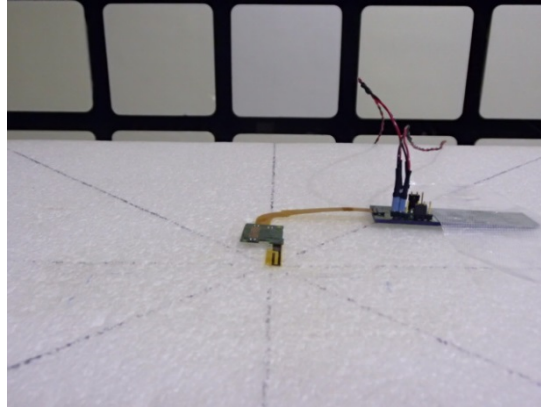
#### **X-axis**

### **Worst Case Position**

Below 1GHz (Horizontal: X-axis/ Vertical:Y-axis)

Above 1GHz (Horizontal: X-axis/ Vertical:Y-axis)

Below 1GHz (Horizontal: X-axis/ Vertical:X-axis)
