### **APPENDIX 3: Photographs of test setup**

#### **Radiated Emission**

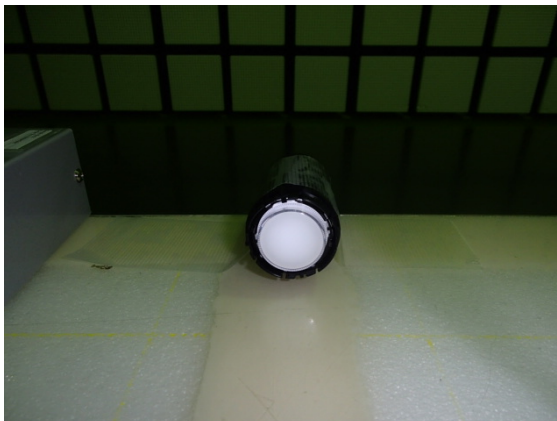
#### **X-axis**

### **Worst Case Position**

Below30MHz: X-axis

Above30MHz Hori:X / Vert:X

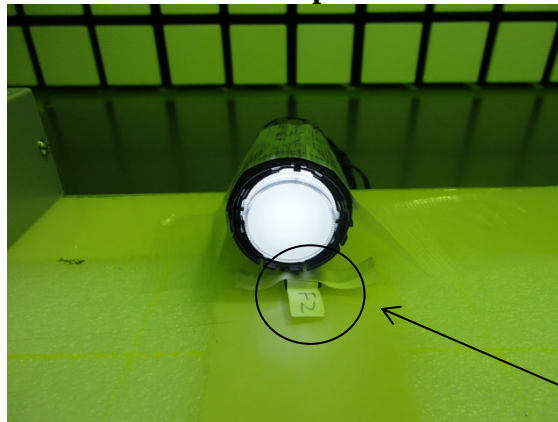
**With transponder**

**Worst Case Position**  
**With transponder / Without transponder**

transponder

**\* With transponder: lighting**  
**Without transponder: flashing**
