# Radiated Emission Measurement

Condition : FCC\_part 15E RE\_Above 1GHz\_PK

EUT : W6M22311-23090

Test Mode : TX 802.11n40 CH151

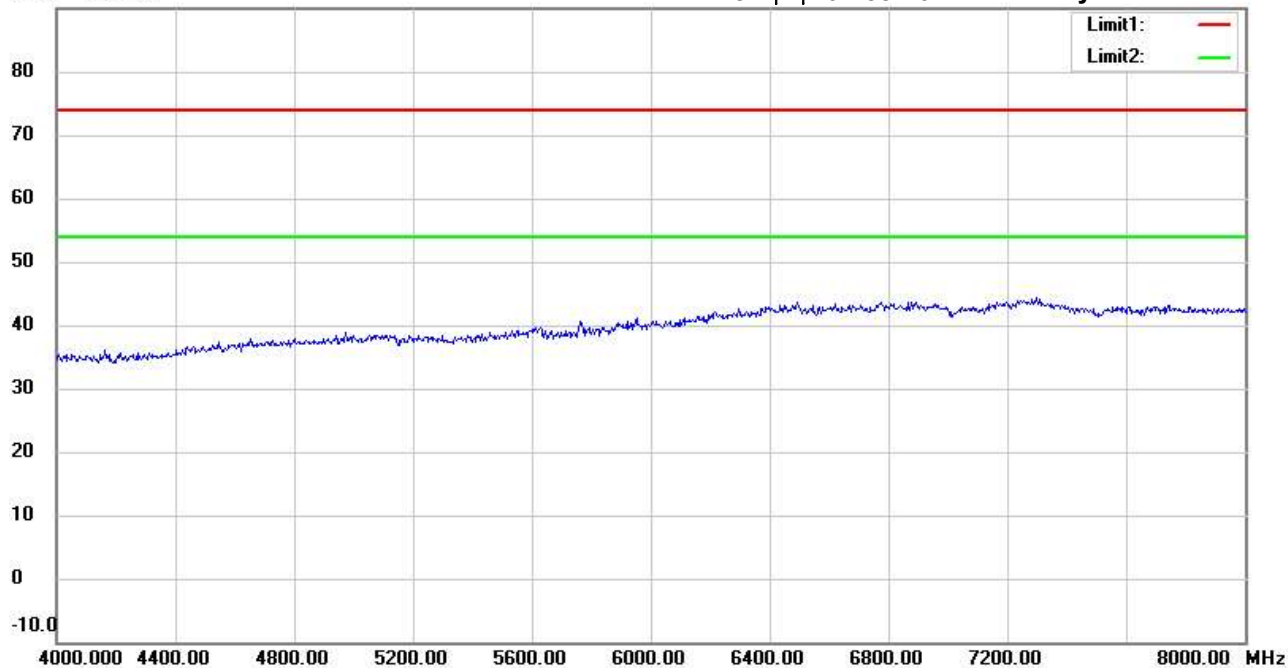
Data :#8

Polarization: **Vertical**

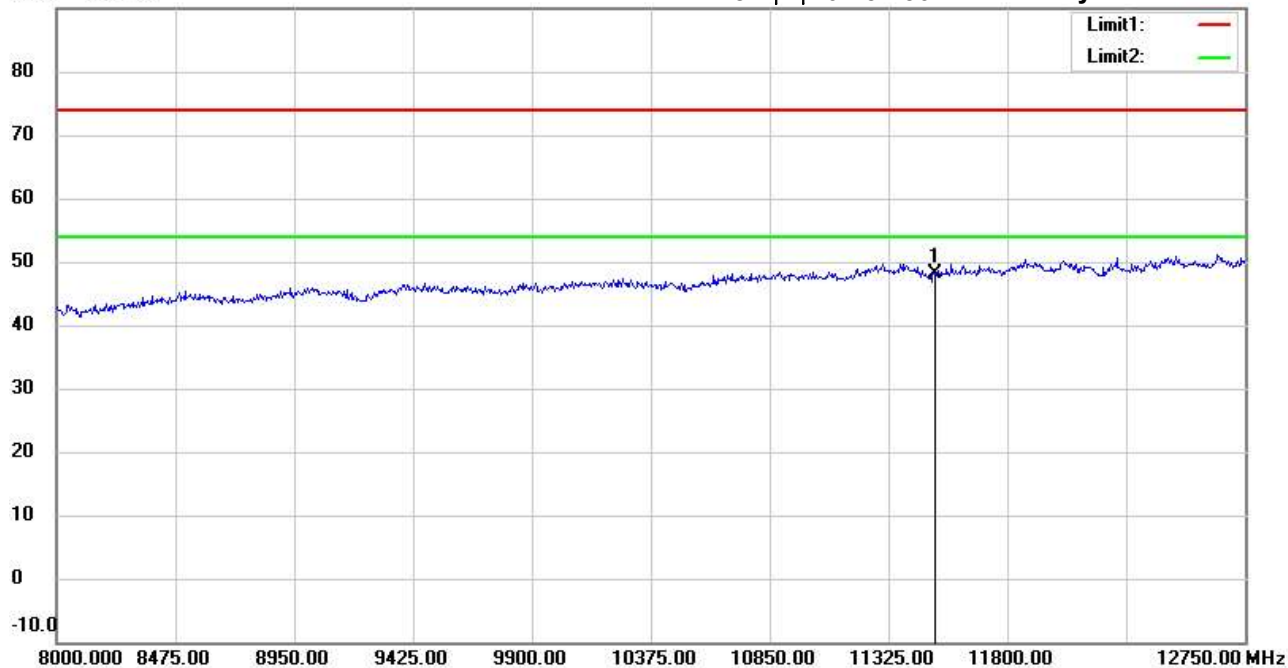
Data : #3

Condition : FCC\_part 15E RE\_Above 1GHz\_PK

Test Mode : TX 802.11n40 CH151

Polarization: **Horizontal**

| Mk. | Frequency (MHz) | Reading (dBuV) | Detector | Corr. factor (dB/m) | Result (dBuV/m) | Limit (dBuV/m) | Ant.Pos (cm) | Tab.Pos (deg.) | Margin (dB) | Comment |
|---|---|---|---|---|---|---|---|---|---|---|
| * | 11510.000 | 31.69 | peak | 16.46 | 48.15 | 74.00 | 150 | 338 | -25.85 | |

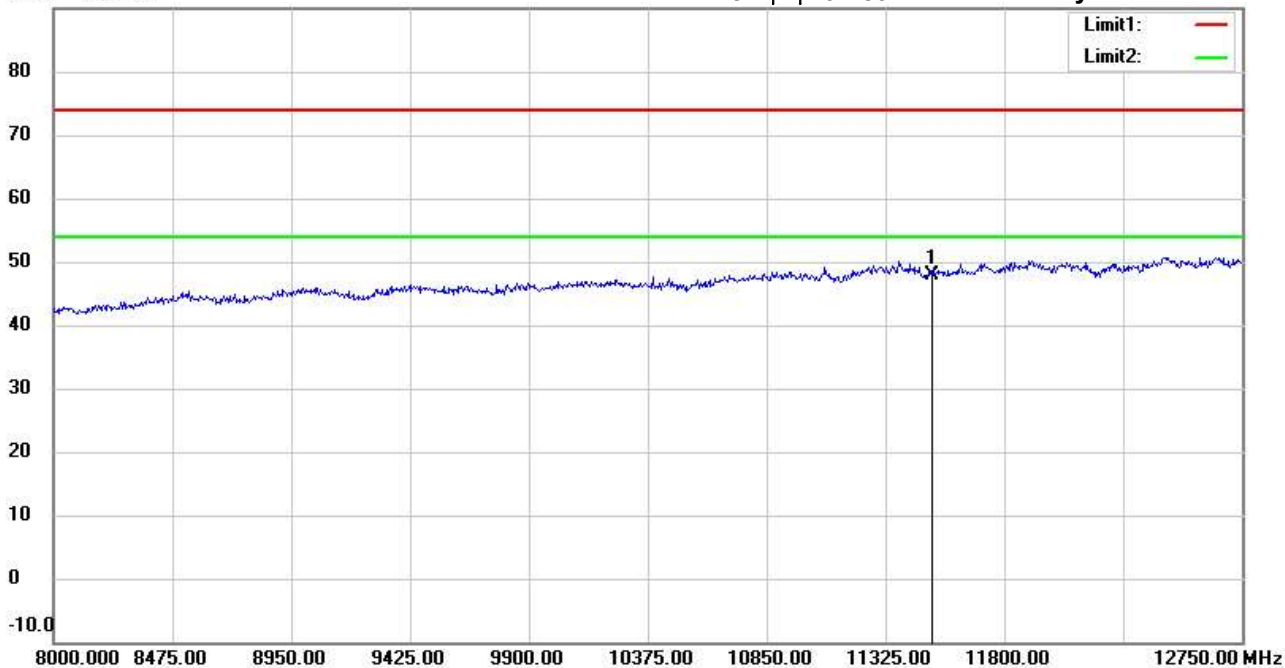
Data : #9

Condition : FCC\_part 15E RE\_Above 1GHz\_PK

Test Mode : TX 802.11n40 CH151

Polarization: Vertical

| Mk. | Frequency (MHz) | Reading (dBuV) | Detector | Corr. factor (dB/m) | Result (dBuV/m) | Limit (dBuV/m) | Ant.Pos (cm) | Tab.Pos (deg.) | Margin (dB) | Comment |
|---|---|---|---|---|---|---|---|---|---|---|
| * | 11510.000 | 31.40 | peak | 16.46 | 47.86 | 74.00 | 150 | 336 | -26.14 | |

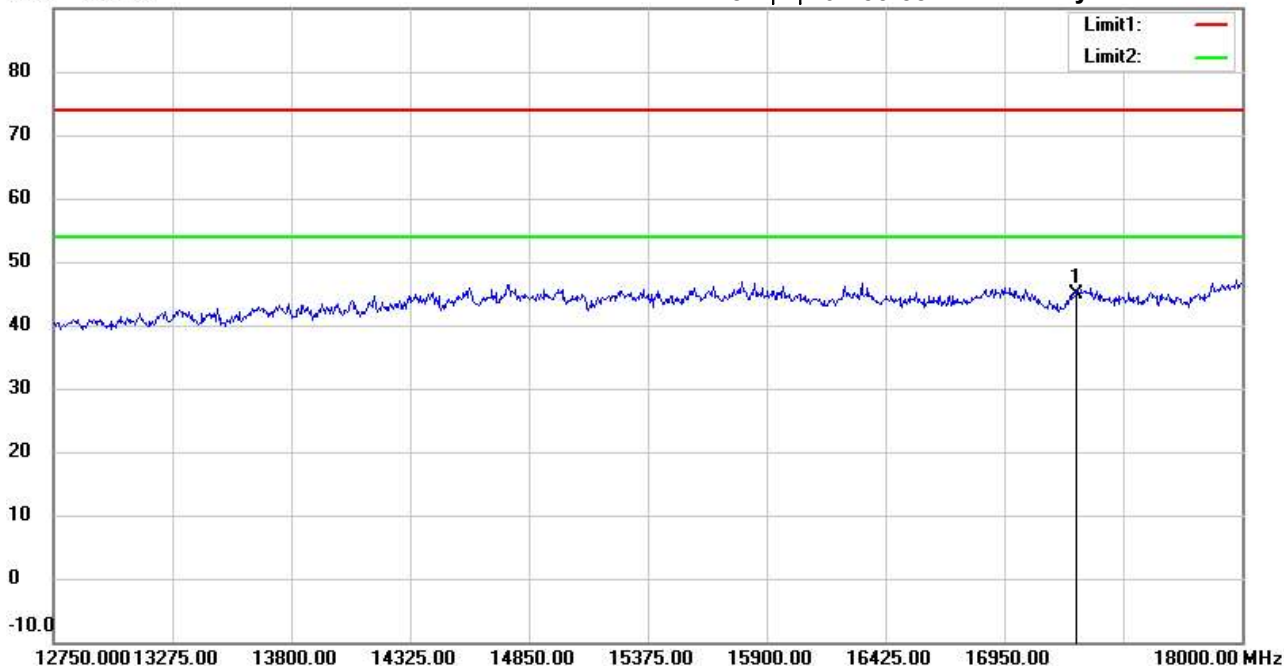
Data : #4

Condition : FCC\_part 15E RE\_Above 1GHz\_PK

Test Mode : TX 802.11n40 CH151

Polarization: **Horizontal**

| Mk. | Frequency (MHz) | Reading (dBuV) | Detector | Corr. factor (dB/m) | Result (dBuV/m) | Limit (dBuV/m) | Ant.Pos (cm) | Tab.Pos (deg.) | Margin (dB) | Comment |
|---|---|---|---|---|---|---|---|---|---|---|
| * | 17265.000 | 20.91 | peak | 23.96 | 44.87 | 74.00 | 150 | 197 | -29.13 | |

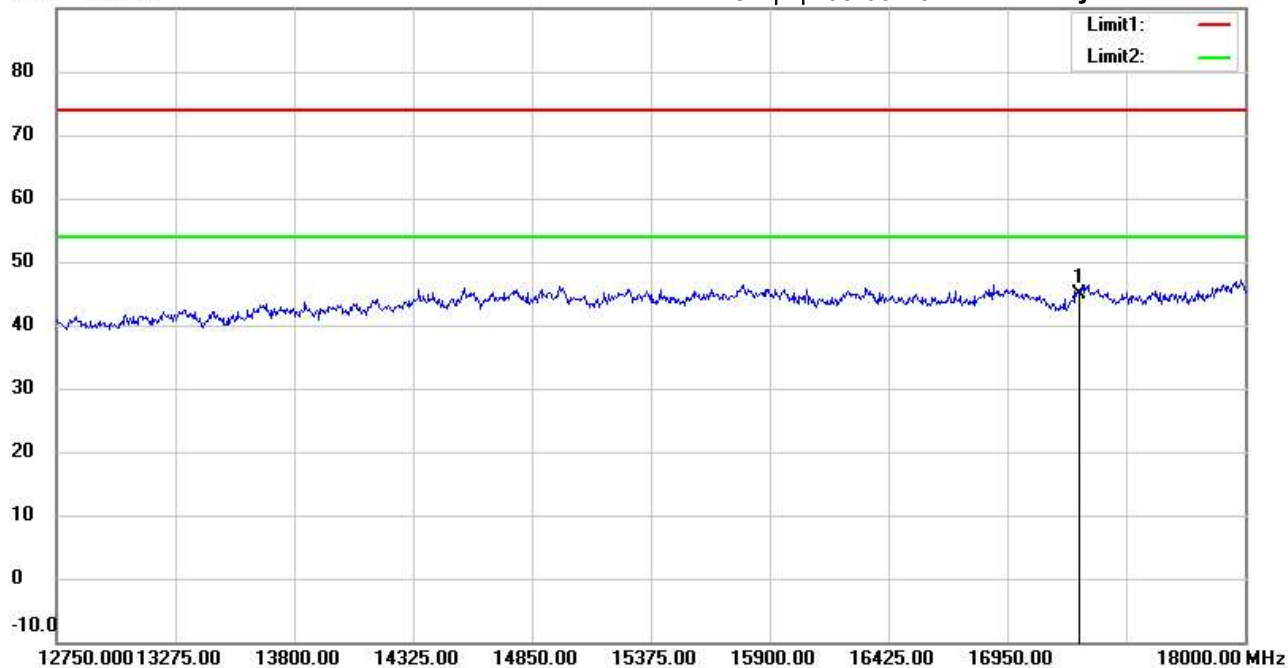
Data : #10

Condition : FCC\_part 15E RE\_Above 1GHz\_PK

Test Mode : TX 802.11n40 CH151

Polarization: Vertical

| Mk. | Frequency (MHz) | Reading (dBuV) | Detector | Corr. factor (dB/m) | Result (dBuV/m) | Limit (dBuV/m) | Ant.Pos (cm) | Tab.Pos (deg.) | Margin (dB) | Comment |
|---|---|---|---|---|---|---|---|---|---|---|
| * | 17265.000 | 20.86 | peak | 23.96 | 44.82 | 74.00 | 150 | 27 | -29.18 | |

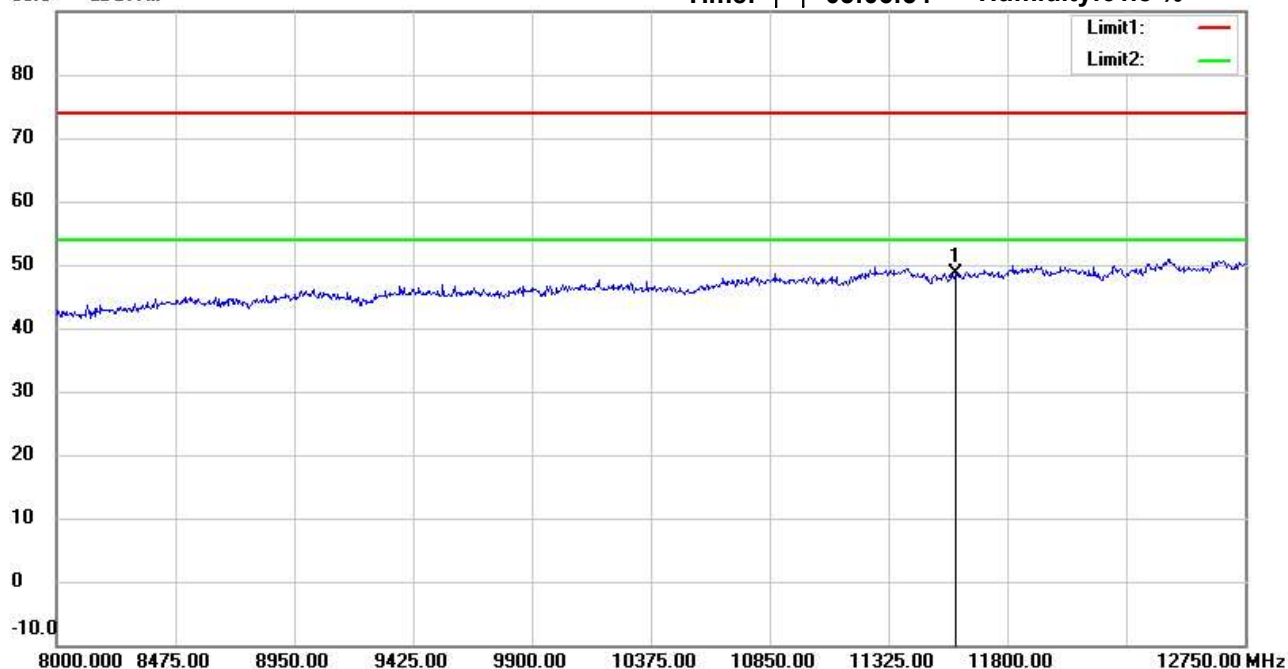
Data : #3

Condition : FCC\_part 15E RE\_Above 1GHz\_PK

Test Mode : TX 802.11n40 CH159

Polarization: **Horizontal**

| Mk. | Frequency (MHz) | Reading (dBuV) | Detector | Corr. factor (dB/m) | Result (dBuV/m) | Limit (dBuV/m) | Ant.Pos (cm) | Tab.Pos (deg.) | Margin (dB) | Comment |
|---|---|---|---|---|---|---|---|---|---|---|
| * | 11590.000 | 32.01 | peak | 16.65 | 48.66 | 74.00 | 150 | 275 | -25.34 | |

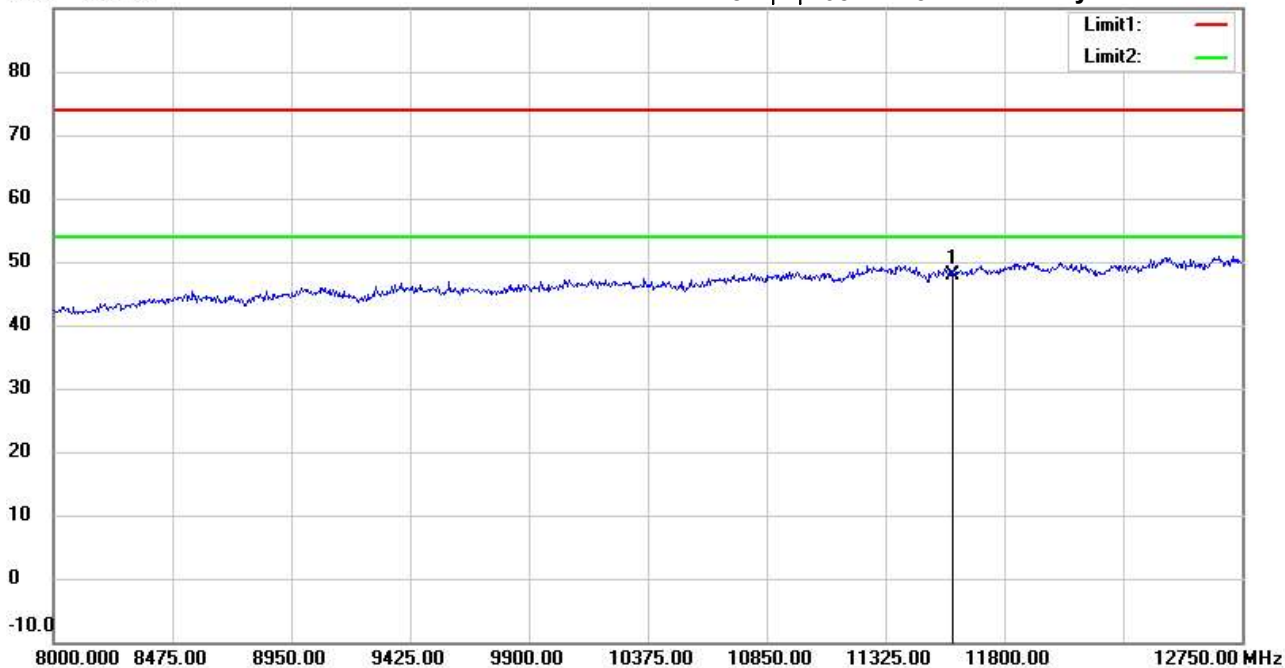
Data : #9

Condition : FCC\_part 15E RE\_Above 1GHz\_PK

Test Mode : TX 802.11n40 CH159

Polarization: Vertical

| Mk. | Frequency (MHz) | Reading (dBuV) | Detector | Corr. factor (dB/m) | Result (dBuV/m) | Limit (dBuV/m) | Ant.Pos (cm) | Tab.Pos (deg.) | Margin (dB) | Comment |
|---|---|---|---|---|---|---|---|---|---|---|
| * | 11590.000 | 31.18 | peak | 16.65 | 47.83 | 74.00 | 150 | 3 | -26.17 | |

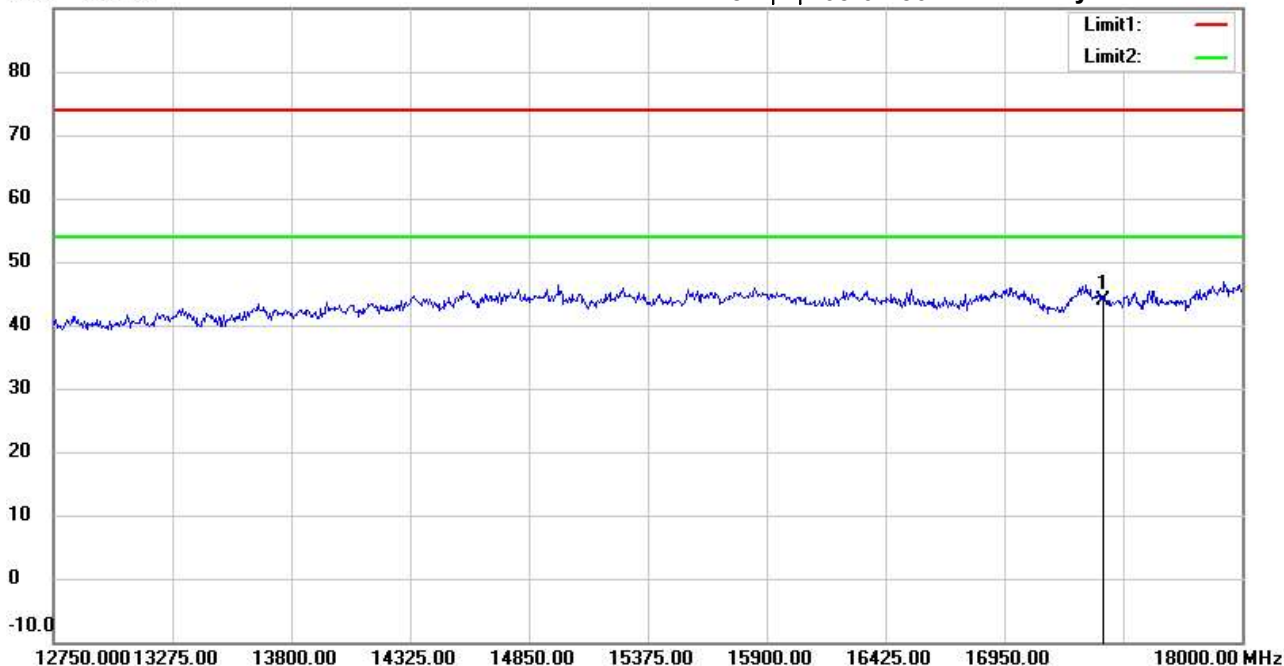
Data :#4

Condition : FCC\_part 15E RE\_Above 1GHz\_PK

Test Mode : TX 802.11n40 CH159

Polarization: **Horizontal**

| Mk. | Frequency (MHz) | Reading (dBuV) | Detector | Corr. factor (dB/m) | Result (dBuV/m) | Limit (dBuV/m) | Ant.Pos (cm) | Tab.Pos (deg.) | Margin (dB) | Comment |
|---|---|---|---|---|---|---|---|---|---|---|
| * | 17385.000 | 19.92 | peak | 23.84 | 43.76 | 74.00 | 150 | 351 | -30.24 | |

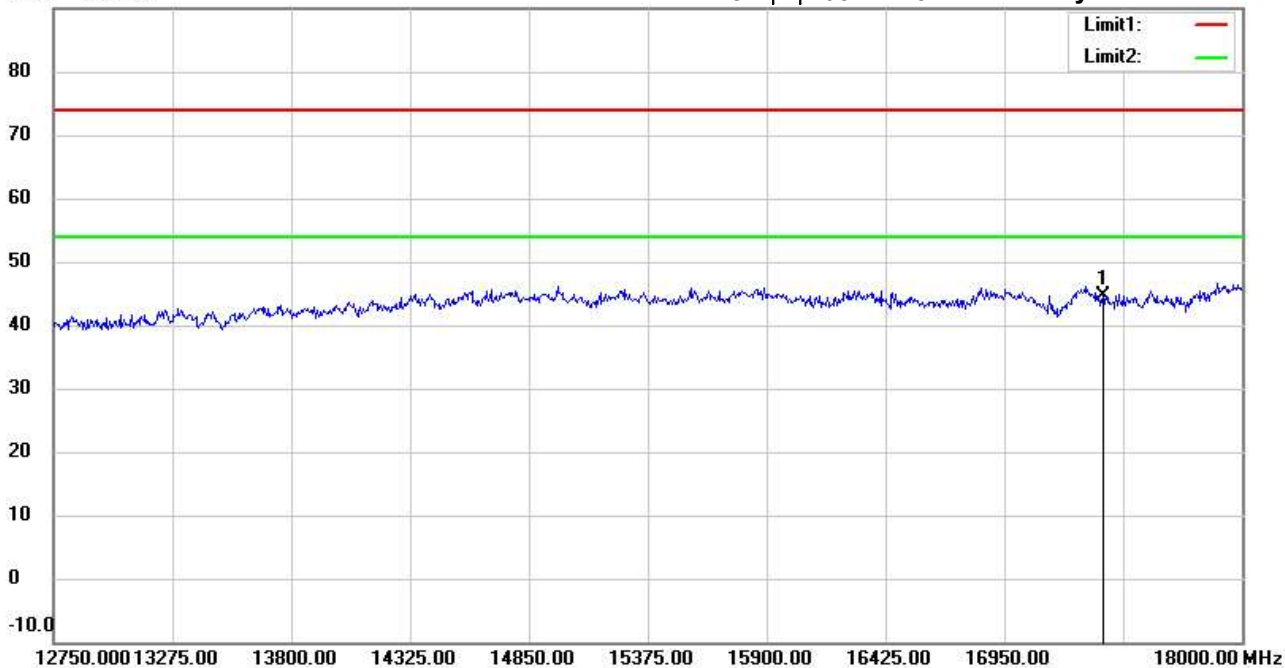
Data : #10

Condition : FCC\_part 15E RE\_Above 1GHz\_PK

Test Mode : TX 802.11n40 CH159

Polarization: Vertical

| Mk. | Frequency (MHz) | Reading (dBuV) | Detector | Corr. factor (dB/m) | Result (dBuV/m) | Limit (dBuV/m) | Ant.Pos (cm) | Tab.Pos (deg.) | Margin (dB) | Comment |
|---|---|---|---|---|---|---|---|---|---|---|
| * | 17385.000 | 20.79 | peak | 23.84 | 44.63 | 74.00 | 150 | 357 | -29.37 | |

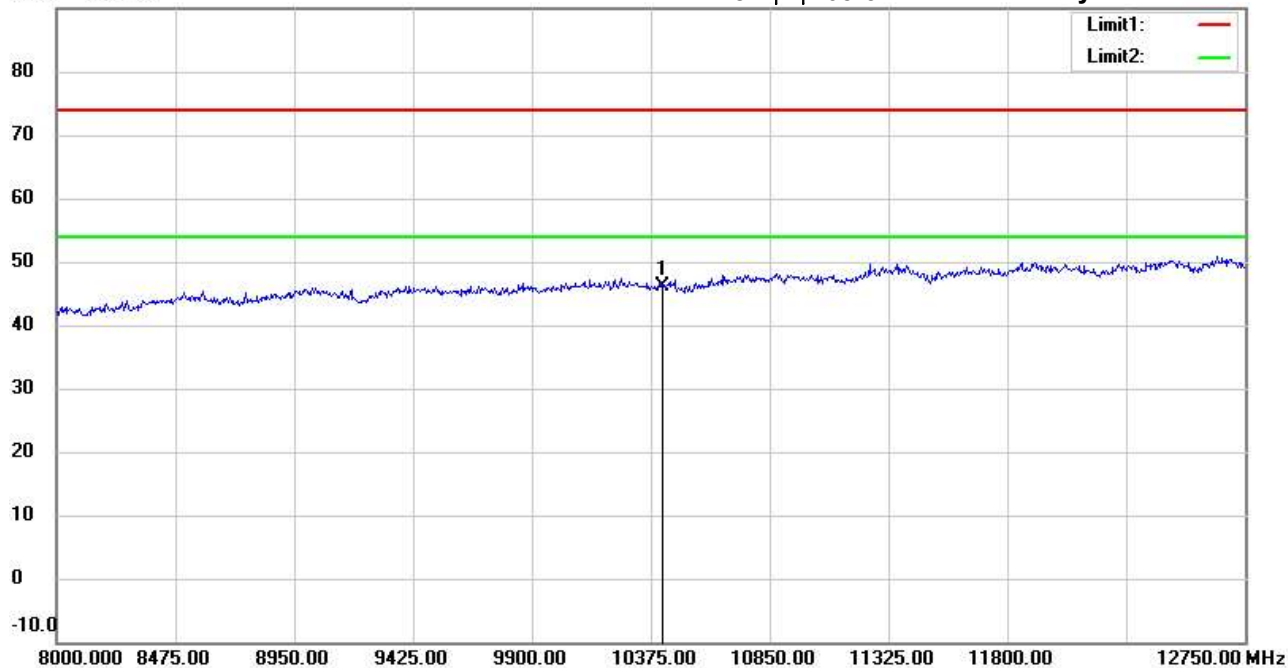
Data : #3

Condition : FCC\_part 15E RE\_Above 1GHz\_PK

Test Mode : TX 802.11ac80 CH42

Polarization: **Horizontal**

| Mk. | Frequency (MHz) | Reading (dBuV) | Detector | Corr. factor (dB/m) | Result (dBuV/m) | Limit (dBuV/m) | Ant.Pos (cm) | Tab.Pos (deg.) | Margin (dB) | Comment |
|---|---|---|---|---|---|---|---|---|---|---|
| * | 10420.000 | 31.91 | peak | 14.13 | 46.04 | 74.00 | 150 | 10 | -27.96 | |

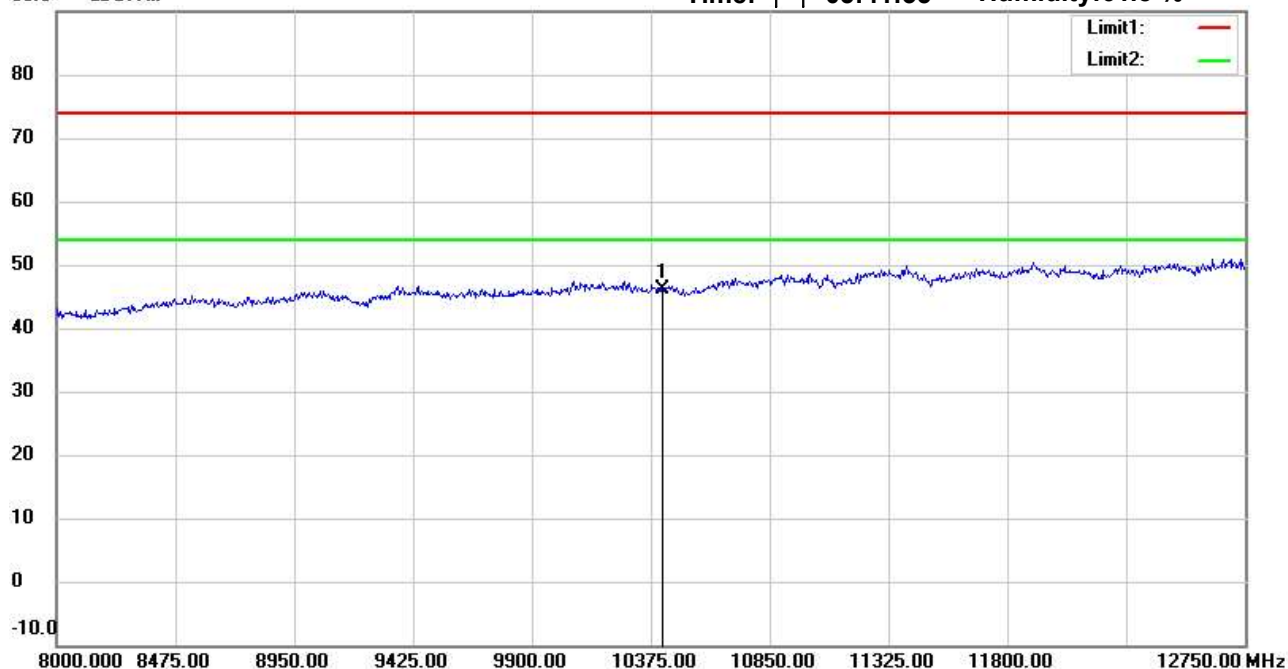
Data : #9

Condition : FCC\_part 15E RE\_Above 1GHz\_PK

Test Mode : TX 802.11ac80 CH42

Polarization: Vertical

| Mk. | Frequency (MHz) | Reading (dBuV) | Detector | Corr. factor (dB/m) | Result (dBuV/m) | Limit (dBuV/m) | Ant.Pos (cm) | Tab.Pos (deg.) | Margin (dB) | Comment |
|---|---|---|---|---|---|---|---|---|---|---|
| * | 10420.000 | 32.12 | peak | 14.13 | 46.25 | 74.00 | 150 | 129 | -27.75 | |
