# IEEE 802.11n- ax40\_ Channel 159

UTTR-RF-RSS247-V1.1

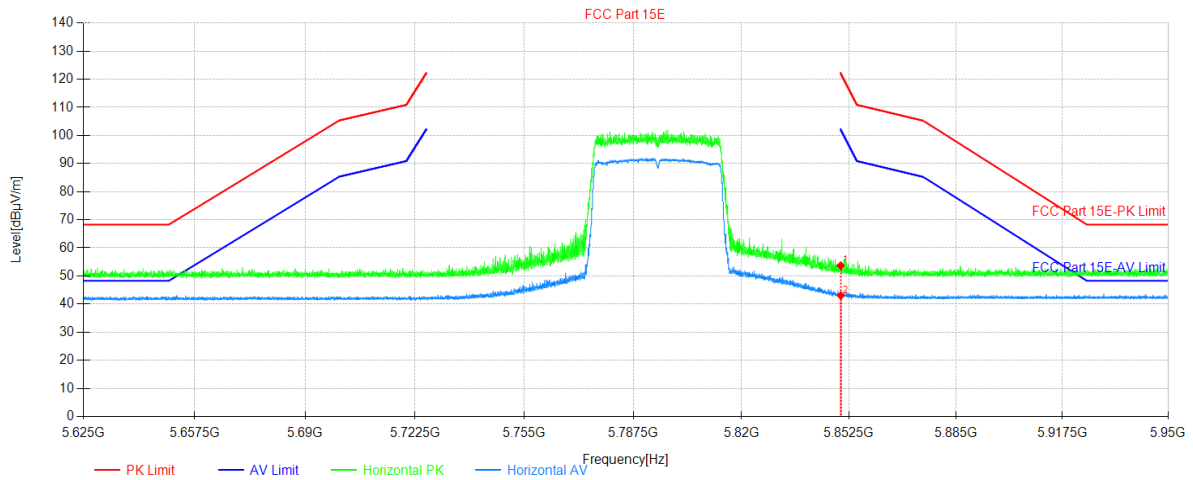
## Test Graph

| NO. | Freq. [MHz] | Reading [dBμV] | Correct Factor [dB/m] | Level [dBμV/m] | Limit [dBμV/m] | Margin [dB] | Height [cm] | Angle [°] | Detector | Polarity | Verdict |
| 1 | 5850.02 | 48.19 | 5.50 | 53.69 | 122.25 | 68.56 | 150 | 233 | PK | Horizontal | PASS |
| 2 | 5850.02 | 37.55 | 5.50 | 43.05 | 102.25 | 59.20 | 150 | 172 | AV | Horizontal | PASS |

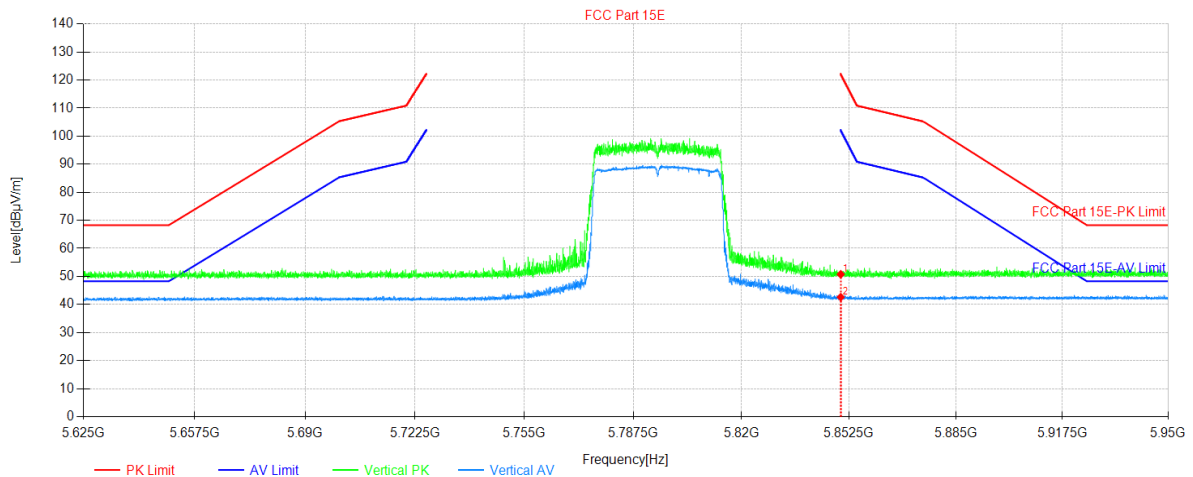
## Test Graph

| NO. | Freq. [MHz] | Reading [dBμV] | Correct Factor [dB/m] | Level [dBμV/m] | Limit [dBμV/m] | Margin [dB] | Height [cm] | Angle [°] | Detector | Polarity | Verdict |
| 1 | 5850.02 | 45.27 | 5.50 | 50.77 | 122.25 | 71.48 | 150 | 109 | PK | Vertical | PASS |
| 2 | 5850.02 | 37.12 | 5.50 | 42.62 | 102.25 | 59.63 | 150 | 300 | AV | Vertical | PASS |

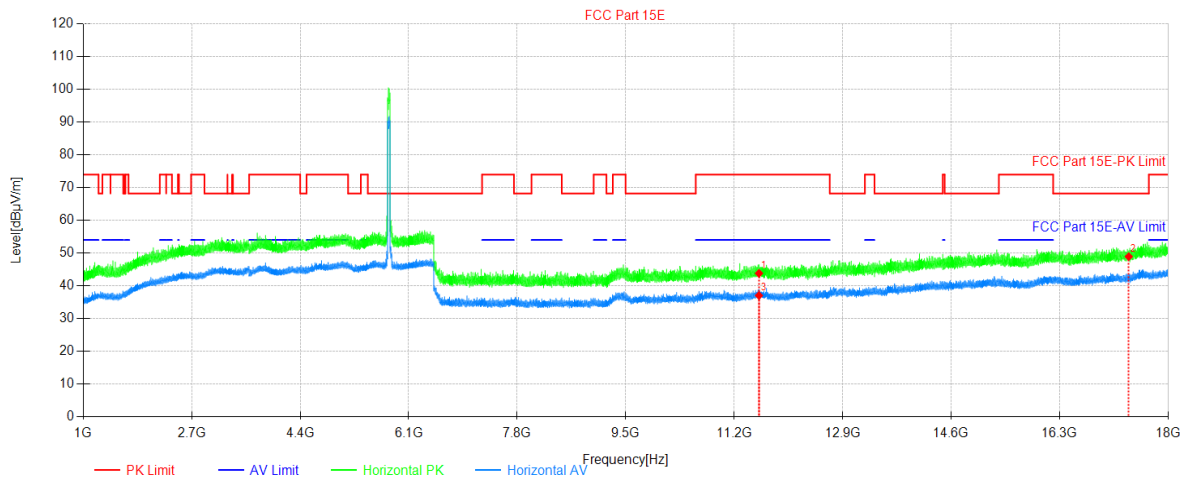
### Test Graph

| NO. | Freq. [MHz] | Reading [dBμV] | Correct Factor [dB/m] | Level [dBμV/m] | Limit [dBμV/m] | Margin [dB] | Height [cm] | Angle [°] | Detector | Polarity | Verdict |
| 1 | 11590.0697 | 41.37 | 2.43 | 43.80 | 74.00 | 30.20 | 150 | 2 | PK | Horizontal | PASS |
| 2 | 17385.1128 | 39.88 | 9.03 | 48.91 | 68.20 | 19.29 | 150 | 2 | PK | Horizontal | PASS |
| 3 | 11590.0697 | 34.59 | 2.43 | 37.02 | 54.00 | 16.98 | 150 | 176 | AV | Horizontal | PASS |

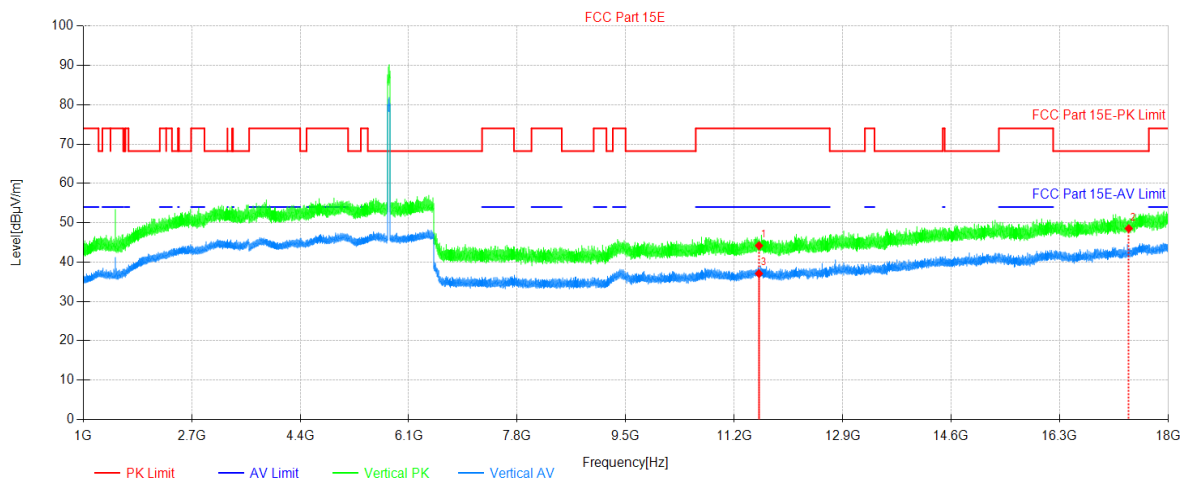
### Test Graph

| NO. | Freq. [MHz] | Reading [dBμV] | Correct Factor [dB/m] | Level [dBμV/m] | Limit [dBμV/m] | Margin [dB] | Height [cm] | Angle [°] | Detector | Polarity | Verdict |
| 1 | 11590.0697 | 41.76 | 2.43 | 44.19 | 74.00 | 29.81 | 150 | 14 | PK | Vertical | PASS |
| 2 | 17385.1128 | 39.51 | 9.03 | 48.54 | 68.20 | 19.66 | 150 | 142 | PK | Vertical | PASS |
| 3 | 11590.0697 | 34.65 | 2.43 | 37.08 | 54.00 | 16.92 | 150 | 142 | AV | Vertical | PASS |
