## Appendix G: Band edge measurements

## Appendix H: Conducted Spurious Emission Test Result

14. TEST SETUP PHOTO

15. EUT PHOTO

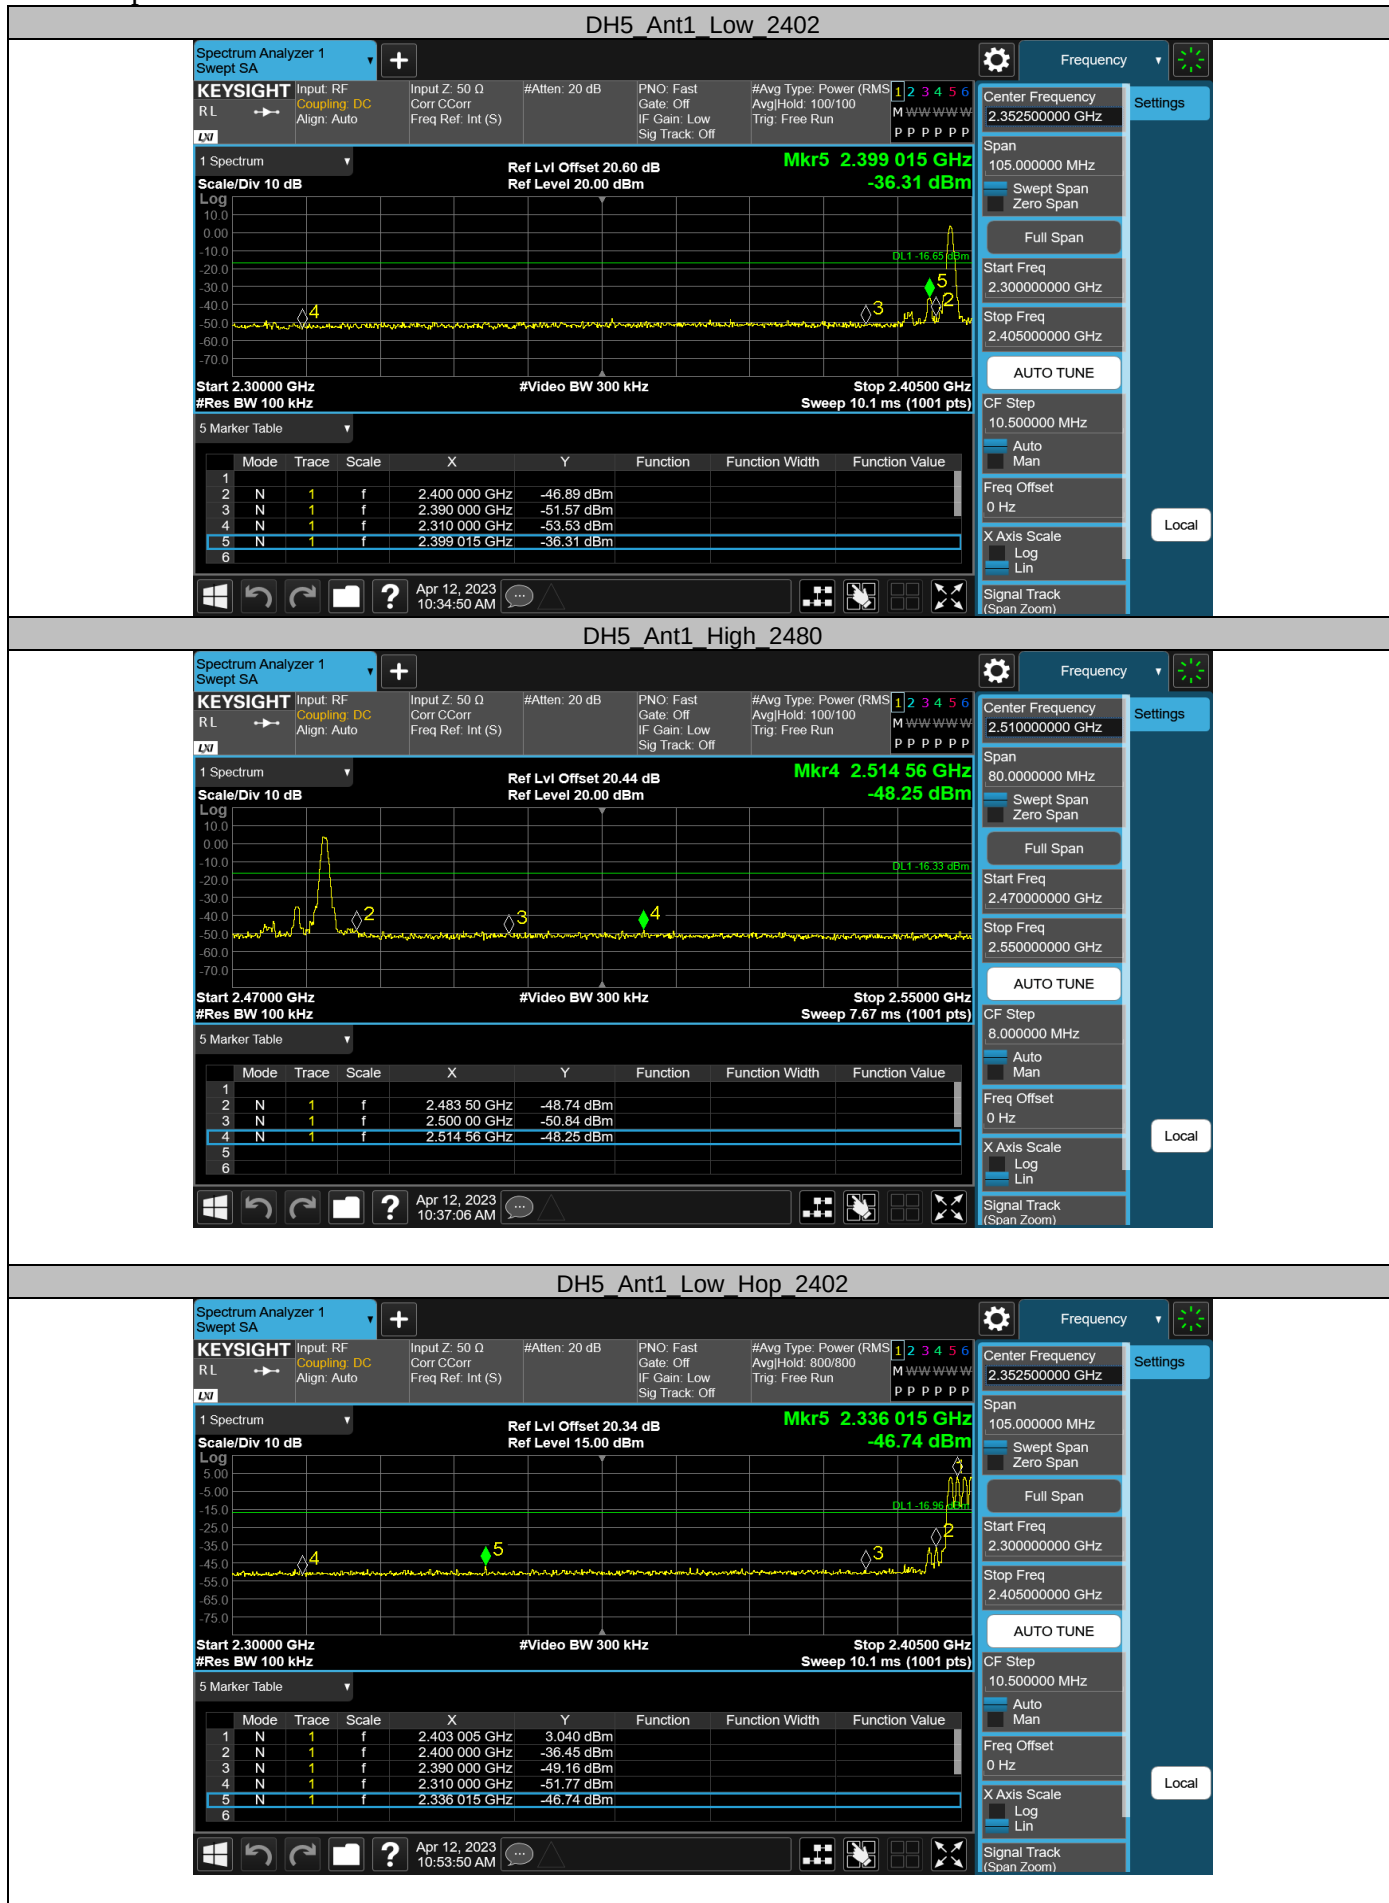
## Test Graphs

### Test Result

| Test Mode | Antenna | Ch Name | Freq(MHz) | Ref Level [dBm] | Result [dBm] | Limit [dBm] | Verdict |
|---|---|---|---|---|---|---|---|
| DH5 | Ant1 | Low | 2402 | 3.35 | -36.31 | $\leq -16.65$ | PASS |
| | | High | 2480 | 3.67 | -48.25 | $\leq -16.33$ | PASS |
| | | Low | Hop_2402 | 3.04 | -46.74 | $\leq -16.96$ | PASS |
| | | High | Hop_2480 | 3.51 | -45.17 | $\leq -16.49$ | PASS |

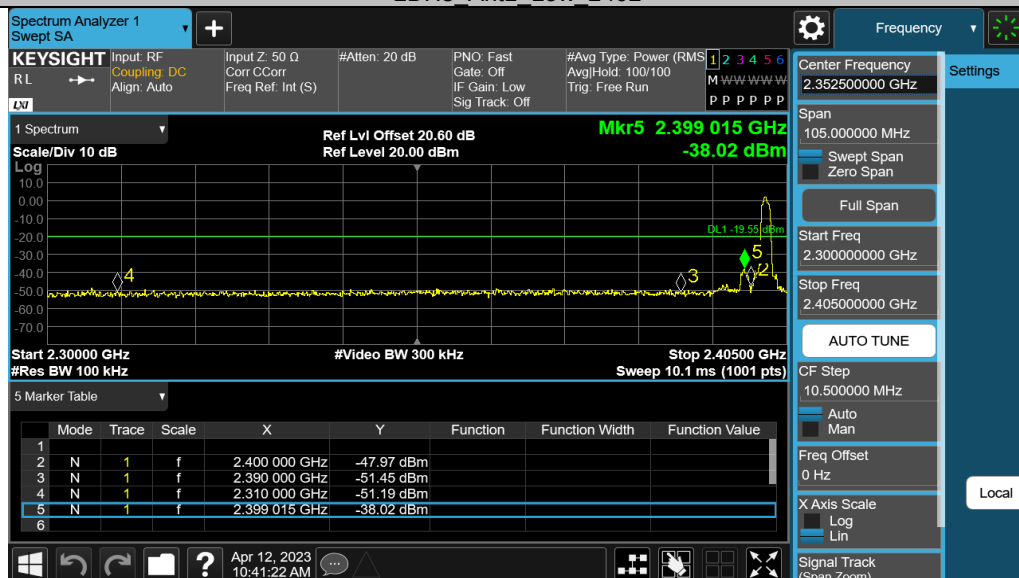
## 2DH5 Ant1 Low 2402

| Test Mode | Antenna | Ch Name | Freq(MHz) | Ref Level [dBm] | Result [dBm] | Limit [dBm] | Verdict |
|---|---|---|---|---|---|---|---|
| 2DH5 | Ant1 | Low | 2402 | 0.45 | -38.02 | $\leq -19.55$ | PASS |

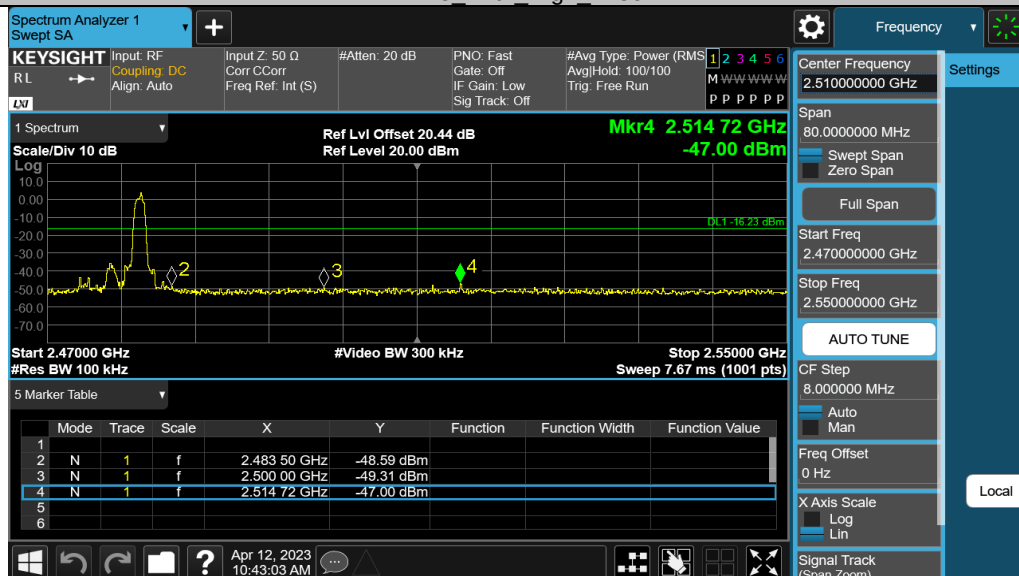
## 2DH5 Ant1 High 2480

| Test Mode | Antenna | Ch Name | Freq(MHz) | Ref Level [dBm] | Result [dBm] | Limit [dBm] | Verdict |
|---|---|---|---|---|---|---|---|
| | | High | 2480 | 3.77 | -47 | $\leq -16.23$ | PASS |

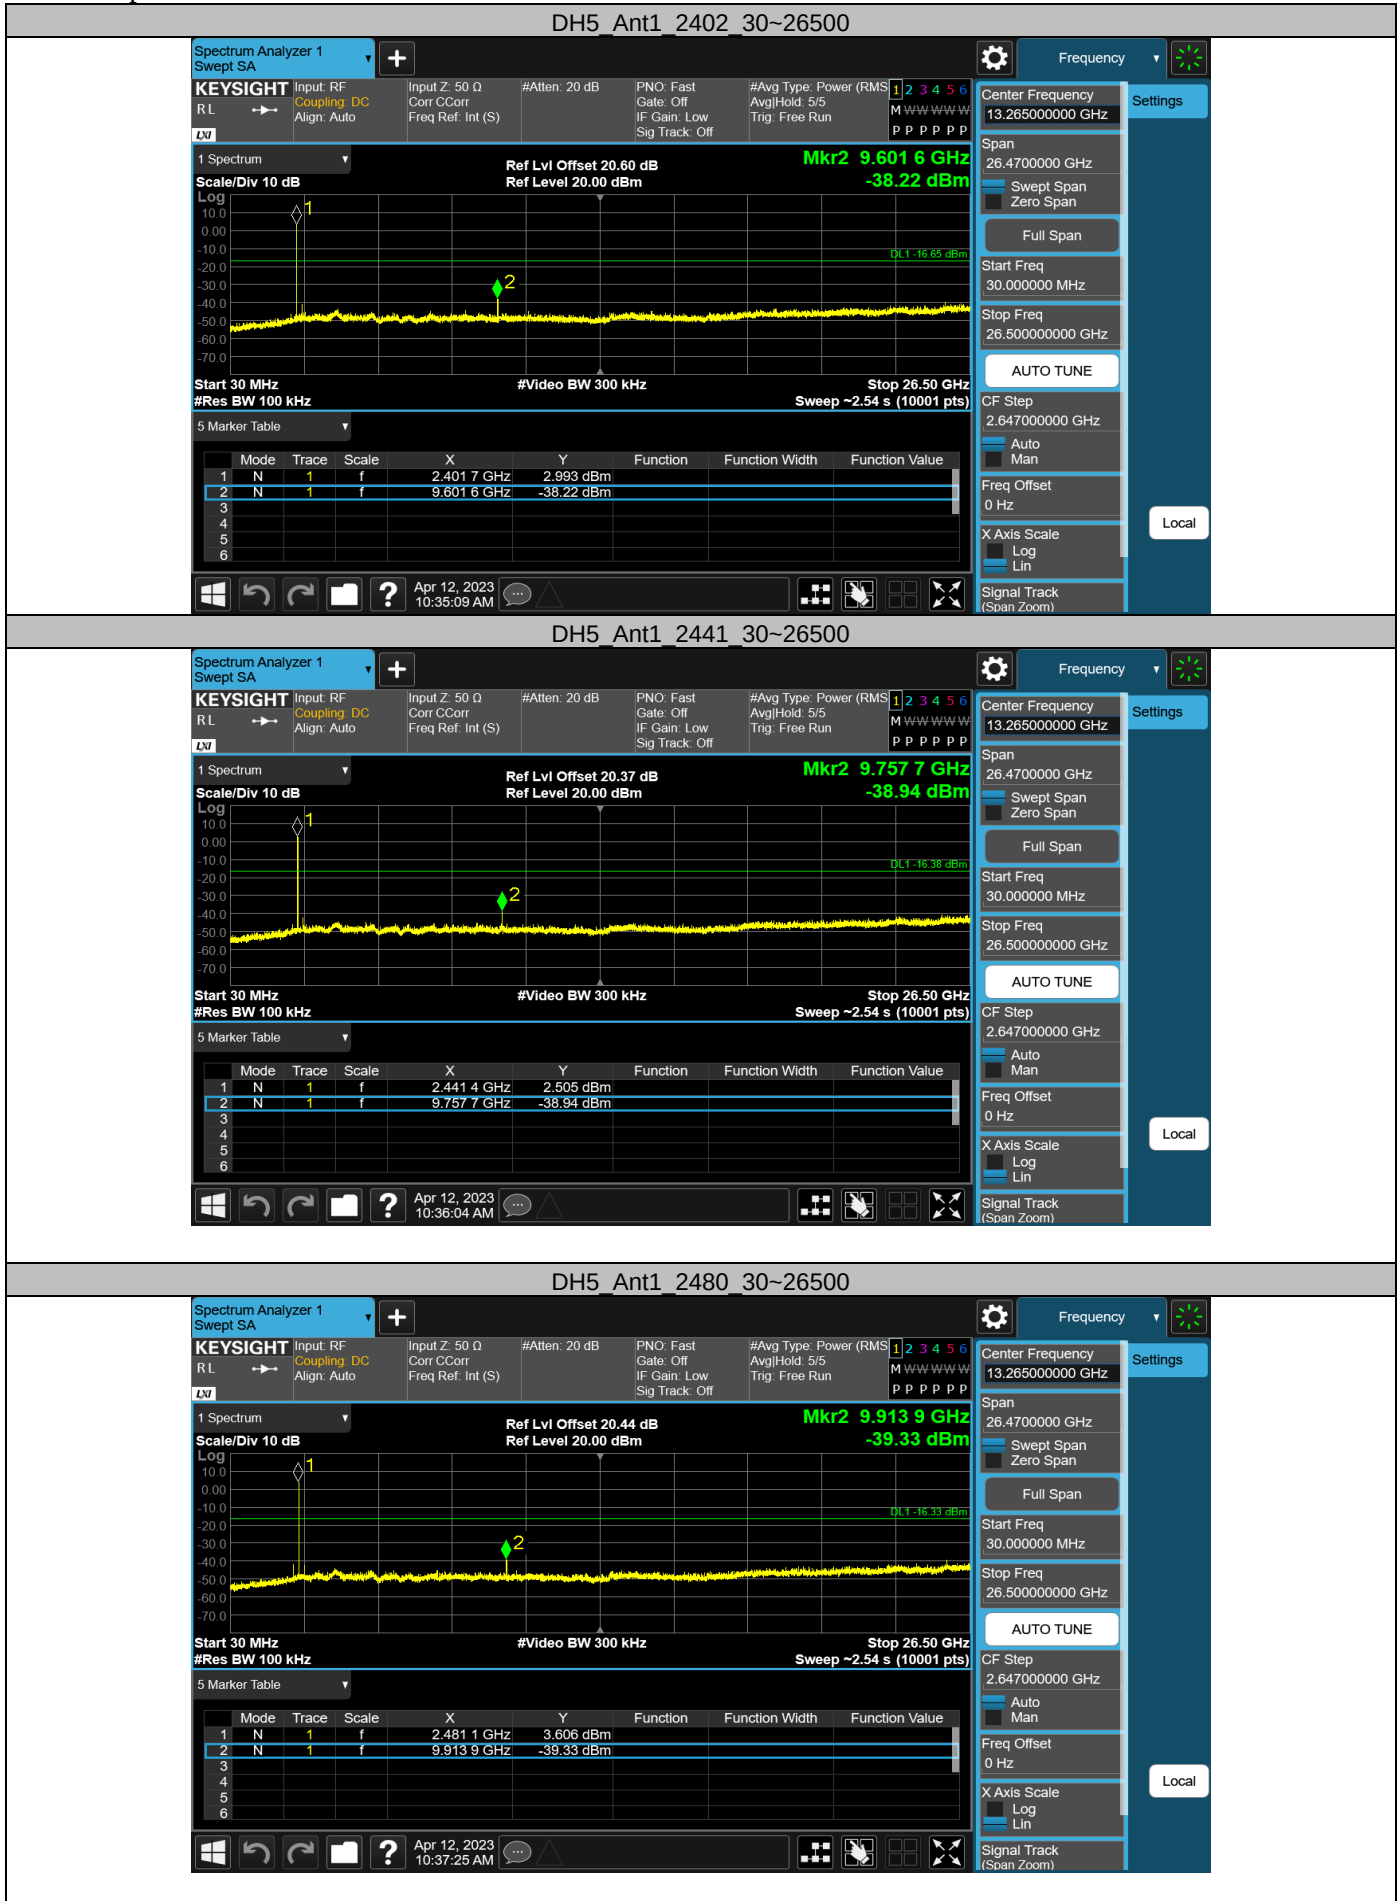
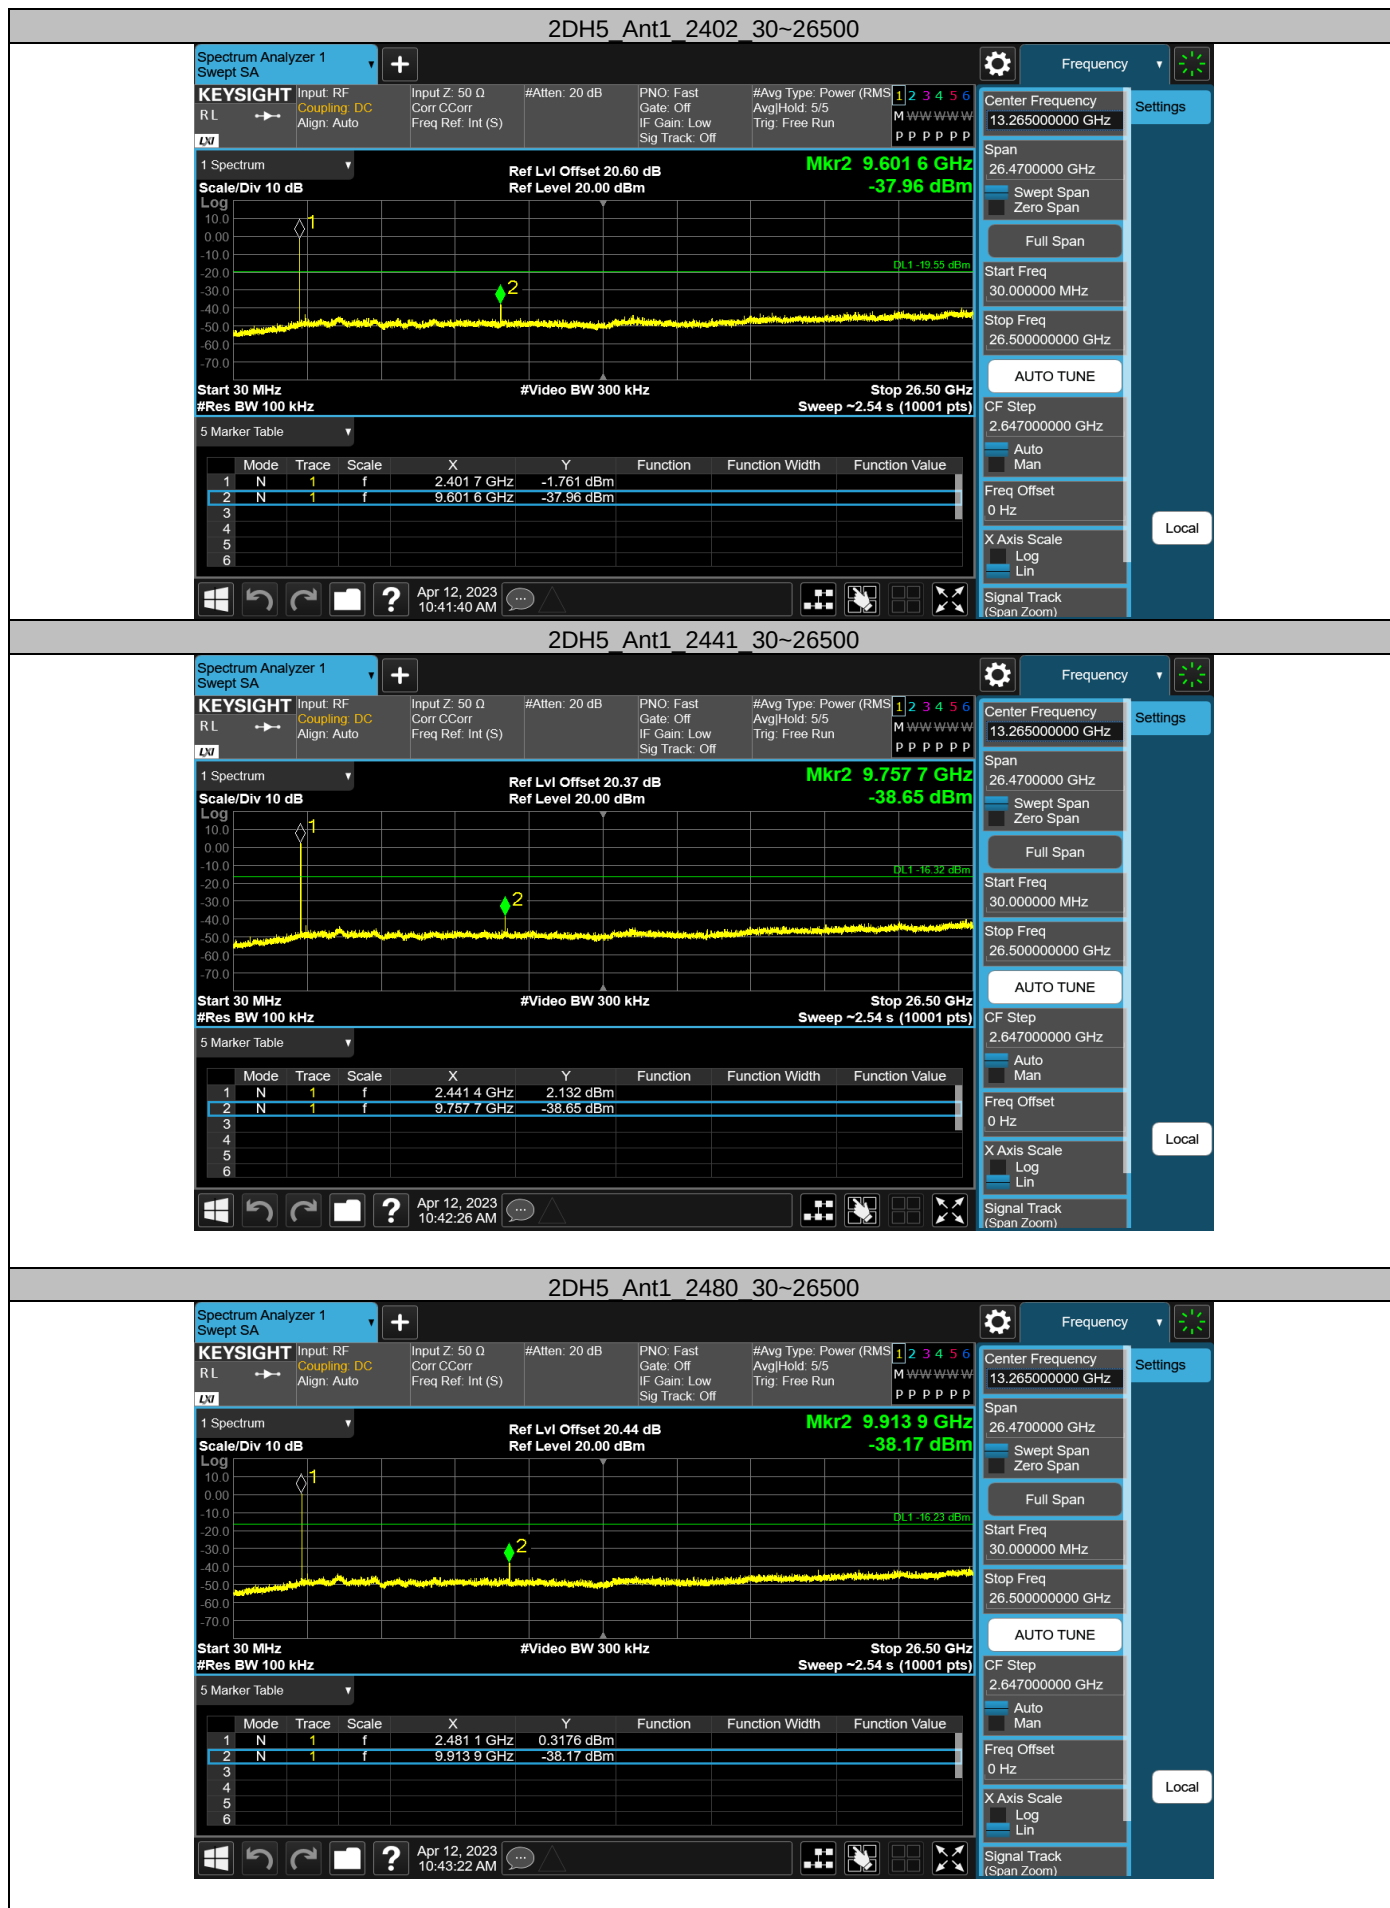
## Test Graphs

| Test Mode | Antenna | Freq(MHz) | Freq Range<br>[MHz] | Ref Level<br>[dBm] | Result<br>[dBm] | Limit<br>[dBm] | Verdict |
|---|---|---|---|---|---|---|---|
| DH5 | Ant1 | 2402 | 30~26500 | 3.35 | -38.22 | $\leq -16.65$ | PASS |
| | | 2441 | 30~26500 | 3.62 | -38.95 | $\leq -16.38$ | PASS |
| | | 2480 | 30~26500 | 3.67 | -39.33 | $\leq -16.33$ | PASS |
| 2DH5 | Ant1 | 2402 | 30~26500 | 0.45 | -37.96 | $\leq -19.55$ | PASS |
| | | 2441 | 30~26500 | 3.68 | -38.65 | $\leq -16.32$ | PASS |
| | | 2480 | 30~26500 | 3.77 | -38.17 | $\leq -16.23$ | PASS |
