## APPENDIX A: PHOTOGRAPHS OF TEST SETUP

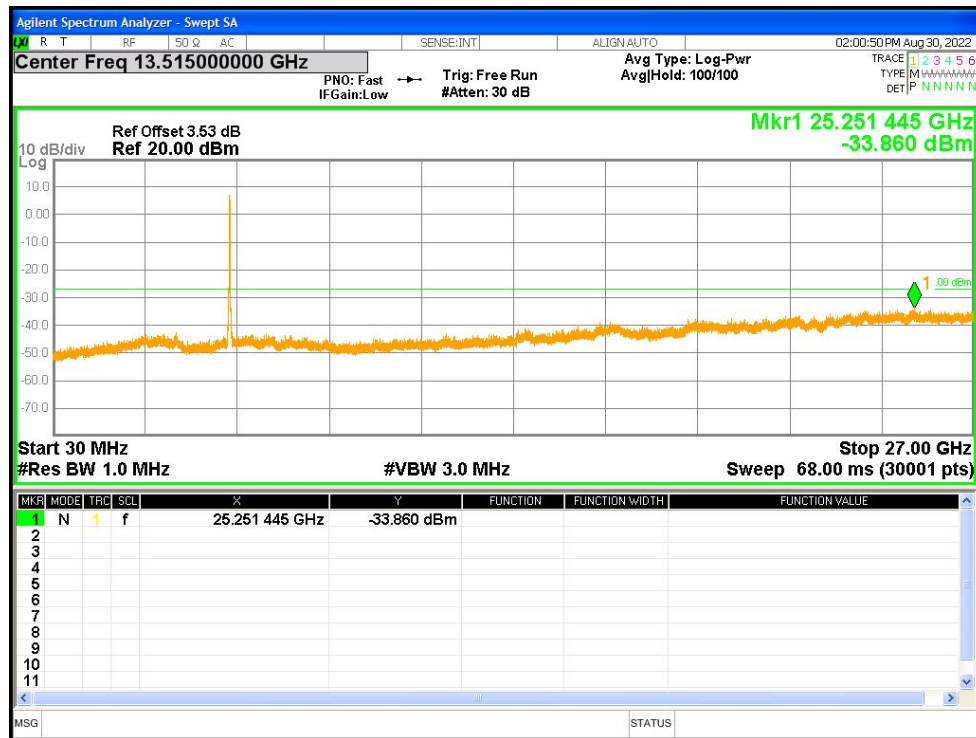
Tx. Spurious NVNT a 5240MHz Ant1 Emission

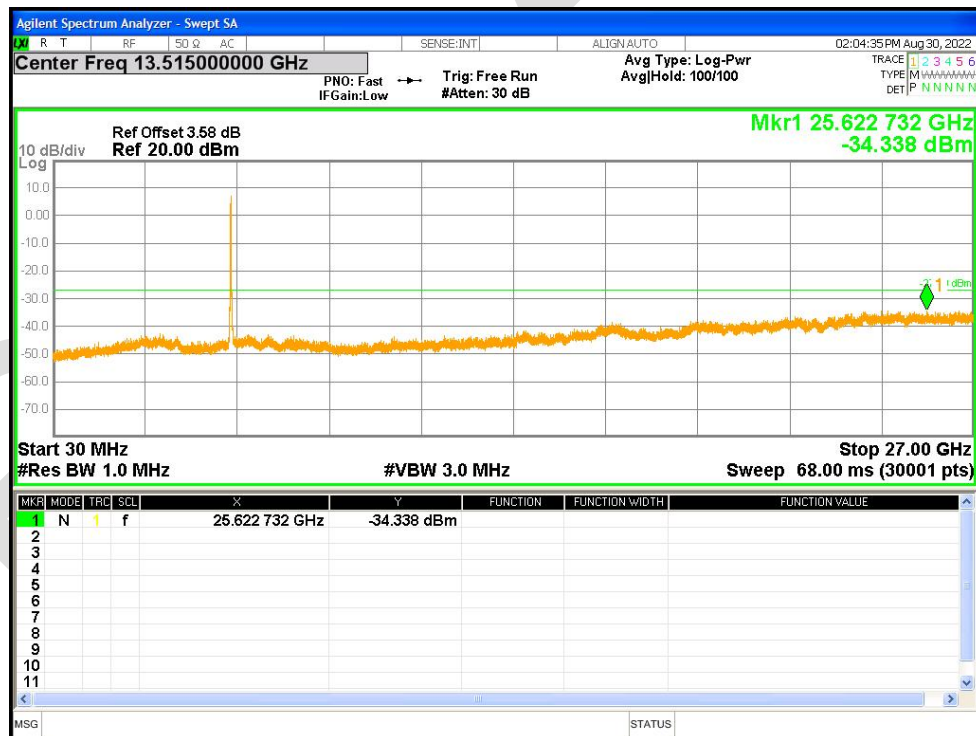
Tx. Spurious NVNT ac20 5180MHz Ant1 Emission

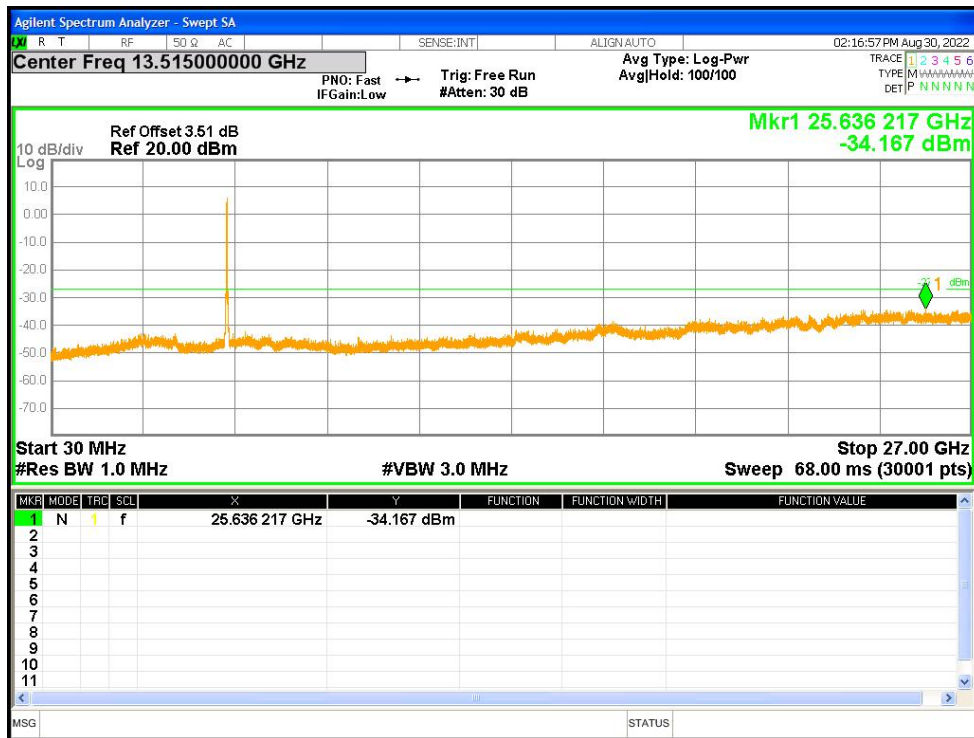
Tx. Spurious NVNT ac20 5200MHz Ant1 Emission

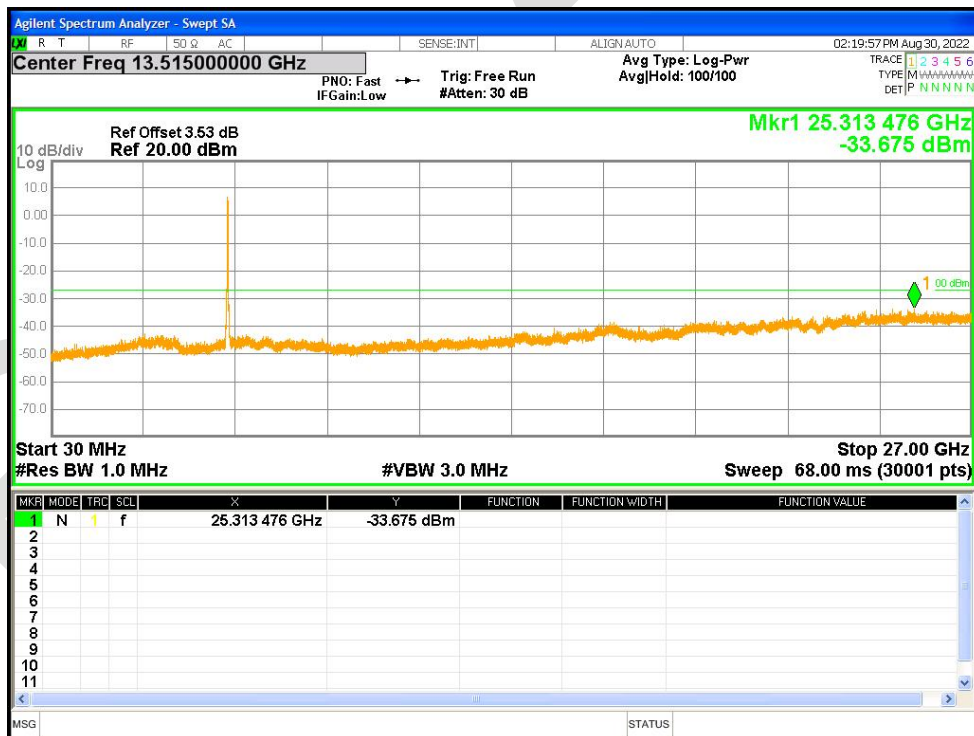
Tx. Spurious NVNT ac20 5240MHz Ant1 Emission

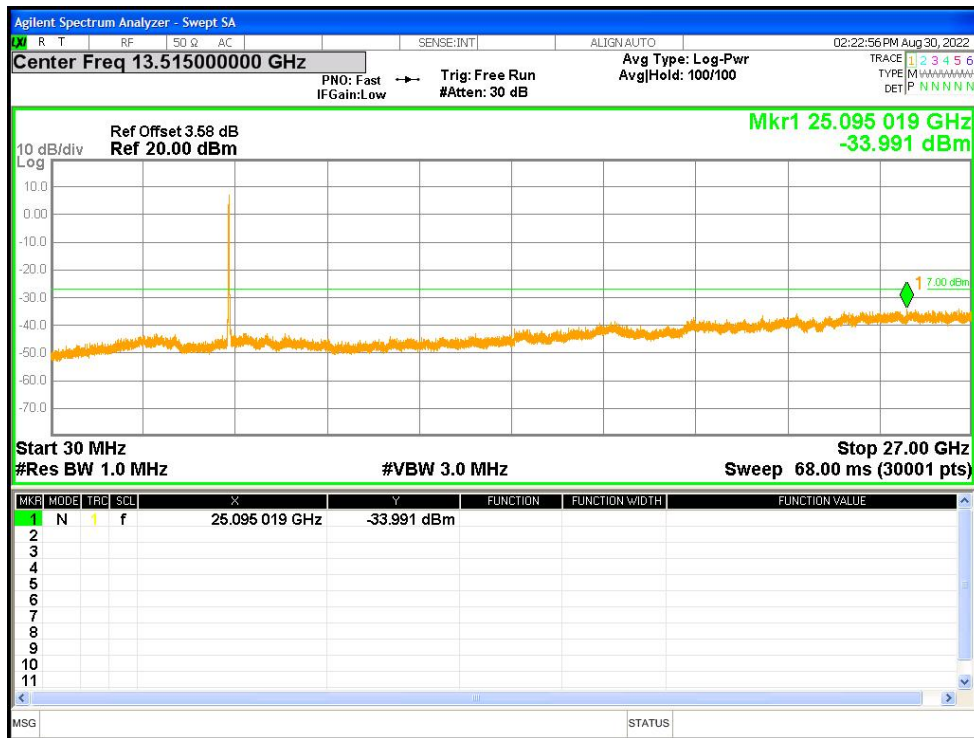
Tx. Spurious NVNT ac40 5190MHz Ant1 Emission

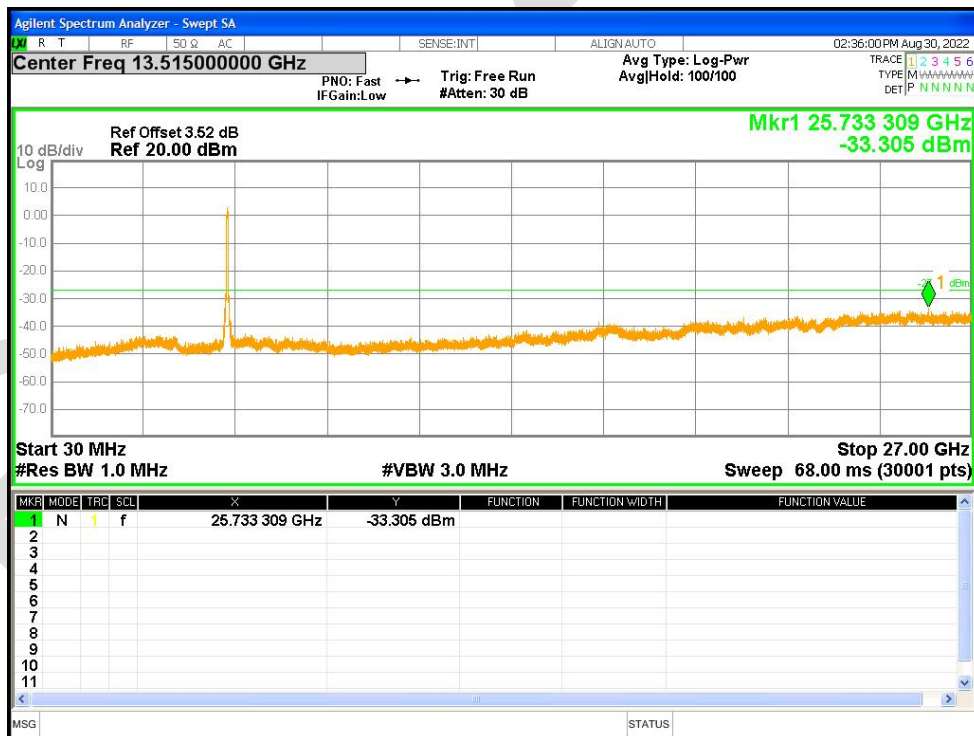
Tx. Spurious NVNT ac40 5230MHz Ant1 Emission

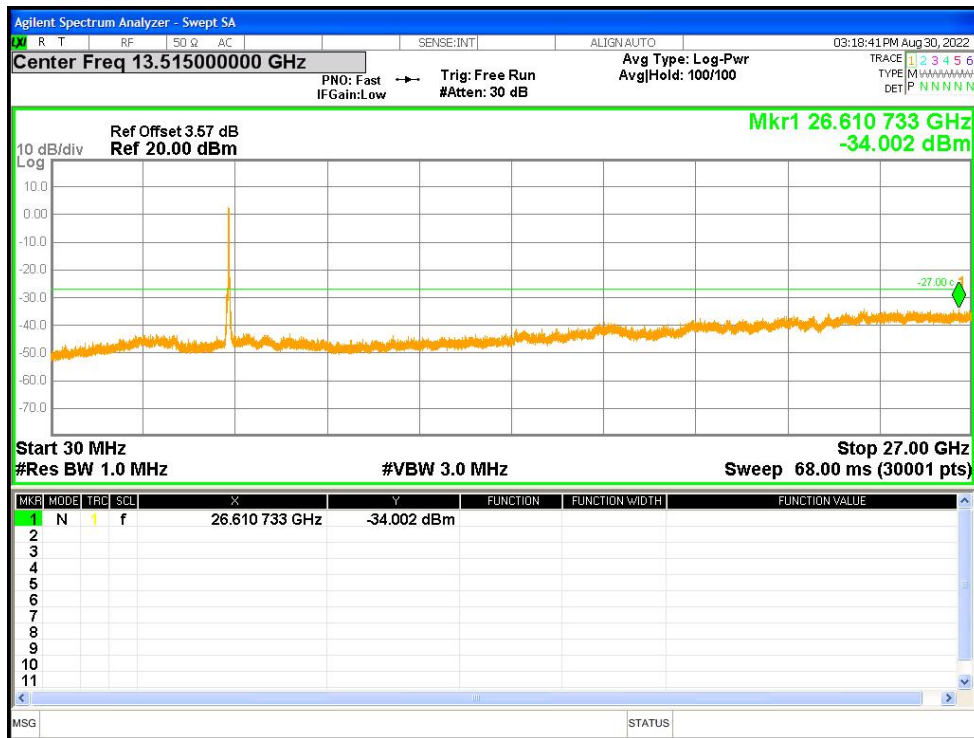
Tx. Spurious NVNT ac80 5210MHz Ant1 Emission

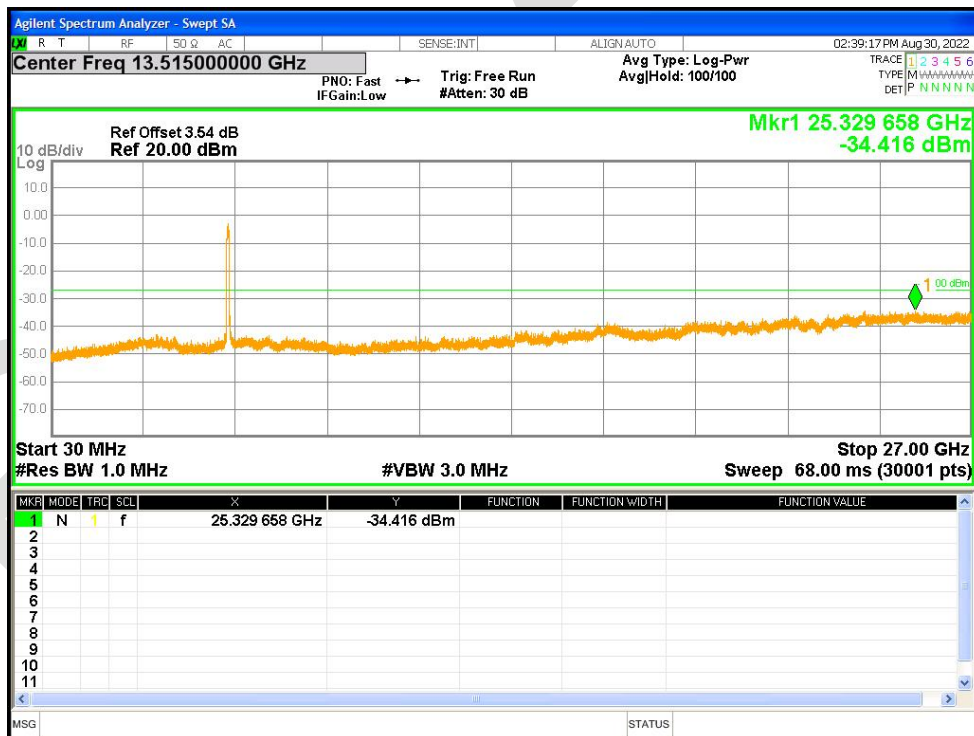
Tx. Spurious NVNT n20 5180MHz Ant1 Emission

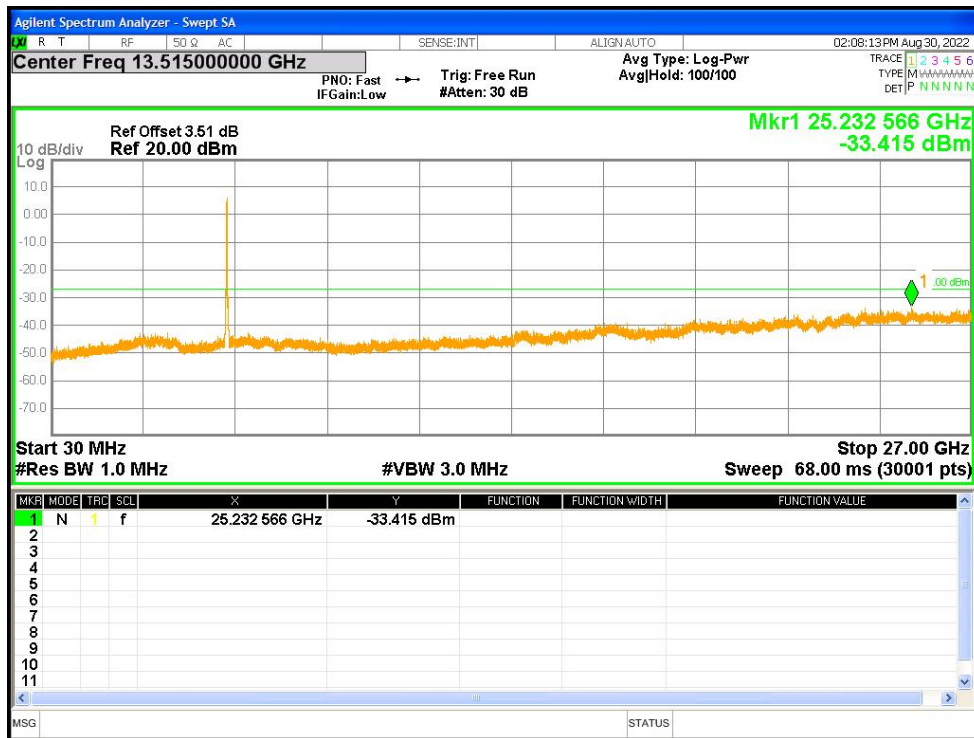
Tx. Spurious NVNT n20 5200MHz Ant1 Emission

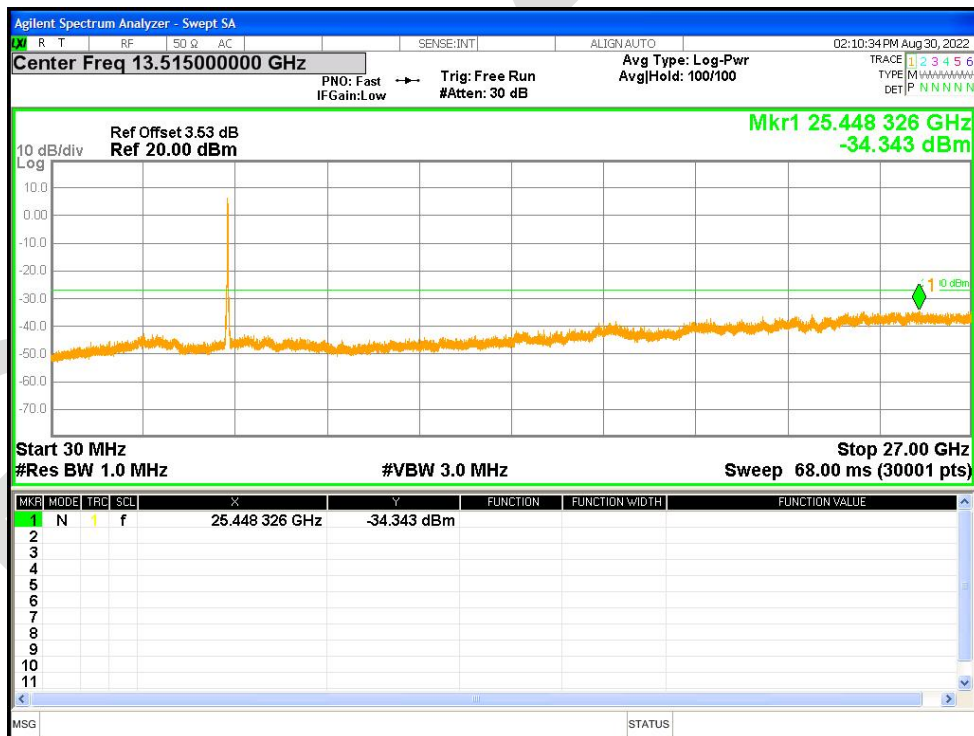
Tx. Spurious NVNT n20 5240MHz Ant1 Emission

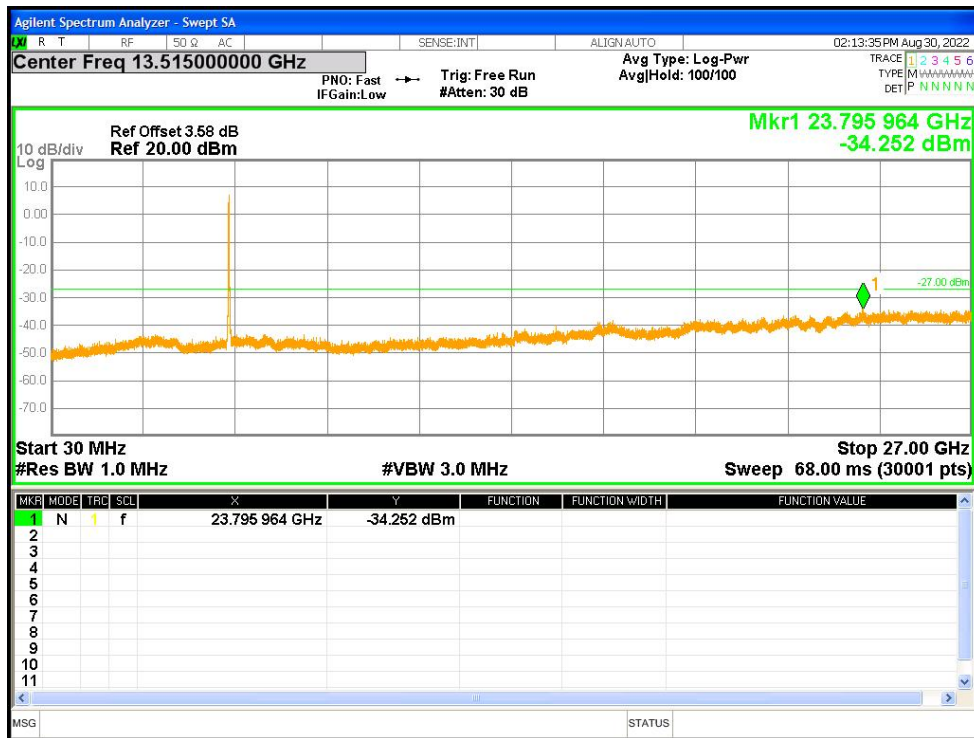
Tx. Spurious NVNT n40 5190MHz Ant1 Emission

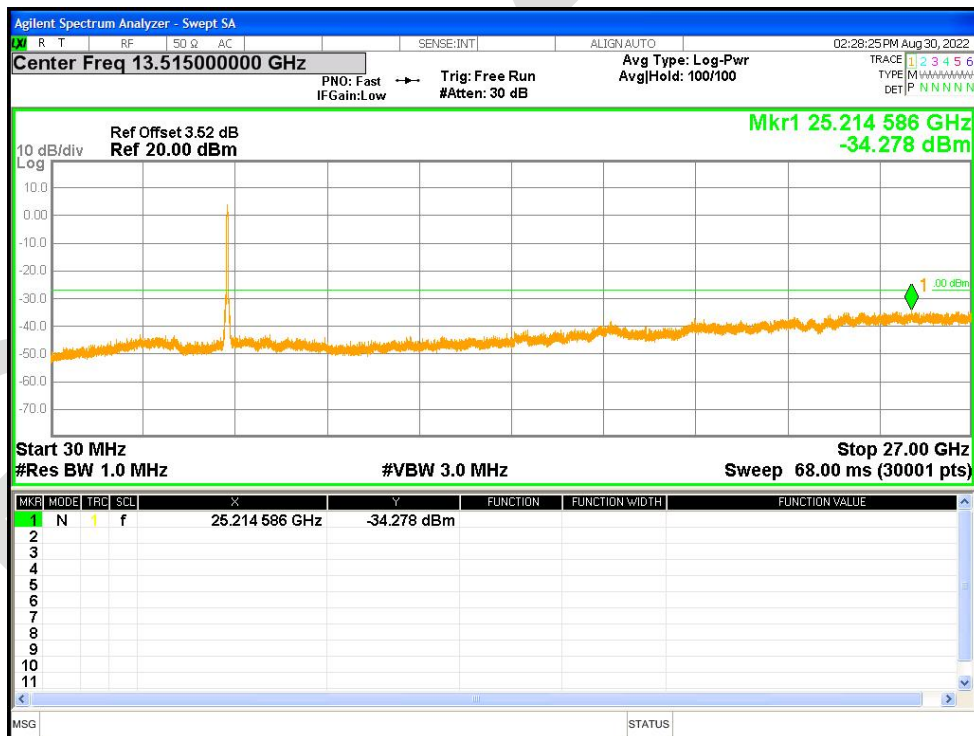
Tx. Spurious NVNT n40 5230MHz Ant1 Emission

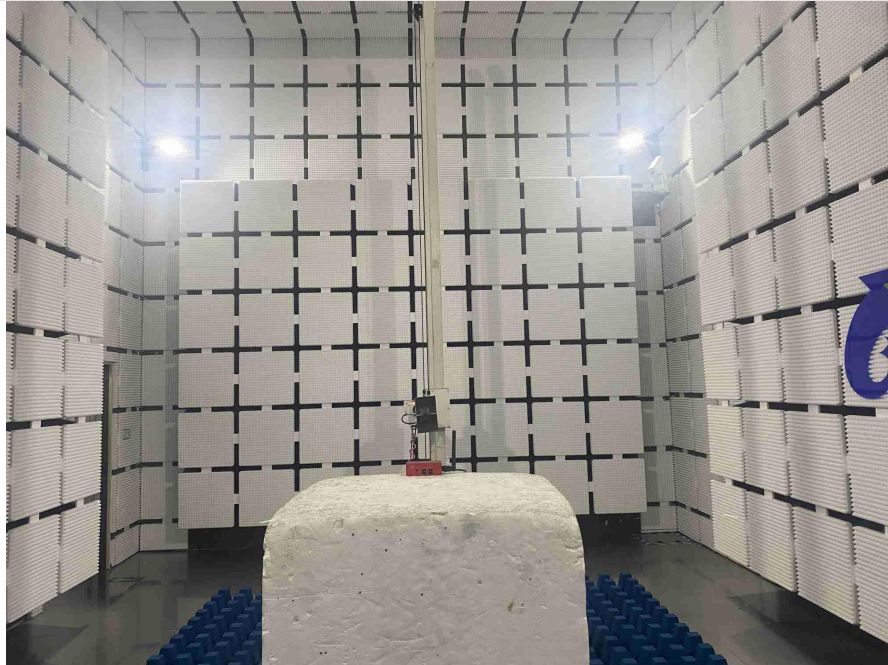
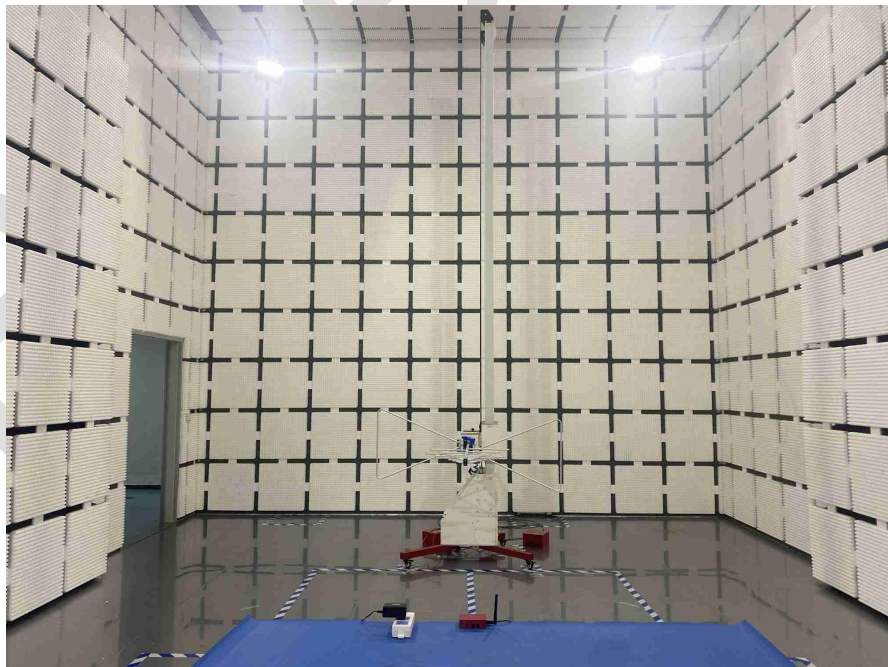
### Radiated Emissions
