### **APPENDIX 3: Photographs of test setup**

#### **Radiated Spurious Emission**

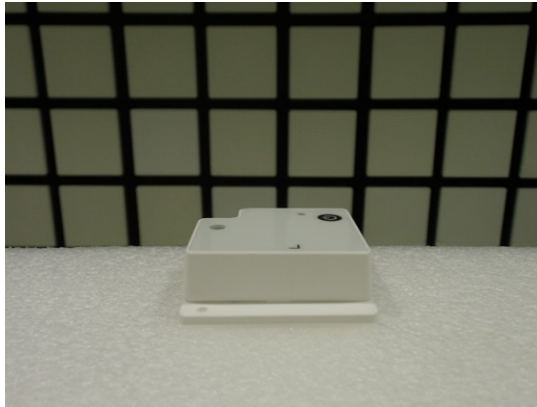
**X-axis**

**Worst Case Position**

**Below 1GHz**    **Horizontal: X-axis / Vertical: X-axis**  
**Above 1GHz:**    **Horizontal: X-axis / Vertical: Z-axis**

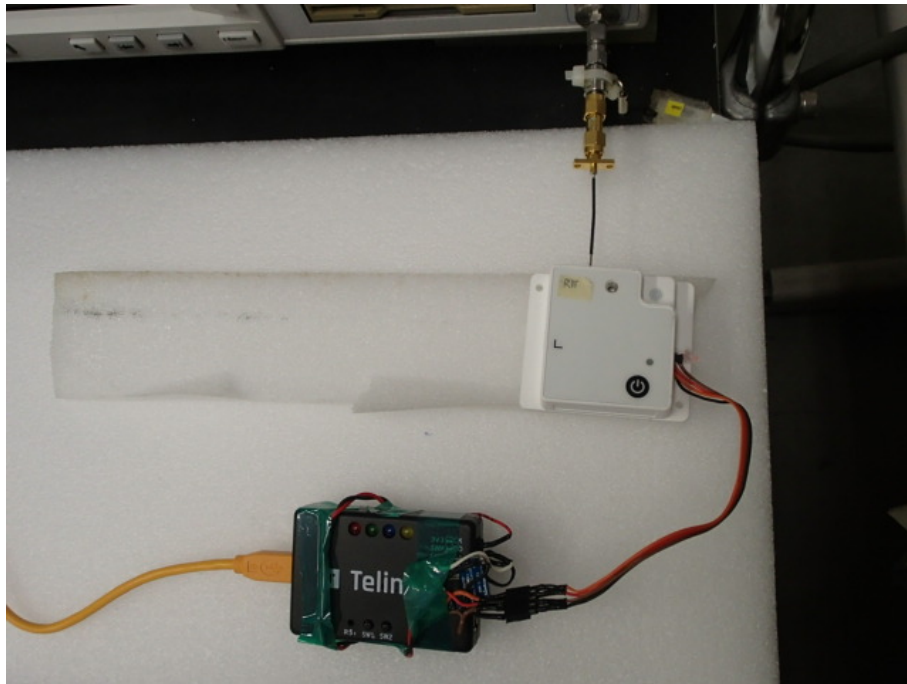
**Photo 1**

### Antenna Terminal Conducted Tests
