Test plots

## 5.10 Spurious RF Conducted Emissions

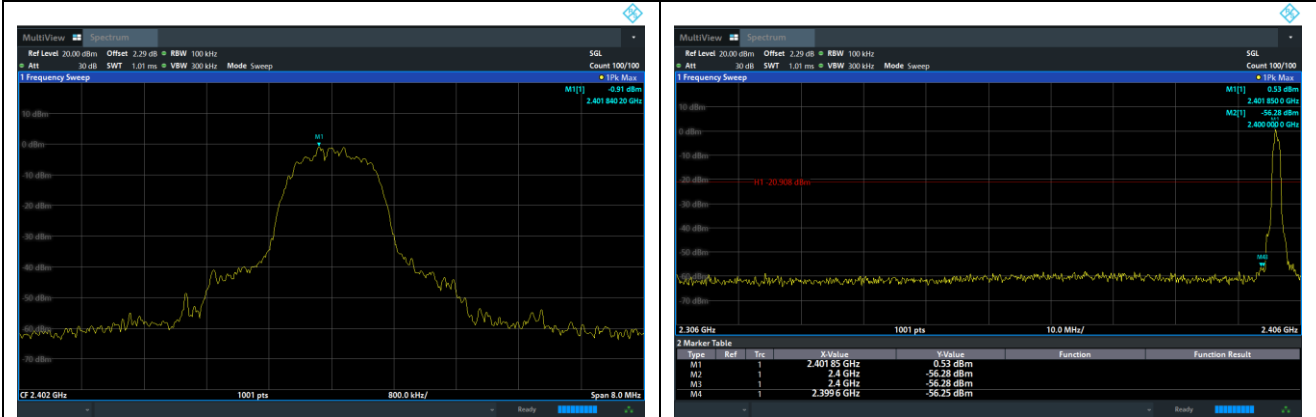
$\pi/4$ -DQPSK: Band Edge, Left Side

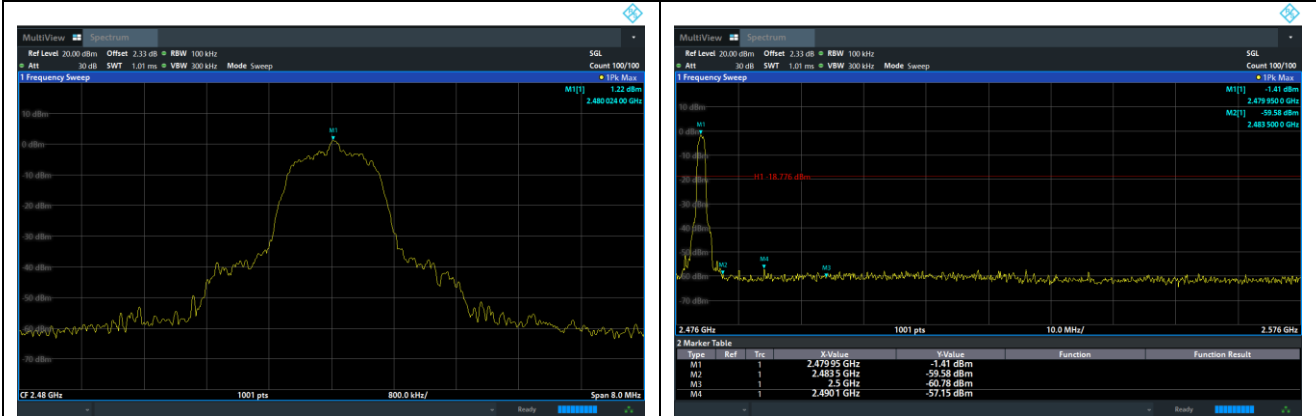
$\pi/4$ -DQPSK: Band Edge, Right Side

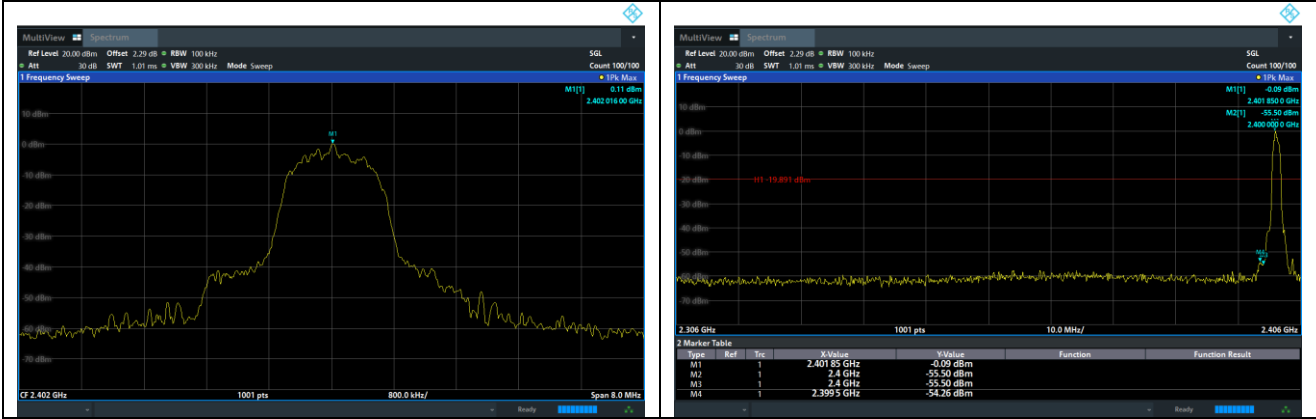
8DPSK: Band Edge, Left Side

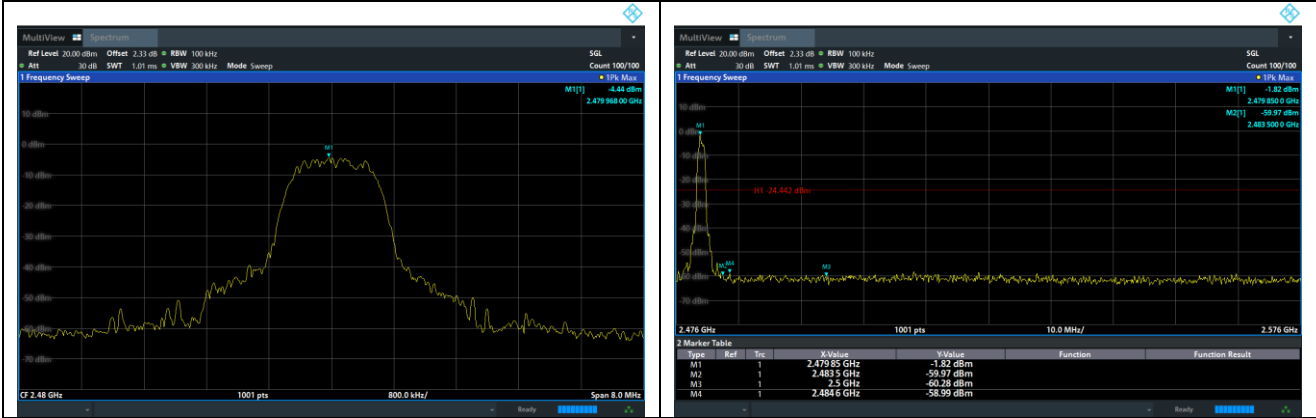
8DPSK: Band Edge, Right Side

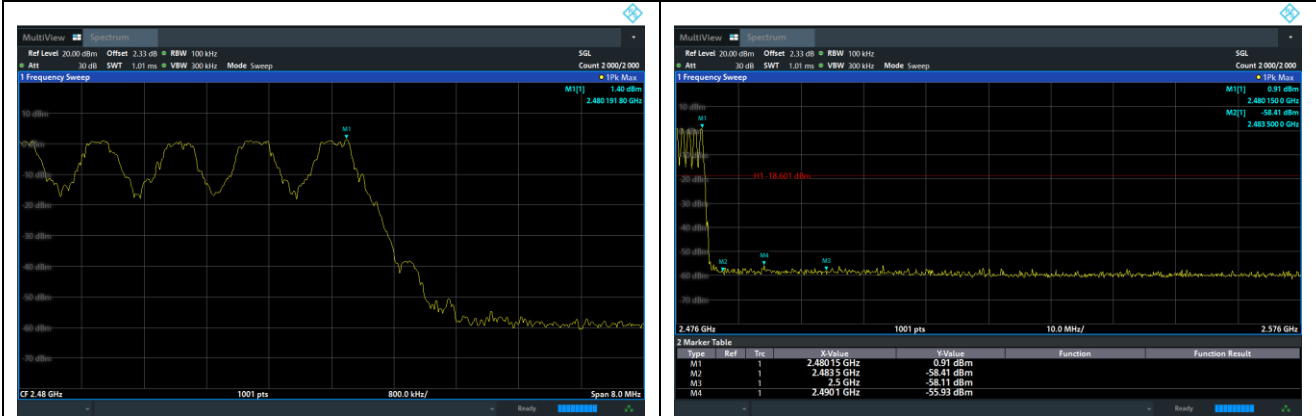
GFSK: Band Edge, Right Side

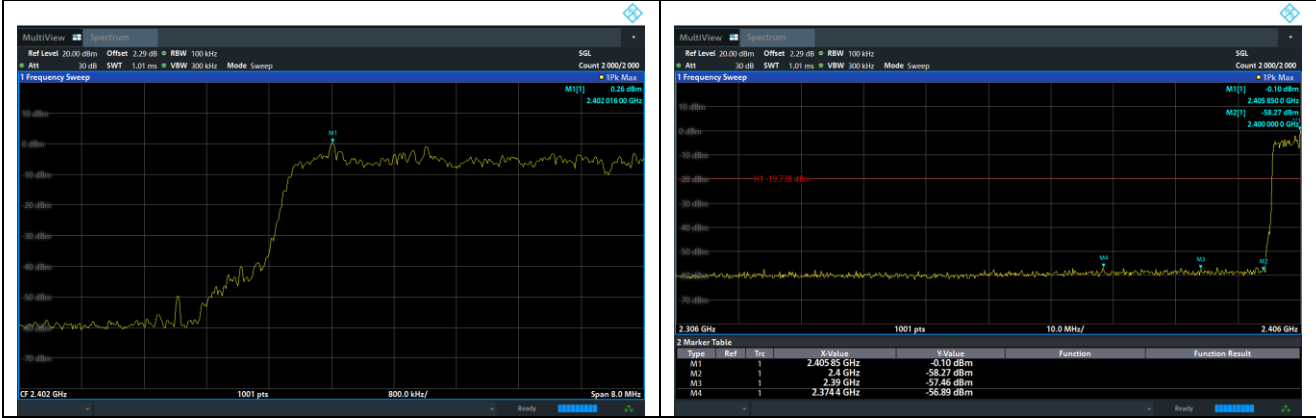
$\pi/4$ -DQPSK: Band Edge, Left Side

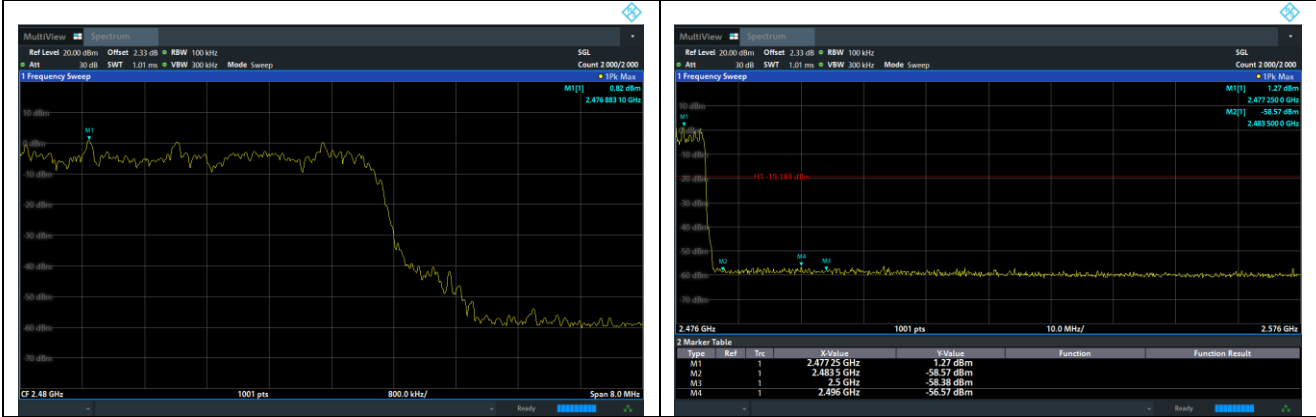
$\pi/4$ -DQPSK: Band Edge, Right Side

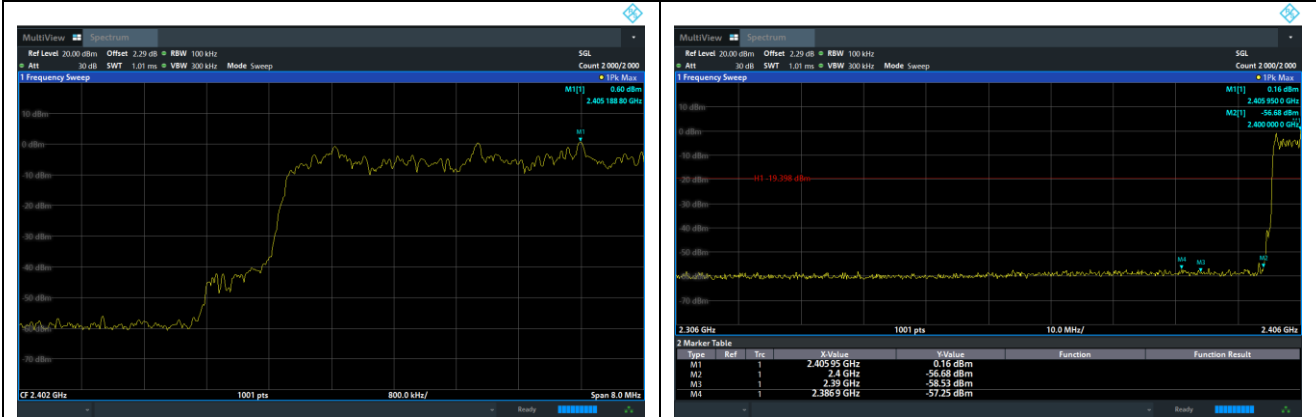
8DPSK: Band Edge, Left Side

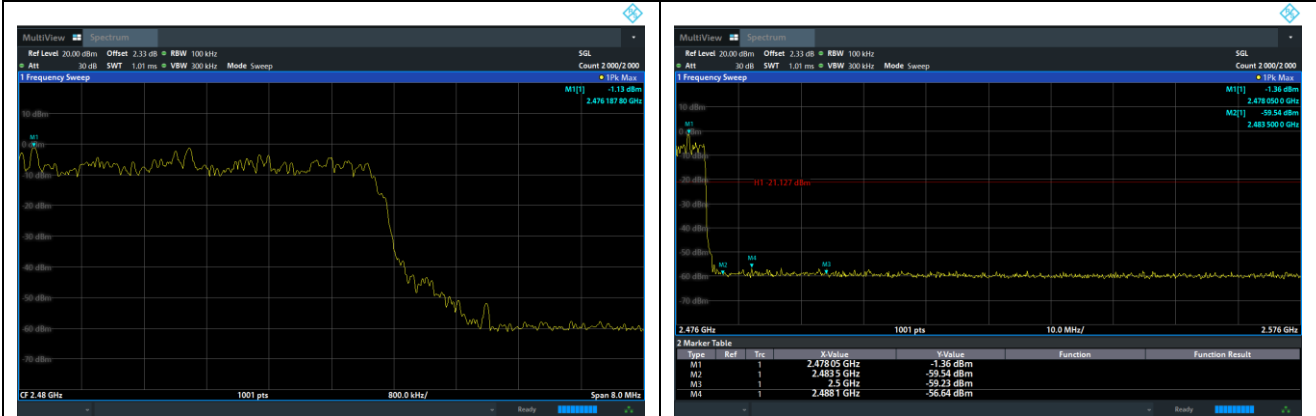
8DPSK: Band Edge, Right Side

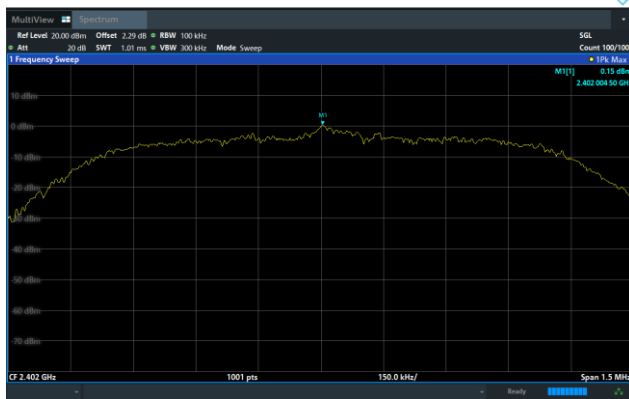
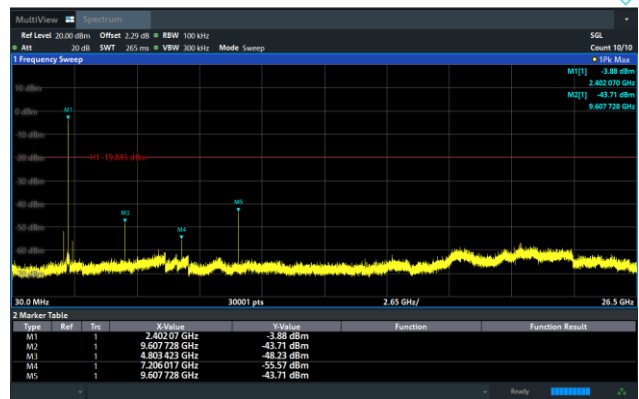
$\pi/4$ -DQPSK on Channel 00

1: The measurement frequency range is from 9kHz to the 10th harmonic of the fundamental frequency. The lowest, middle and highest channels are tested to verify the spurious emissions and band edge measurement data.

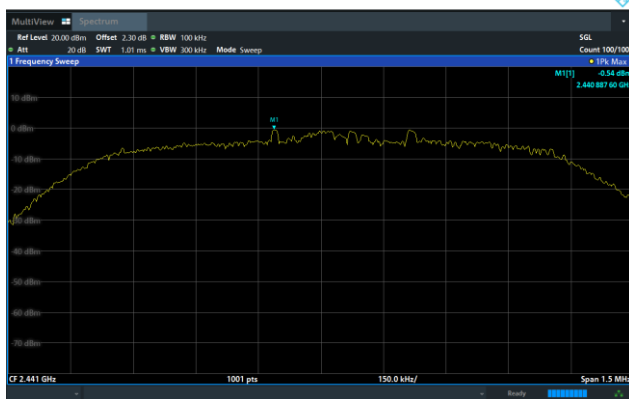
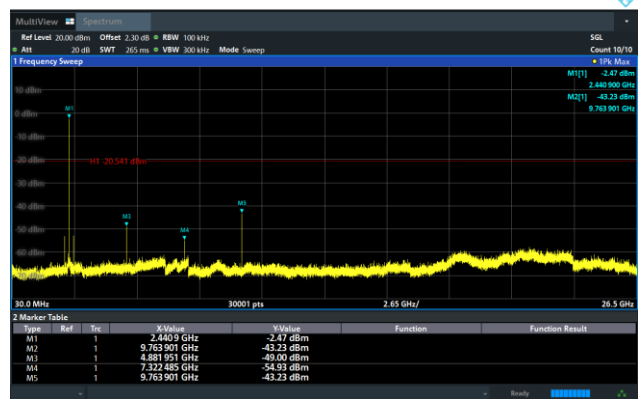
$\pi/4$ -DQPSK on Channel 39

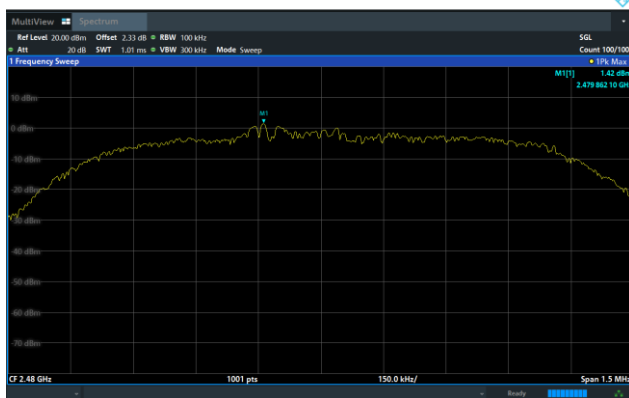
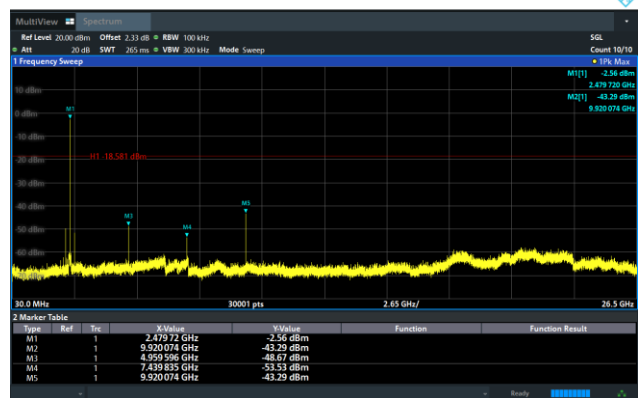
$\pi/4$ -DQPSK on Channel 78

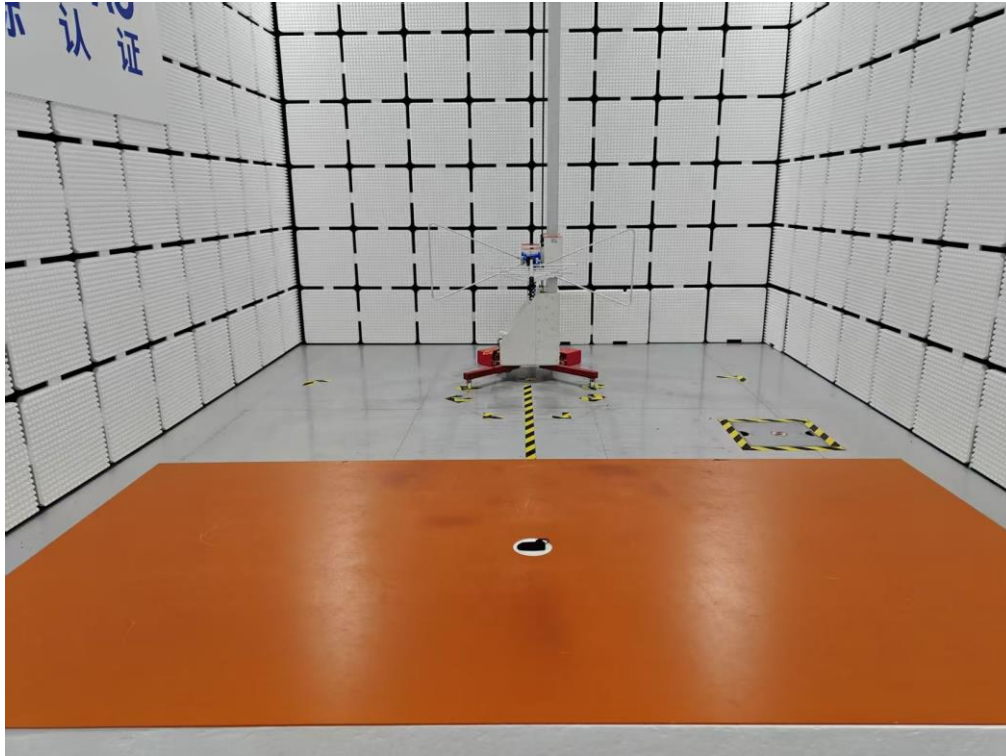
Radiated Emission Below 1GHz

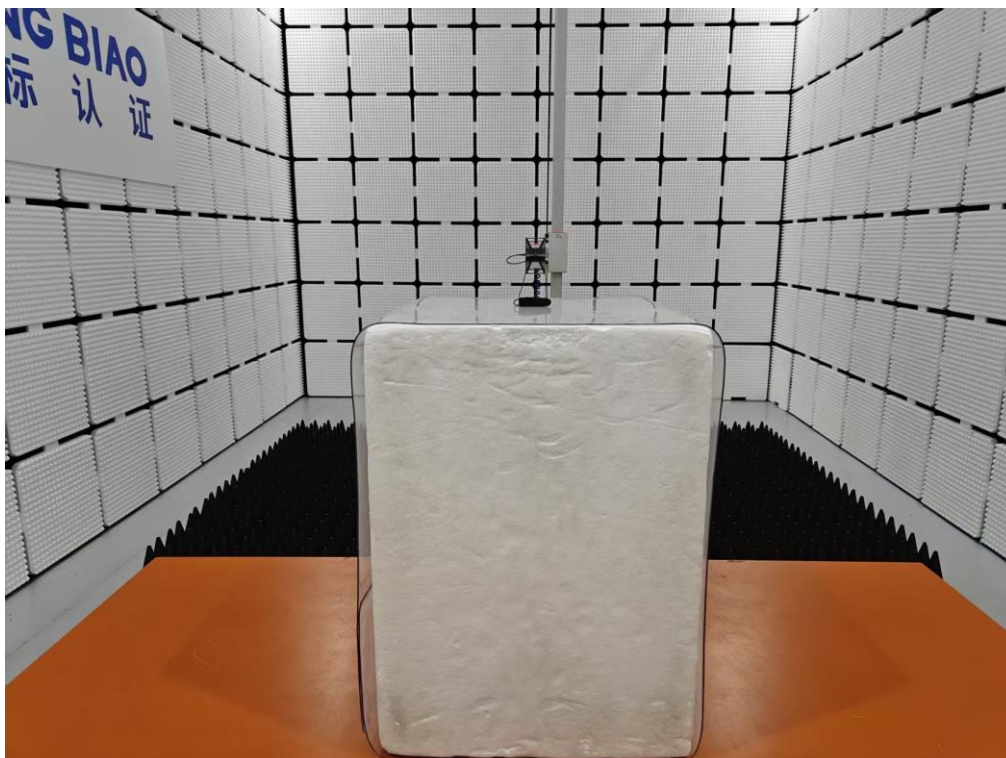
Radiated Emission Above 1GHz
