## Appendix B: photographs of test setup

Reference to the test report no. BLA-EMC-202404-A10901

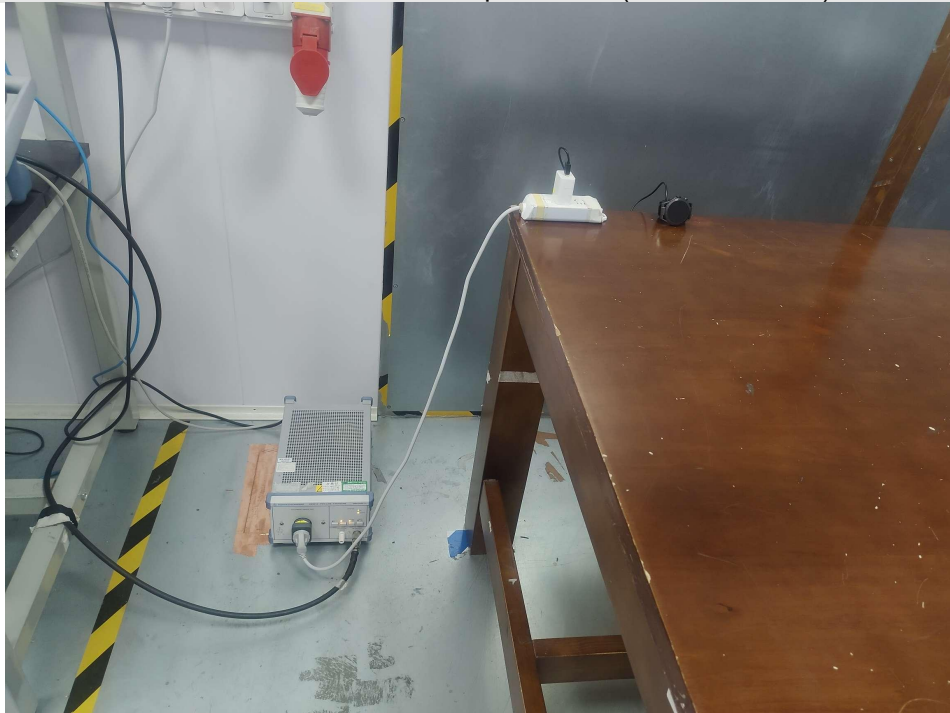
Conducted emissions at AC power line (150kHz-30MHz)

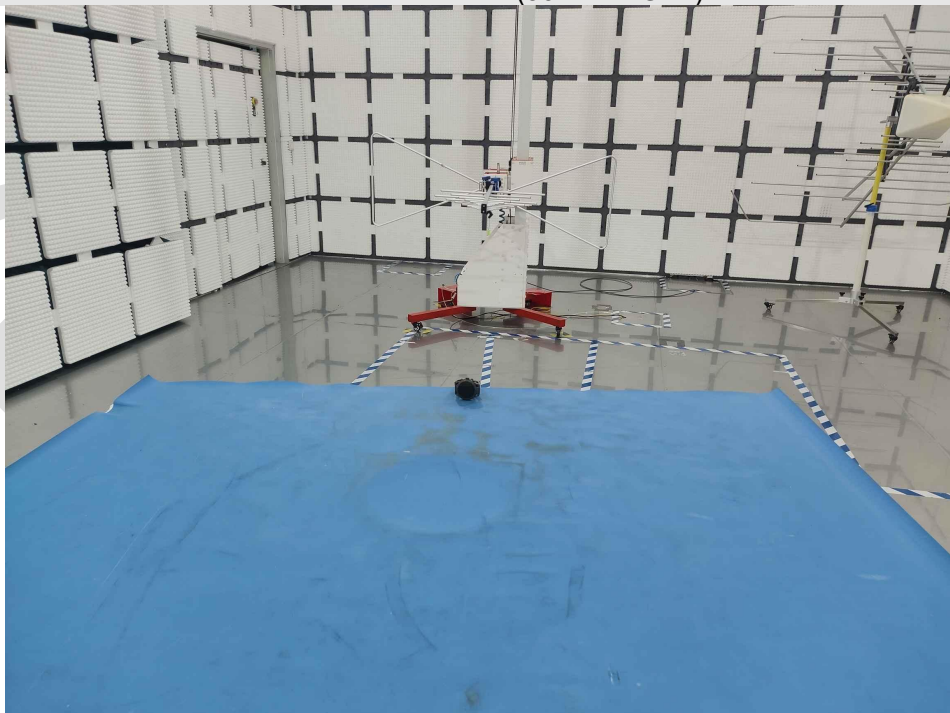
Radiated Emissions (30MHz-1GHz)
