## **RF Test Setup Photo**

## **SAR Test Setup Photo**

Report No.: 2203RSU031-UT

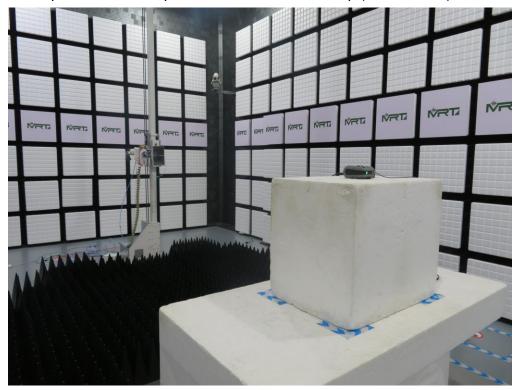
Description: Radiated Spurious Emissions Test Setup (above 1GHz)

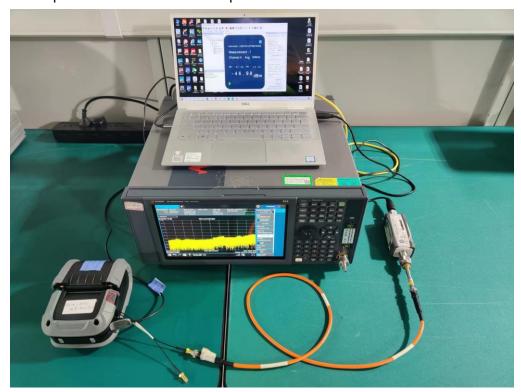
Description: Conducted Test Setup

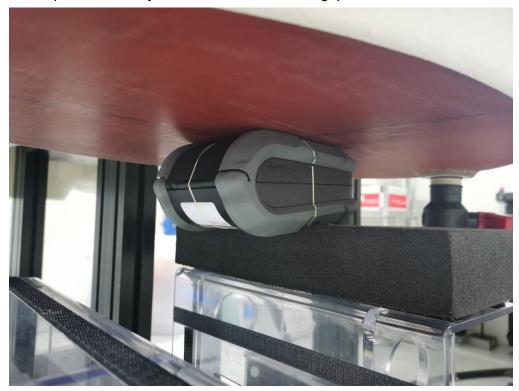
Description: Extremity Front Position with 0mm gap

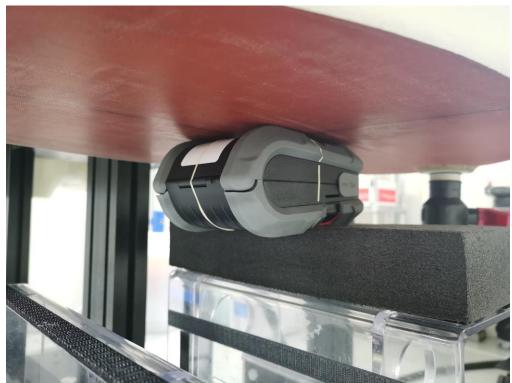
Description: Body Back Position with 0mm gap

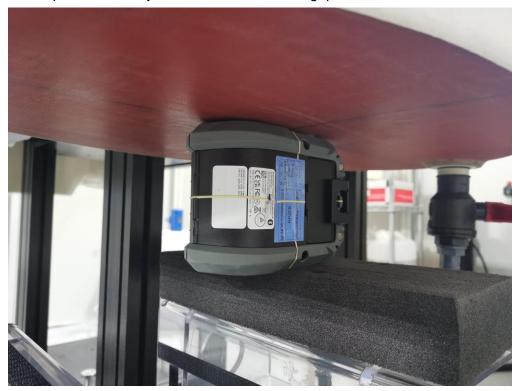
Description: Extremity Left Position with 0mm gap

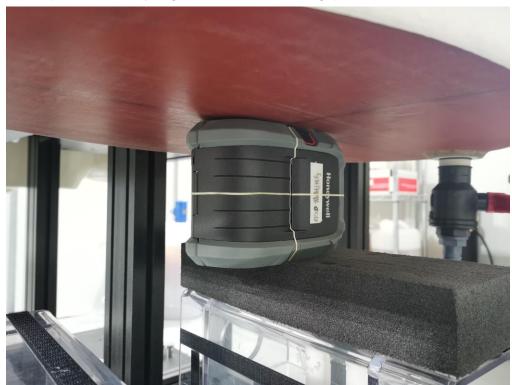
Description: Extremity Right Position with 0mm gap

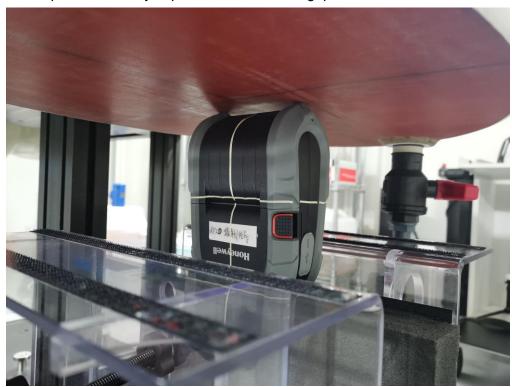
Description: Extremity Top Position with 0mm gap

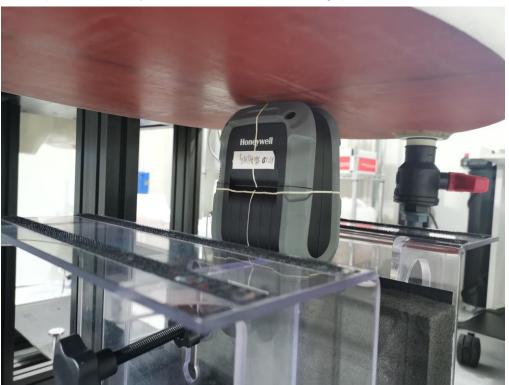
Description: Extremity Bottom Position with 0mm gap
