| Company | QUALCOMM Inc. | Equipment | GLOBALSTAR GSP 1610 |
| GS USER TERMINAL SAR REPORT | | Page Number | 41 |

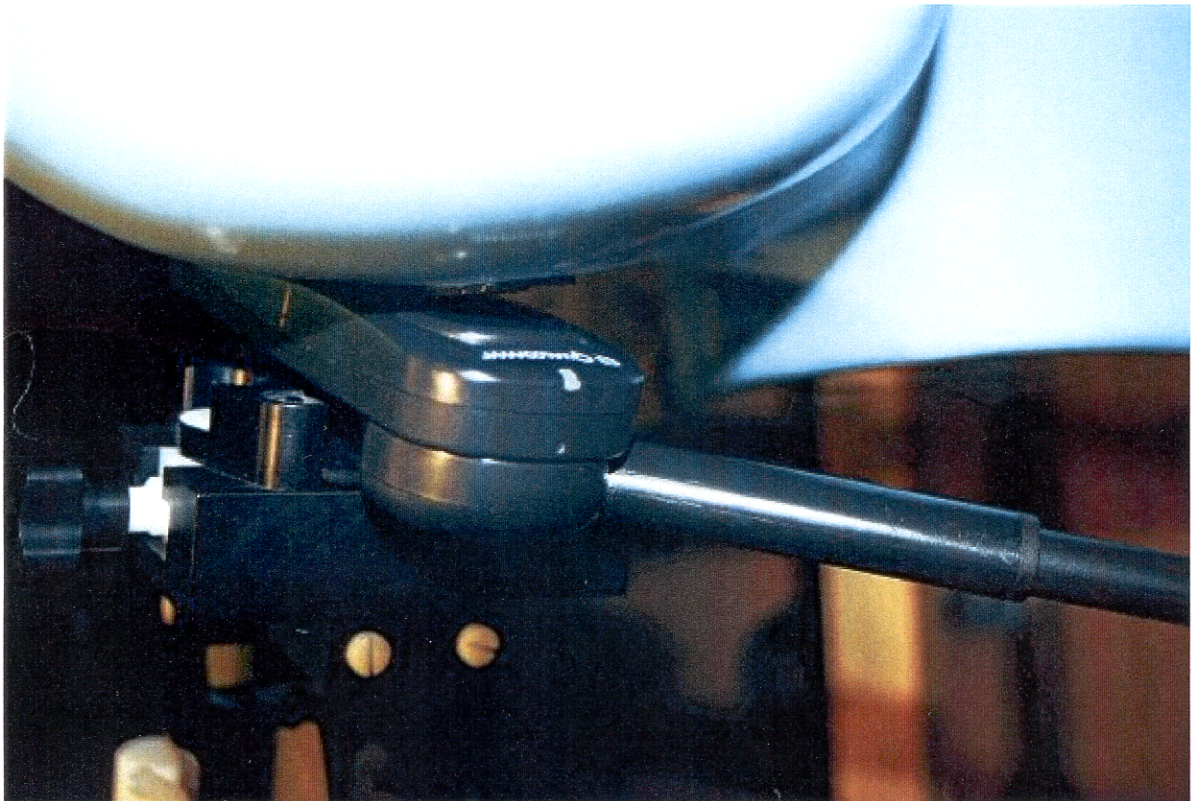
Photo 9 – SAR set-up: Bottom view, right side of head, incorrect antenna position
