## Appendix B: photographs of test setup

## Appendix C: photographs of EUT

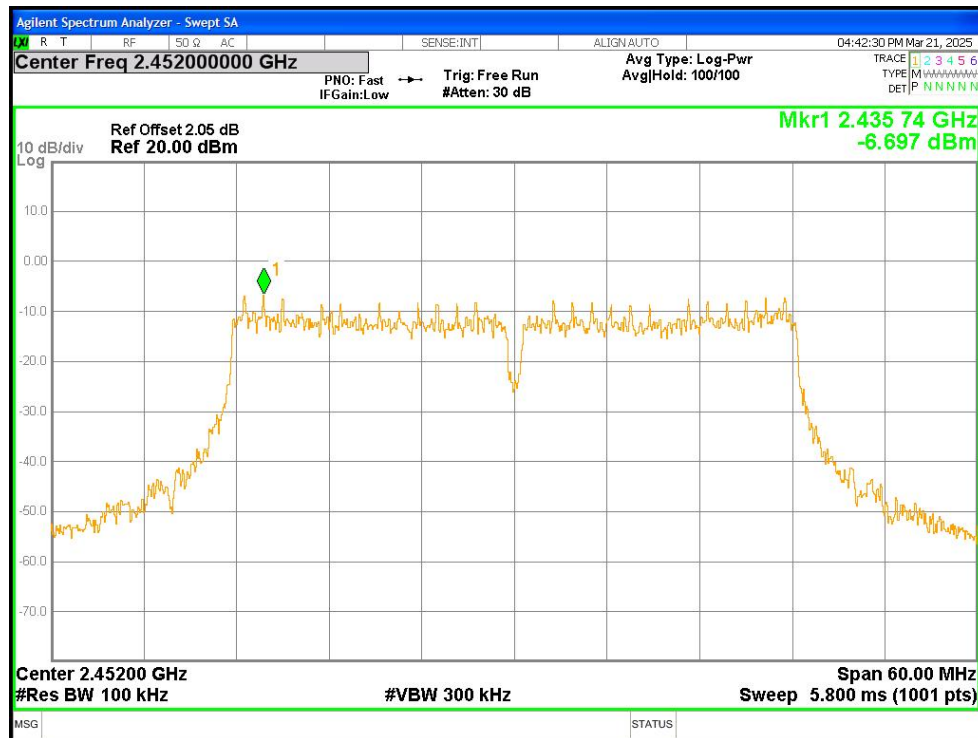
Tx. Spurious NVNT n40 2452MHz Ant2 Ref

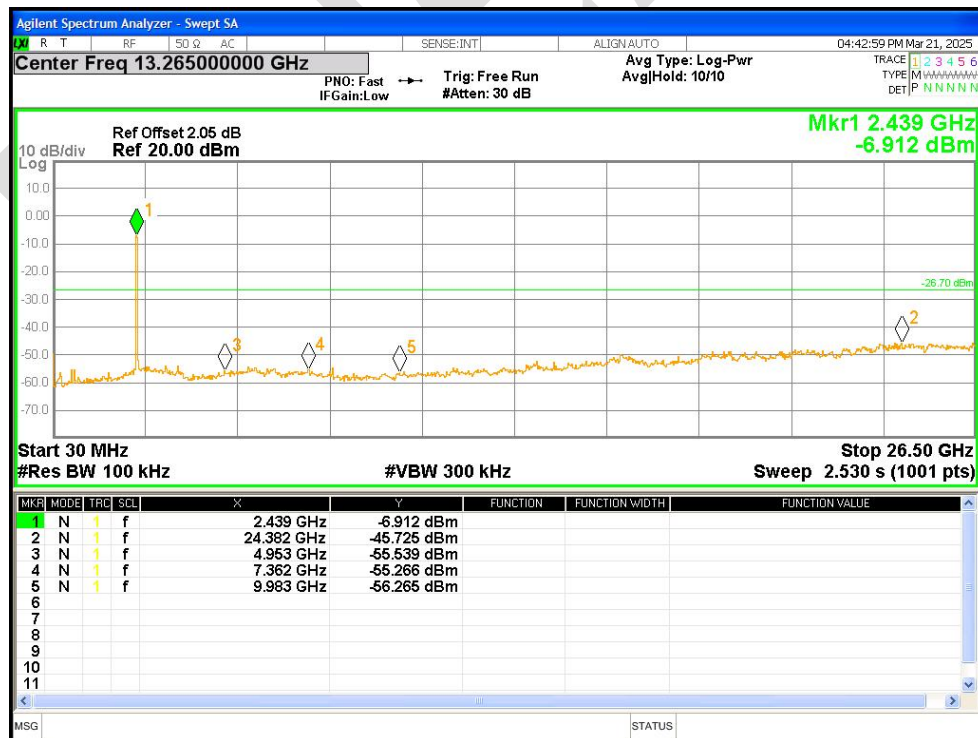
Tx. Spurious NVNT n40 2452MHz Ant2 Emission

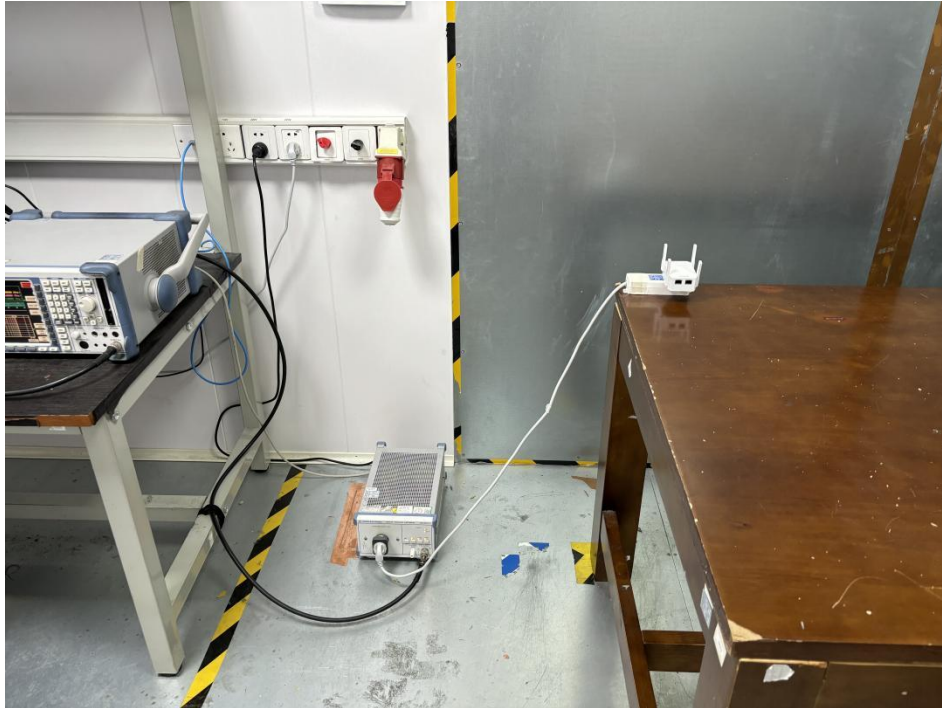
Conducted emissions at AC power line (150kHz-30MHz)

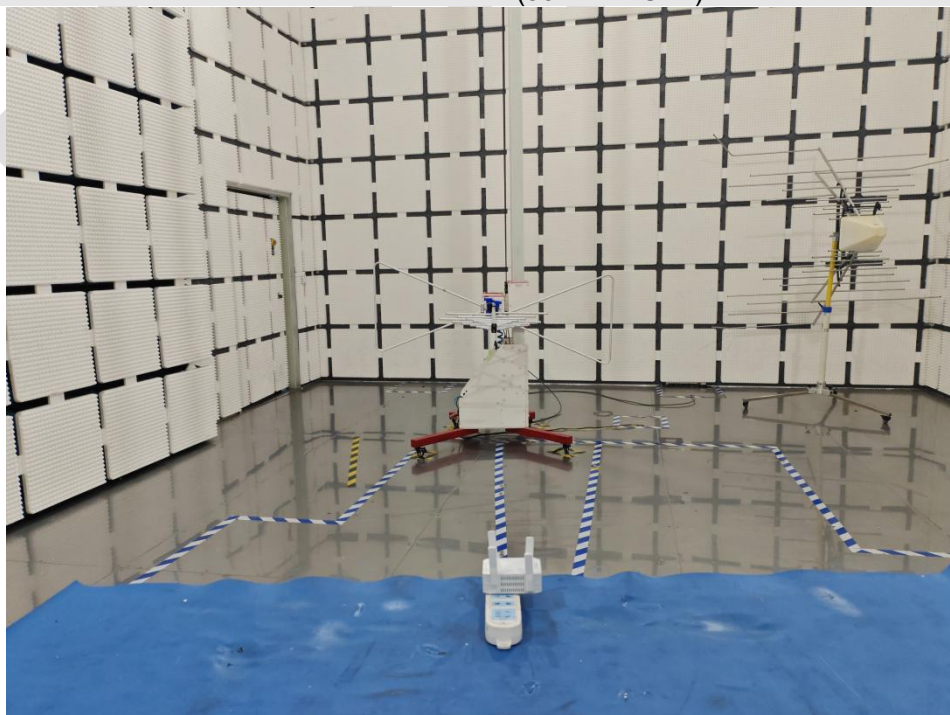
Radiated Emissions (30MHz-1GHz)

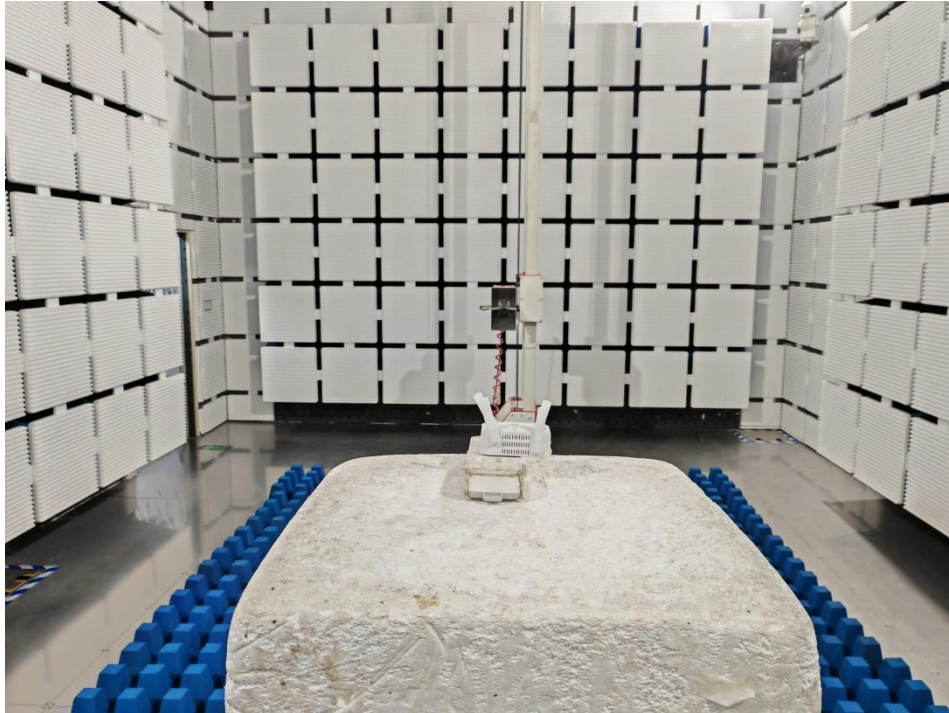
Radiated Emissions (above 1GHz)
