## Appendix B: photographs of test setup

## Appendix C: photographs of EUT

Reference to the test report no. BLA-EMC-202412-A2701

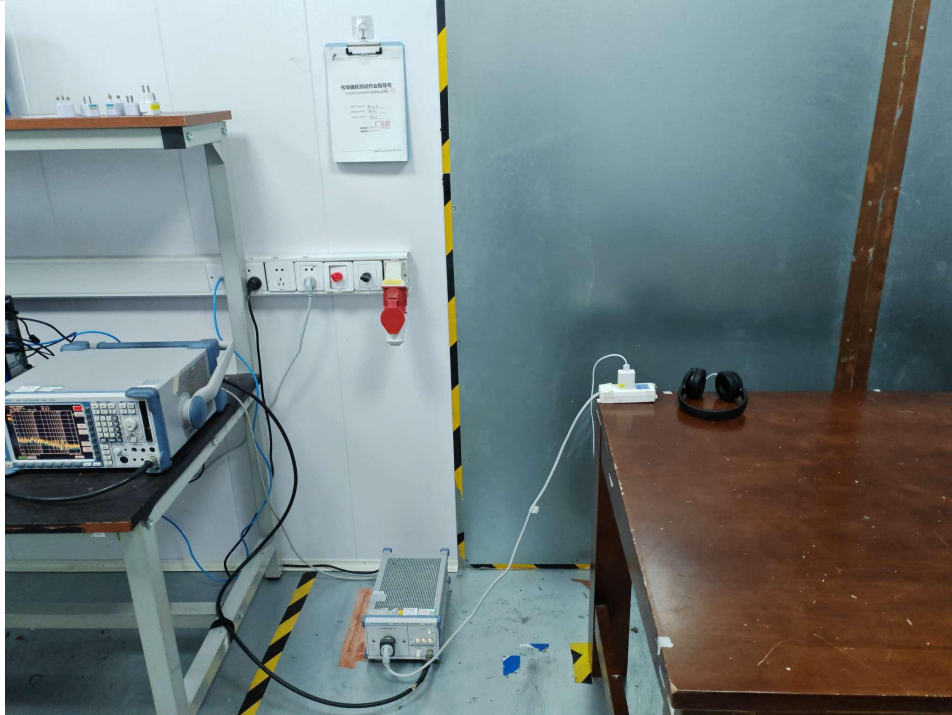
Conducted emissions at AC power line (150kHz-30MHz)

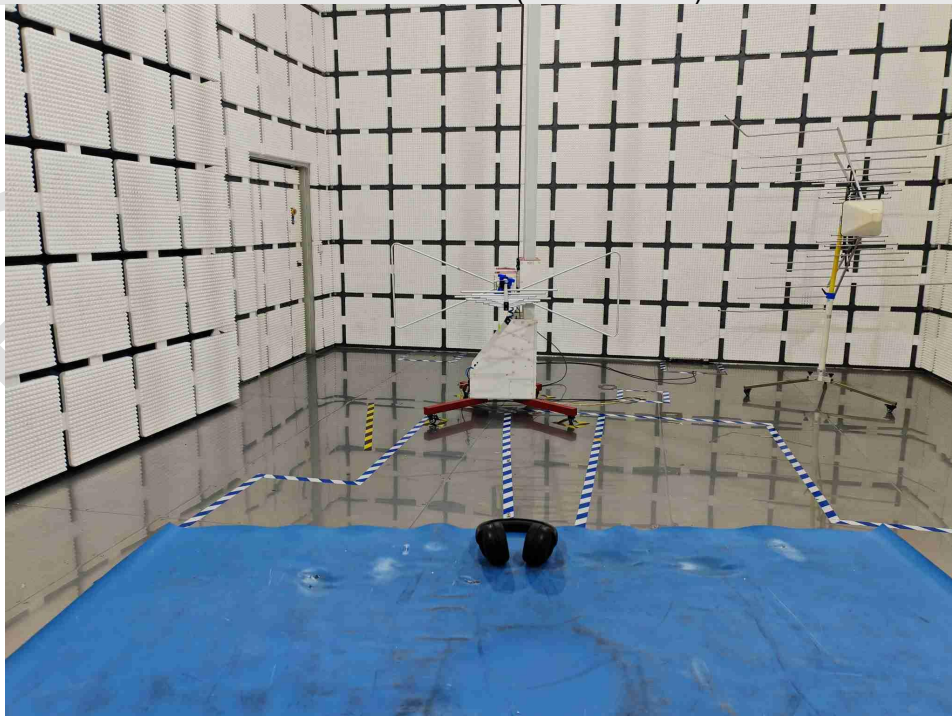
Radiated Emissions (30MHz-1GHz)

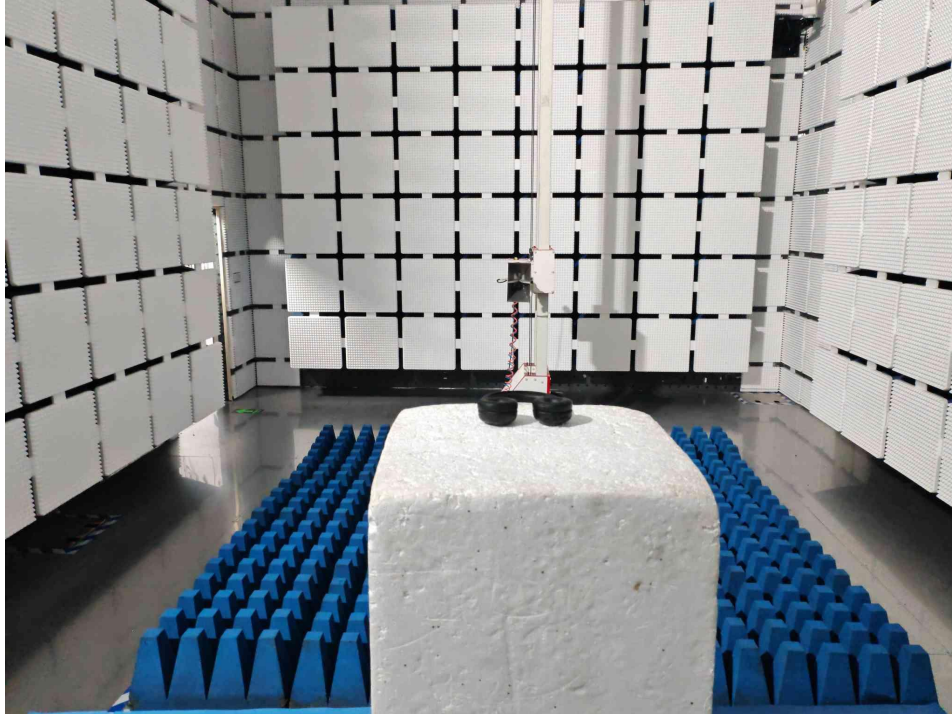
Radiated Emissions (above 1GHz)
