Test Report S/N: 062501-129KBC Dates of Tests: April 03-06, 2001 FCC Part 90 Certification

## INTERNAL EUT PHOTOGRAPHS RIM 802 DataTAC Radio Modem

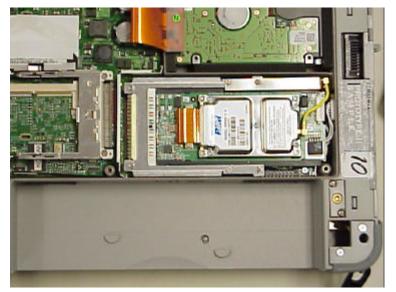
A 1.8 inch coax is routed from the radio to a MMCX to MMCX bulkhead in the magnesium case.

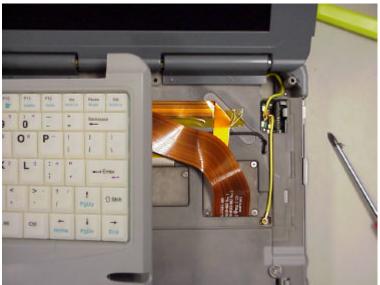
Outside the magnesium case and under the keyboard bezel a 3.8 inch cable routes to the cradle contact board that uses the same mechanical switch as the IX250. From the cable a 17.5 inch cable routes up through the display hinge.

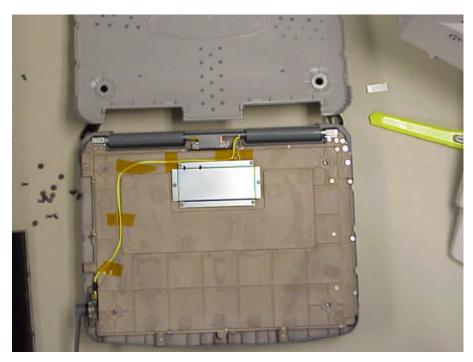
The coax then routes up the back of the display case to the antenna matching network PCB. The matching PCB varies with network type and is generally not the same between IX550 and IX250 due to the different mechanical form factors. The back case is covered with a plastic overmold. Note that the antenna is located on the upper left corner on the display on the IX550 and on the upper right for the IX250.

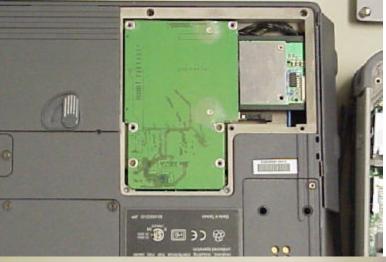
In the IX250 the radio board is located on the same side as the IX550 but more towards the front of the unit.

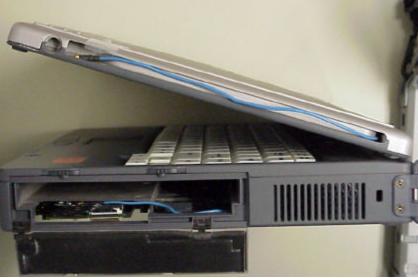
The IX250 does not use a bulkhead connector, but instead has a 8 inch coax that routes from the radio to a cradle contact board. The coax used is the same type as is used for IX550.

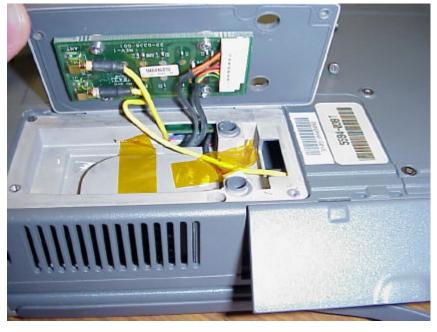
The IX250 uses a different cradle contact board with additional functions, but the RF path is similar to IX550's. The RF signal is routed onto the PCB through a mechanical switch and out towards the display. The second coax is approximately 20 inches in length.

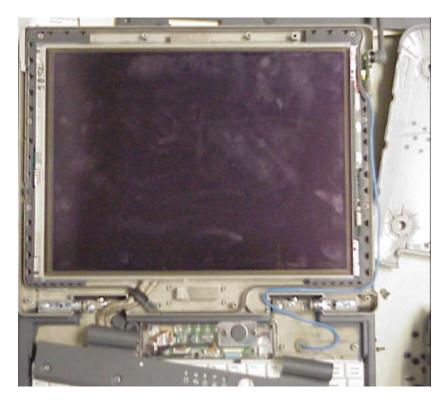
The coax passes through a hole in the magnesium case and then routs through a hinge to the display case. It then routes up the right side in a channel to the antenna matching pcb. The side channel has a plastic cover to protect the coax and seal the display area. The antenna is located on the upper right corner. The IX250 and IX550 use the same metal radiating element encased in a slightly different overmold form. However, the overmold material is the same in both cases.

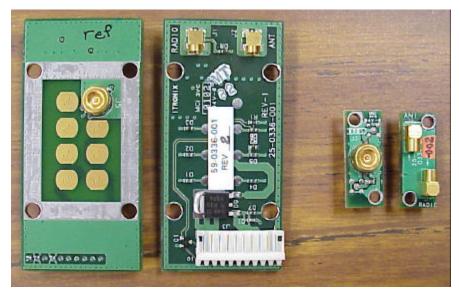
Although significantly different in size, the RF functionality is the same. The RF path routes through an identical mechanical switch which allows the signal to be switched to an external antenna. Both boards were designed with 50 ohm characteristic impedance traces. Also on the RF signal path is a low capacitance transient voltage suppression (TVS) component which is intended to provide ESD protection to the radio. Both boards use the same TVS part.
