Report No.: TRE1705023101 Page 36 of 50 Issued: 2017-06-21

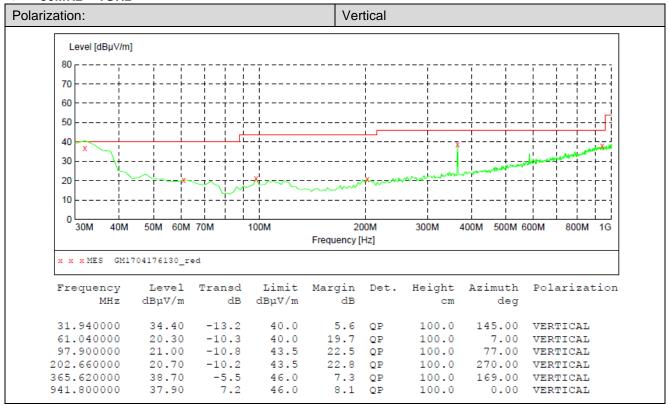
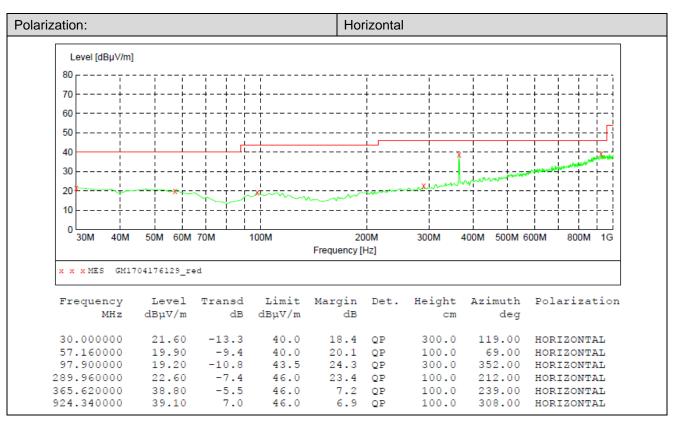
> 30MHz ~ 1GHz

- 1. Final Level =Receiver Read level + Antenna Factor + Cable Loss Preamplifier Factor
- 2. The peak level is lower than average limit(54dBuV/m), this data is the too weak instrument of signal is unable to test.
- 3. The emission levels of other frequencies are very lower than the limit and not show in test report.
