Line Conducted Emission Test Line 2-N

APPENDIX A: PHOTOGRAPHS OF TEST SETUP
RADIATED EMISSION TEST SETUP BELOW 1GHZ

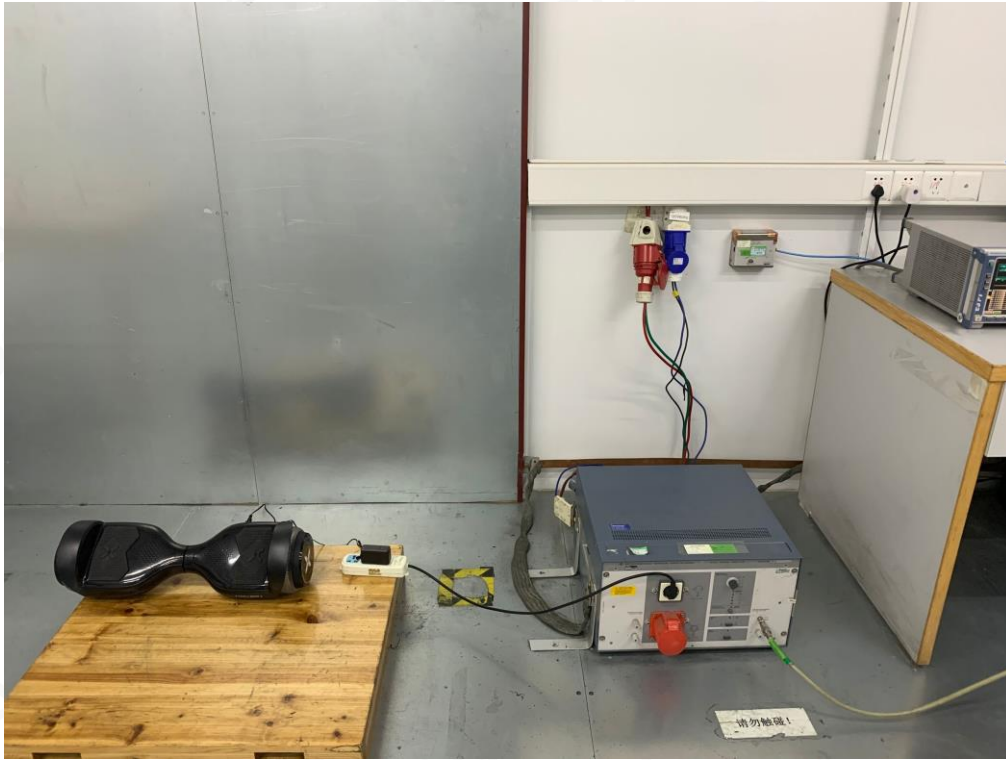
CONDUCTED EMISSION TEST SETUP
