**Prüfbericht - Nr.:**  
*Test Report No.:***50274553 001****Seite 46 von 53**  
*Page 46 of 53*

## 6. Photographs of the Test Setup

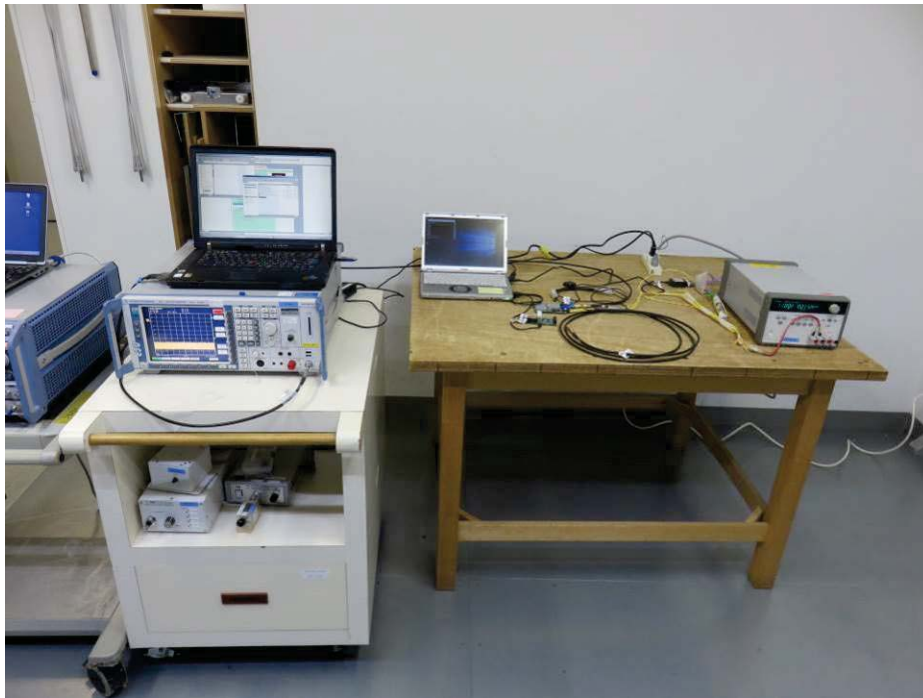
**Photograph 1: Set-up for Conducted Emissions at Antenna Port**

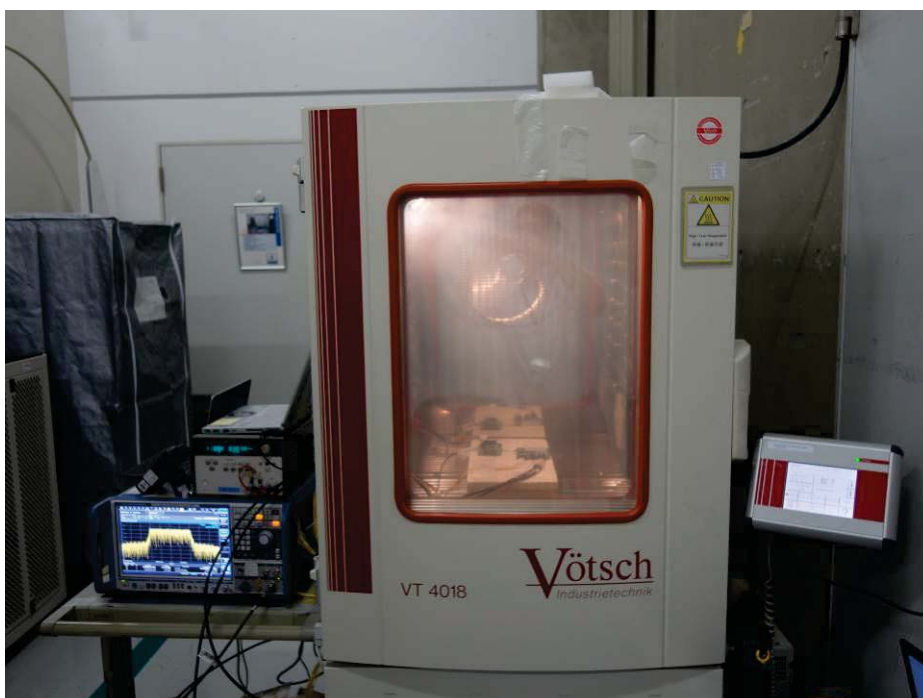
**Photograph 2: Set-up for Frequency Tolerance**

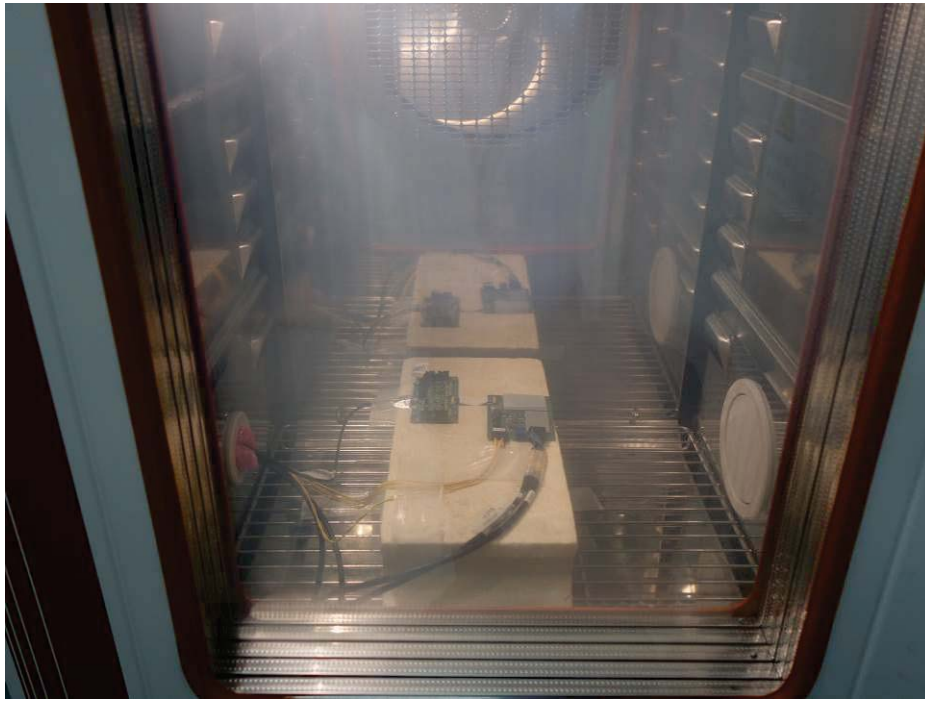
**Photograph 3: Set-up for Frequency Tolerance, Inside Temperature Chamber**

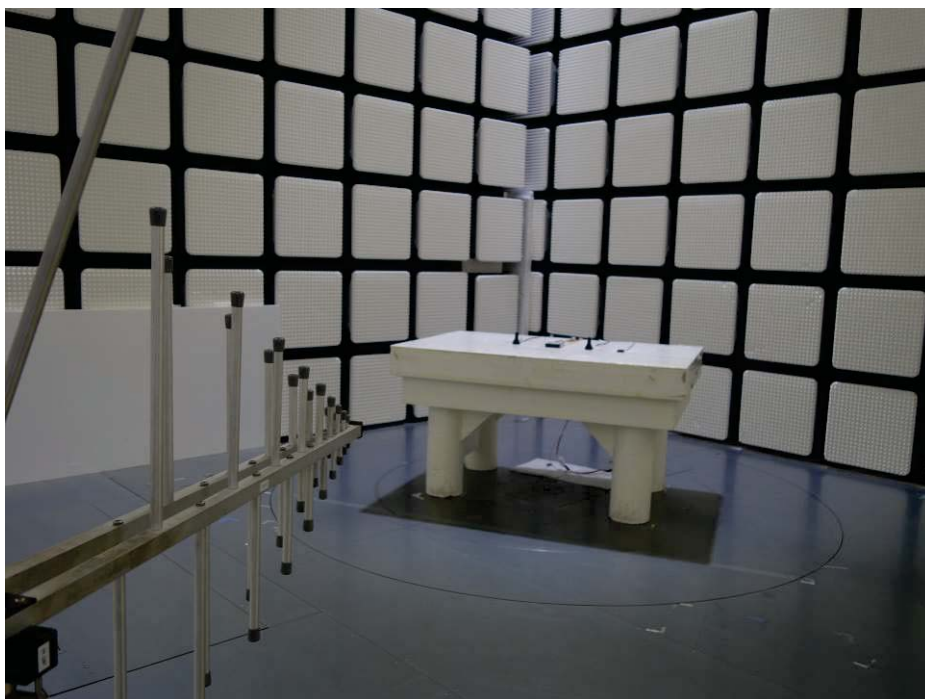
**Photograph 4: Set-up for Radiated Spurious Emission of Transmitter, Front View below 1GHz**

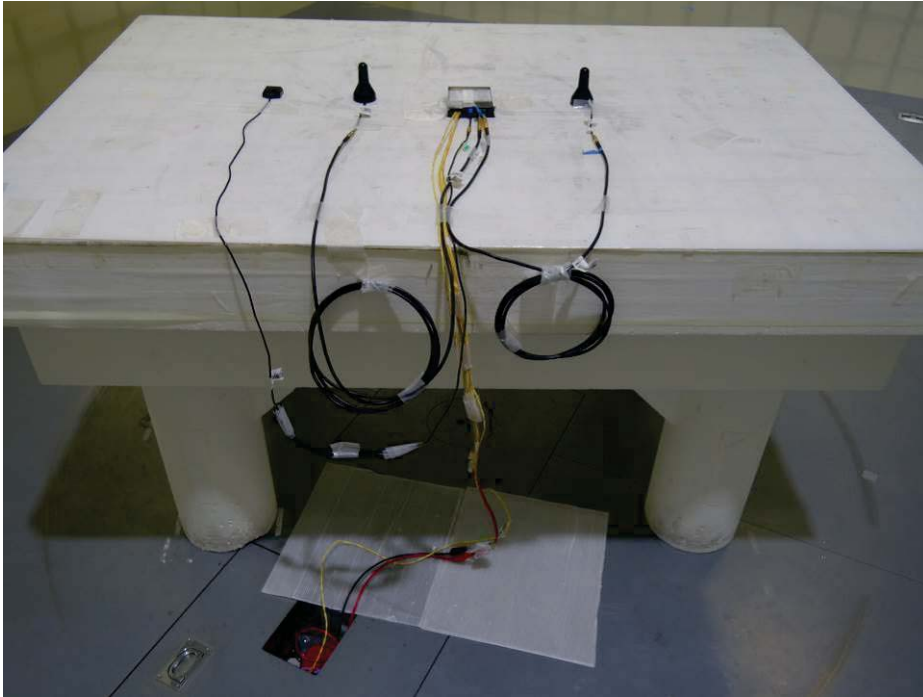
**Photograph 5: Set-up for Radiated Spurious Emission of Transmitter, Rear View below 1GHz**

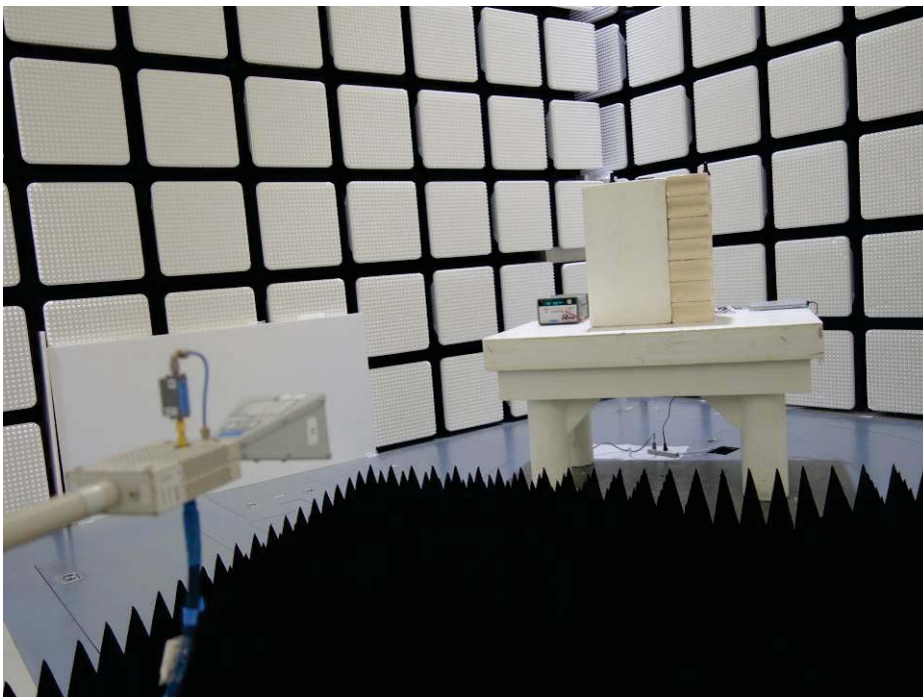
**Photograph 6: Set-up for Radiated Spurious Emission of Transmitter, Front View above 1GHz**

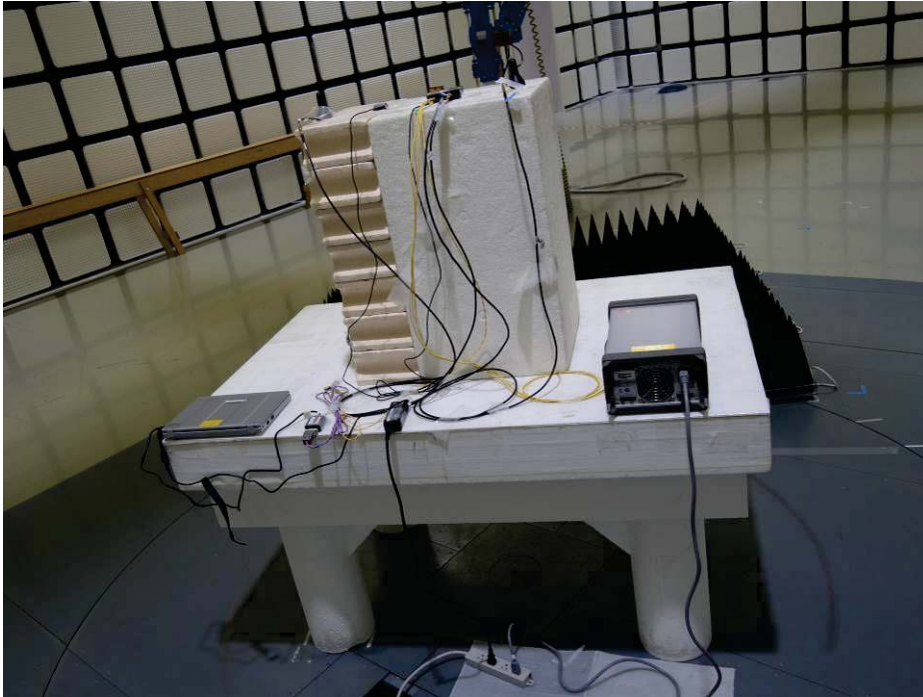
**Photograph 7: Set-up for Radiated Spurious Emission of Transmitter, Rear View above 1GHz**

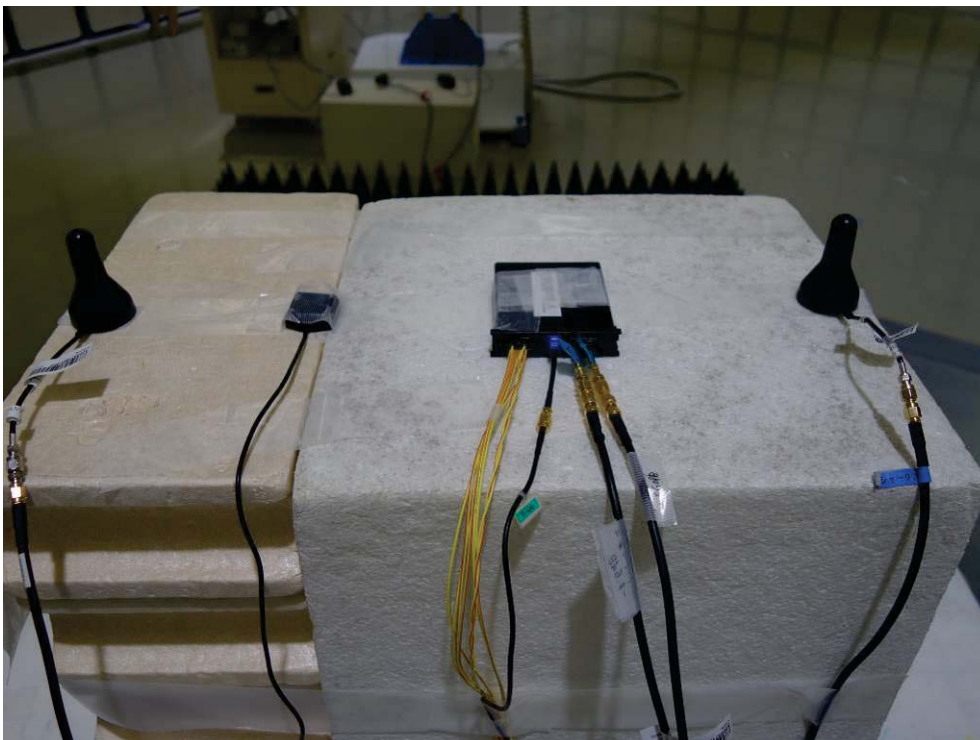
**Photograph 8: Set-up for Radiated Spurious Emission, EUT Configuration X-Axis**

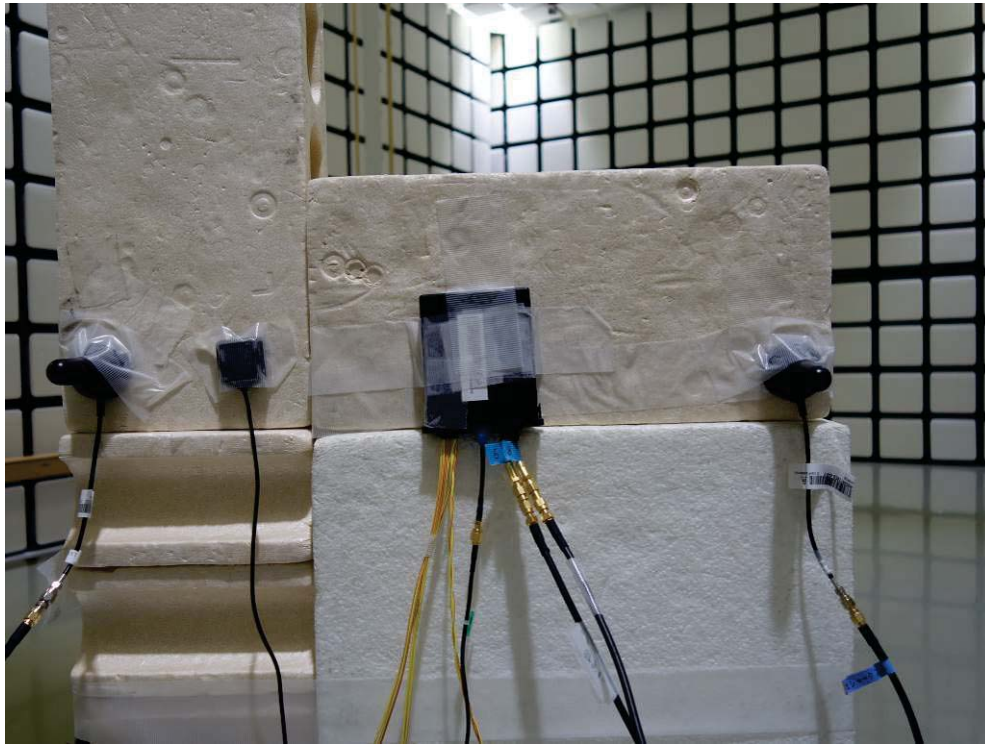
**Prüfbericht - Nr.:**  
Test Report No.:**50274553 001****Seite 50 von 53**  
Page 50 of 53**Photograph 9: Set-up for Radiated Spurious Emission, EUT Configuration Y-Axis**

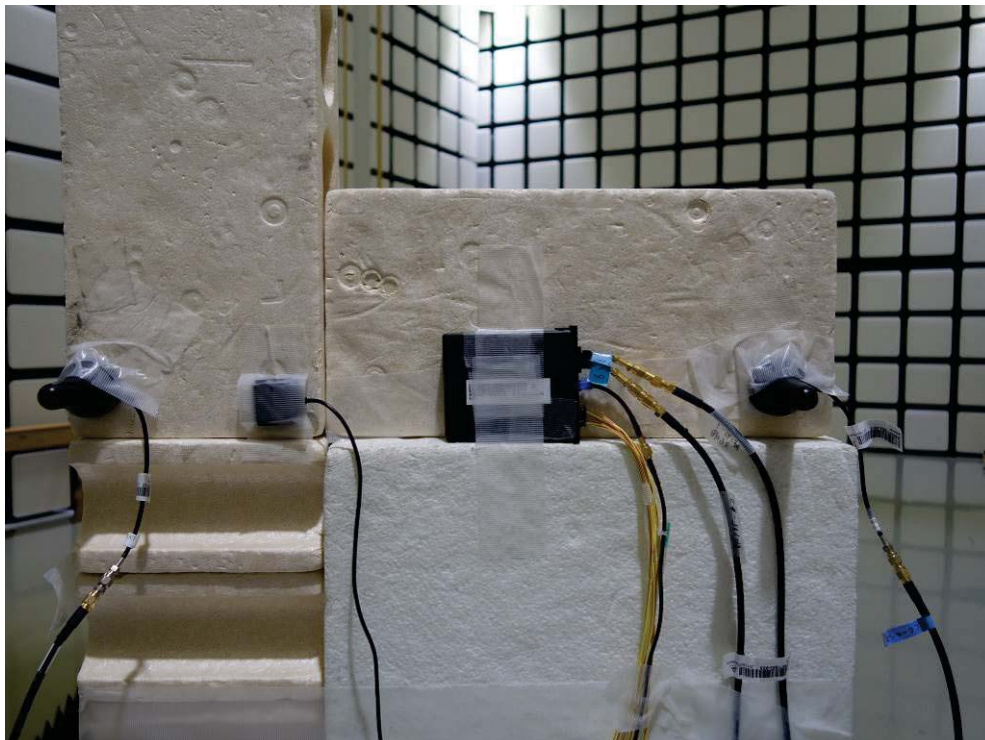
**Photograph 10: Set-up for Radiated Spurious Emission, EUT Configuration Z-Axis**

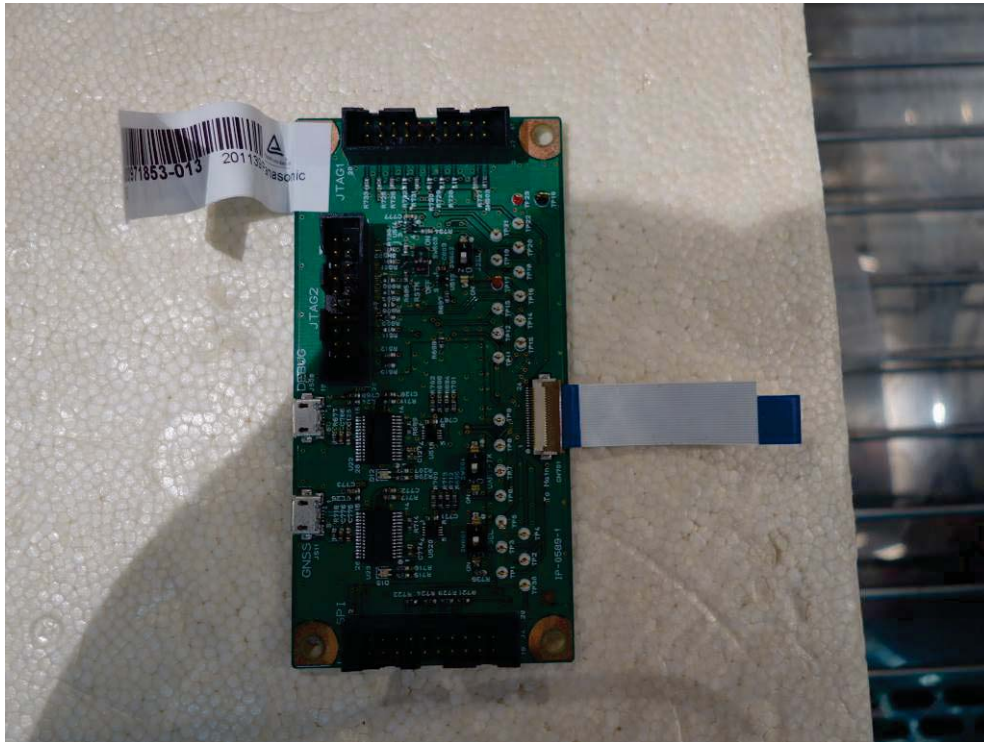
**Prüfbericht - Nr.: 50274553 001**  
Test Report No.:**Seite 51 von 53**  
Page 51 of 53**Photograph 11: Jig board**
