EXHIBIT 11**Section 2.1033 (b)(14) SETUP DRAWINGS OR PHOTOGRAPHS**

The setup drawings and photos for measurement are provided in the Exhibit 12, Test Report Sections 4 and 5 and reattached below.

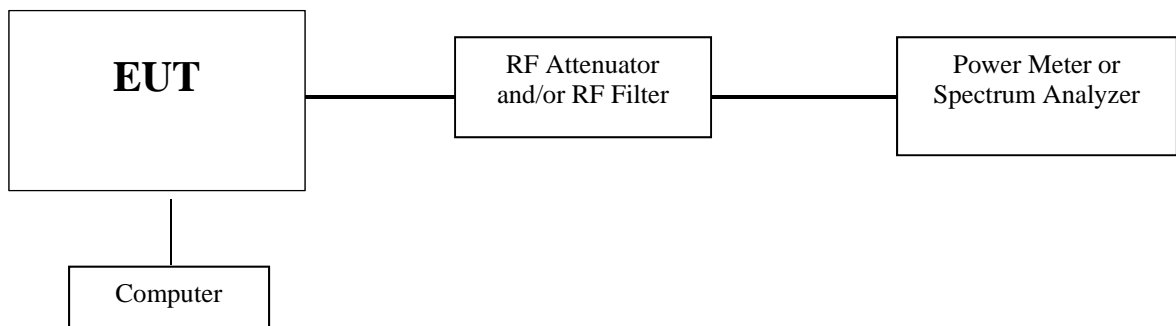
Figure 1. Setup Diagram of Conducted Test for RF Output Power, Power Spectrum Density, Modulation Characteristics, Occupied Bandwidth and Unwanted Emissions.

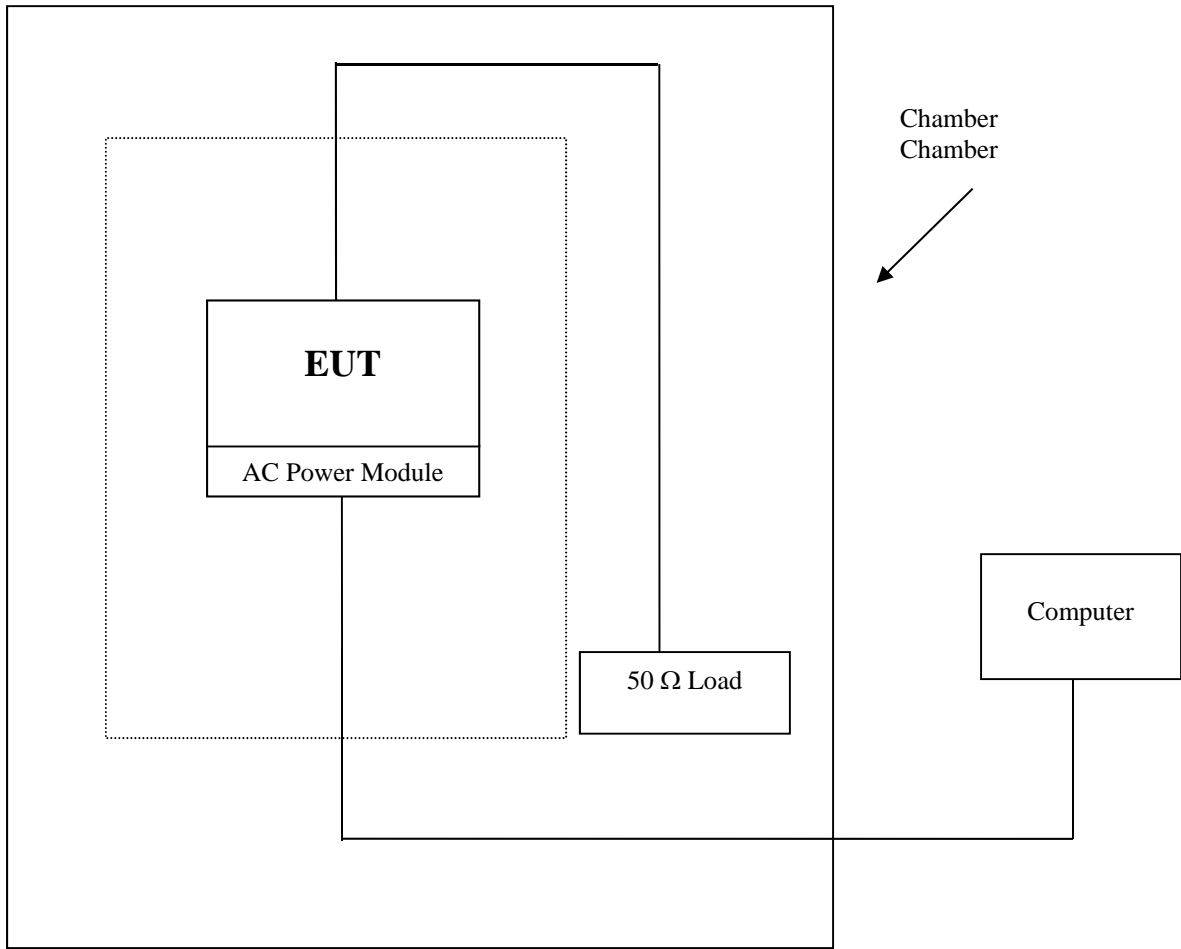
Figure 2. Setup Diagram of Radiated Test

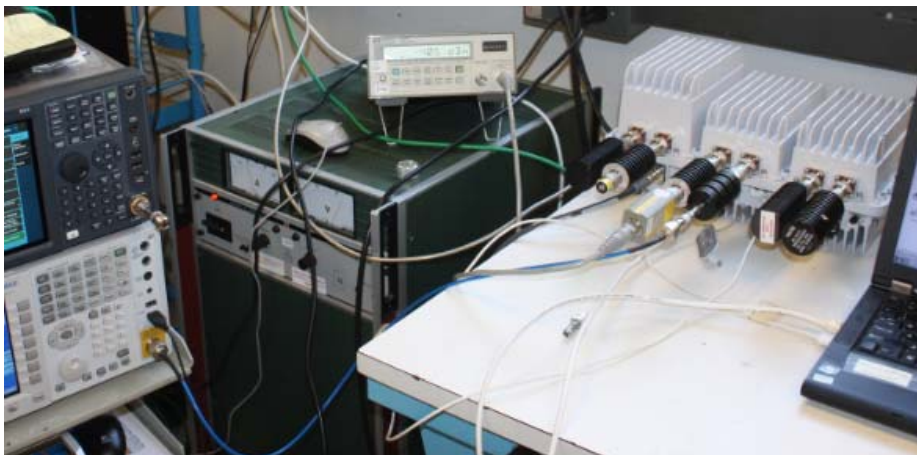
Figure 3. Photo of RF Conducted Tests

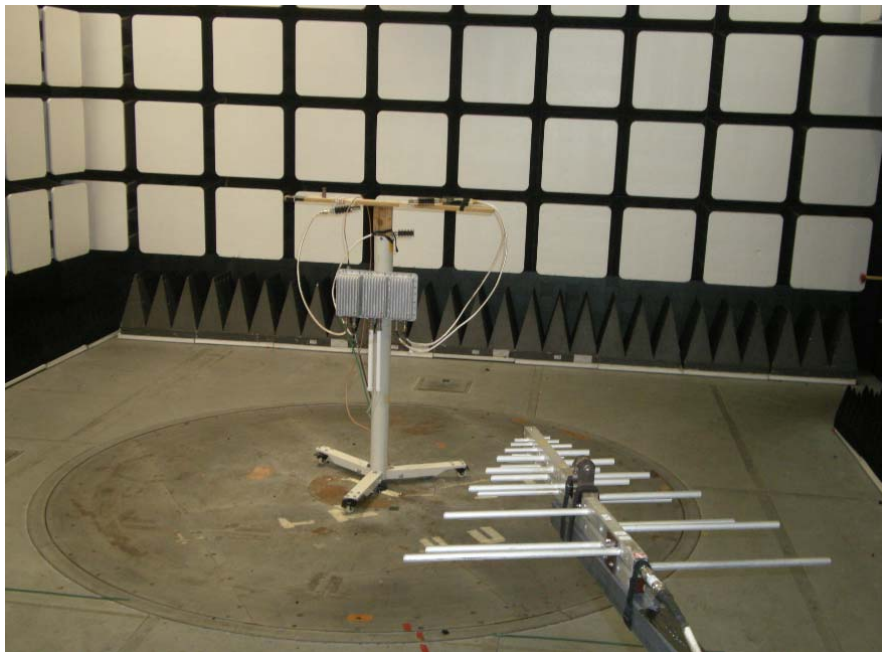
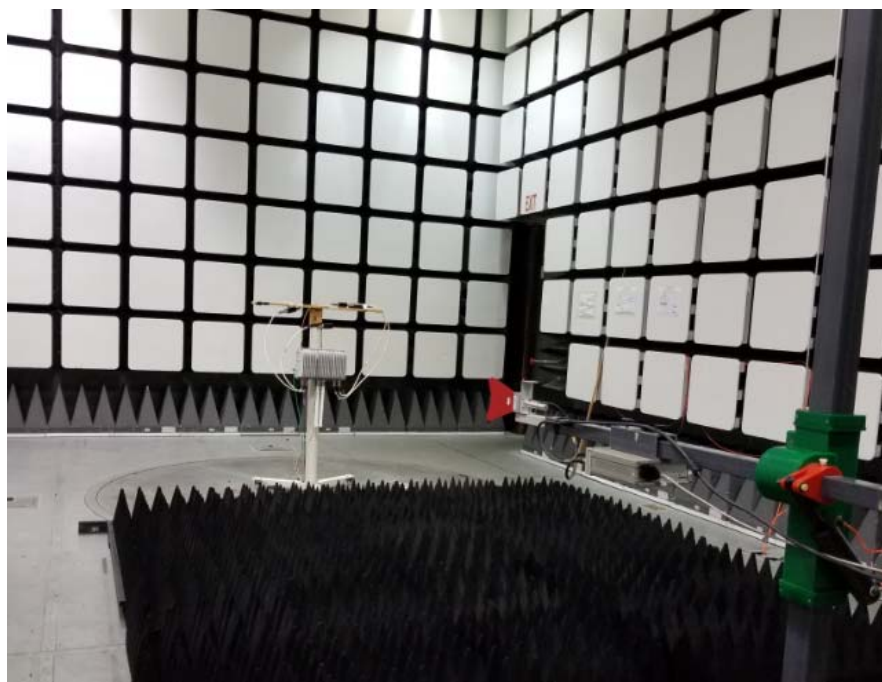
Figure 4. Photos of Radiated Tests

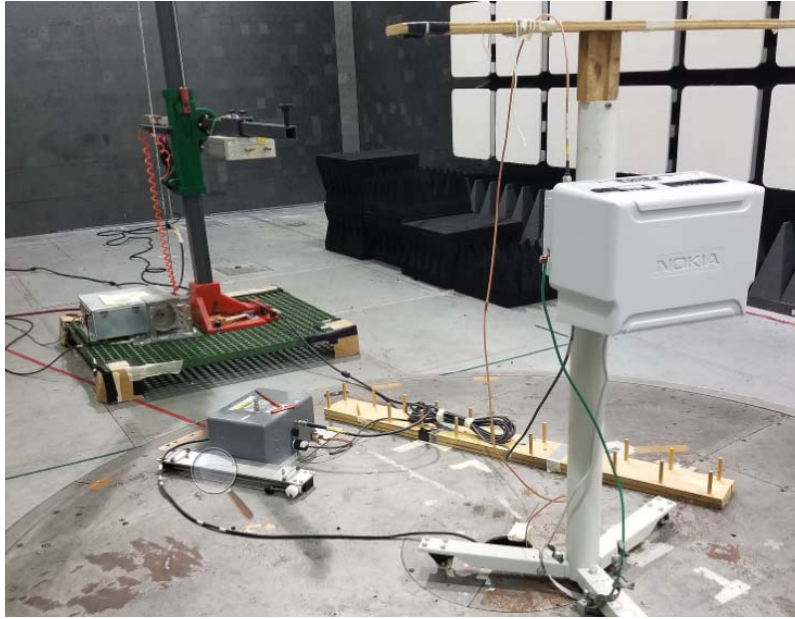
Figure 5. Photo of AC Power Line Conducted Test
