## APPENDIX A: PHOTOGRAPHS OF TEST SETUP

Reference to the test report No. BLA-EMC-202304-A3201

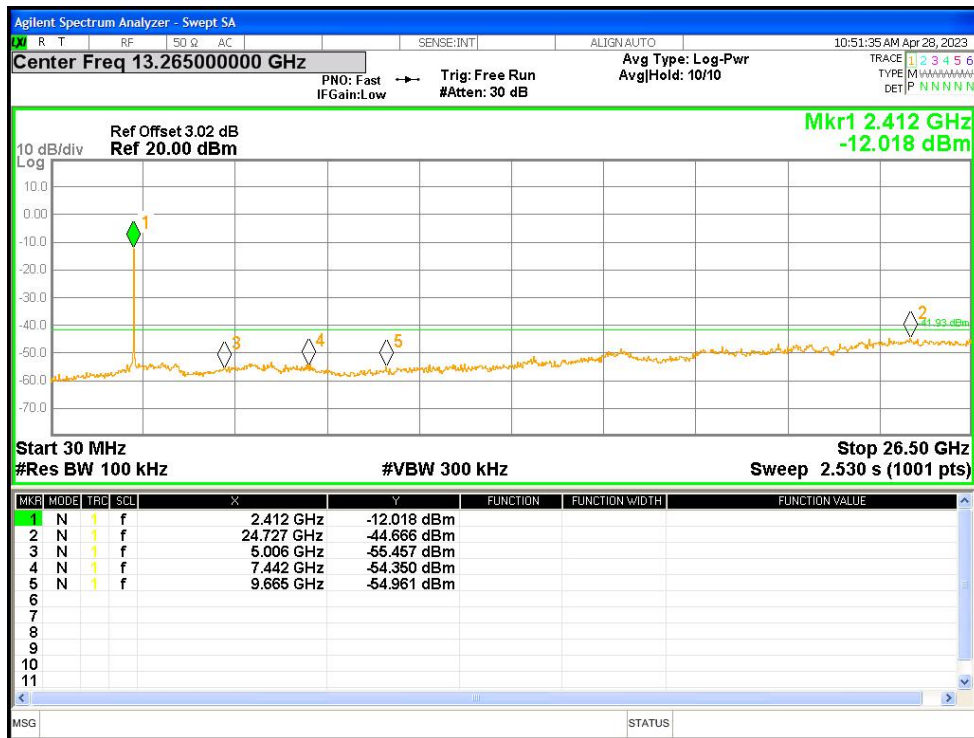
Tx. Spurious NVNT n40 2437MHz Ant1 Ref

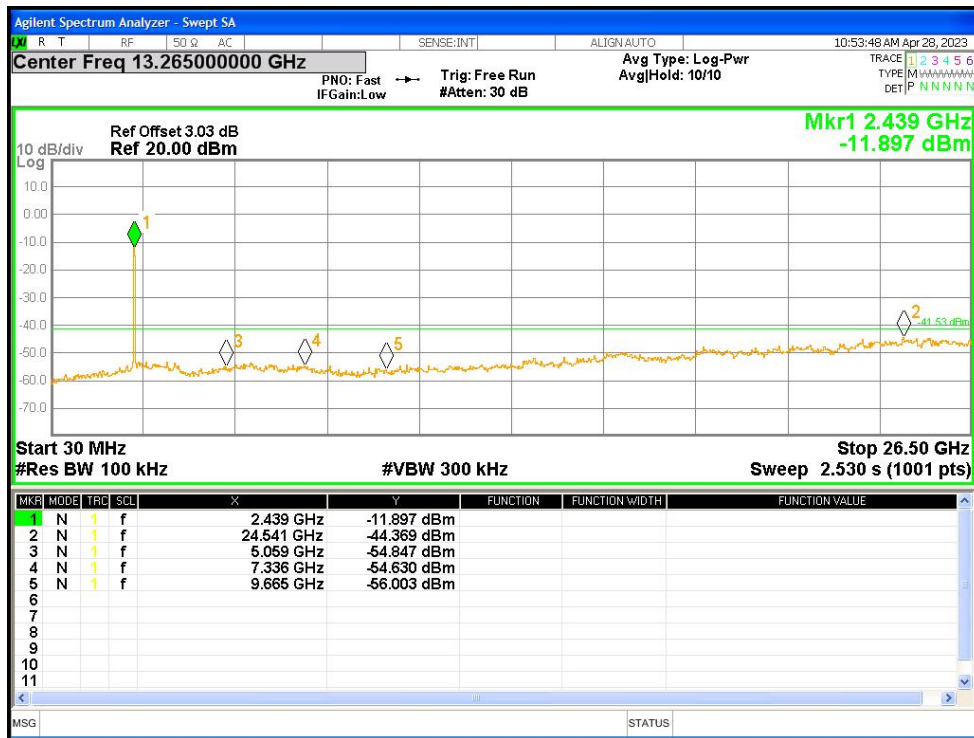
Tx. Spurious NVNT n40 2452MHz Ant1 Ref
