SAR TEST REPORT

No. I22Z61808-SEM02

Mobile Phone

Model Name: CPH2483

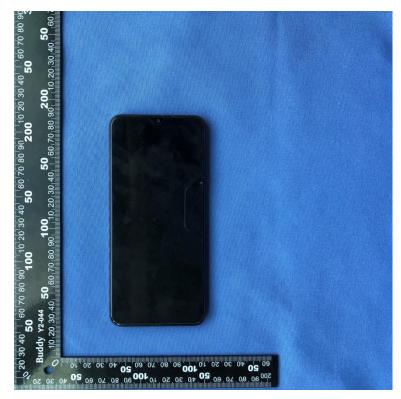
Picture 1: Front side of the sample (Plate material shell)

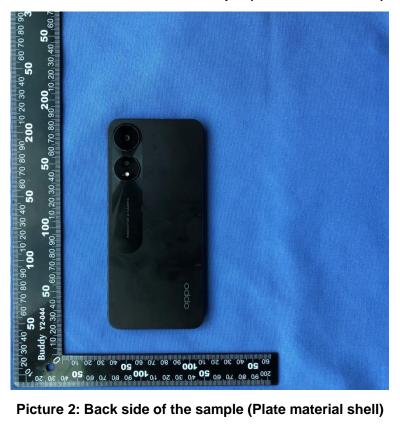
Picture 2: Back side of the sample (Plate material shell)

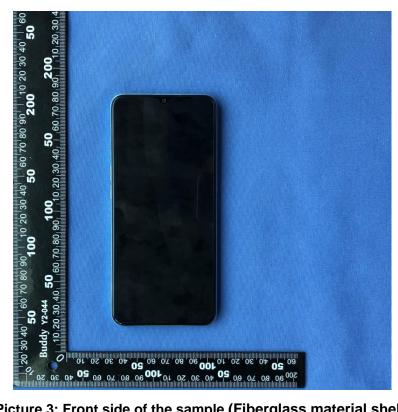
Picture 3: Front side of the sample (Fiberglass material shell)

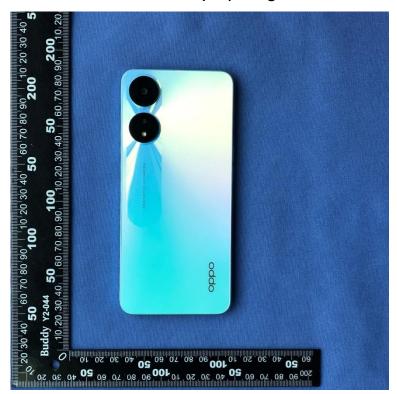
Picture 4: Back side of the sample (Fiberglass material shell)

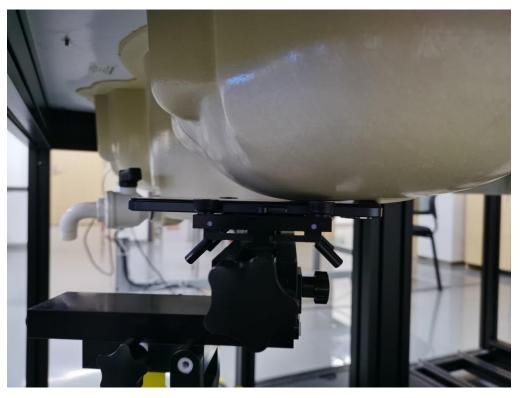
Picture 5: Left Cheek Position

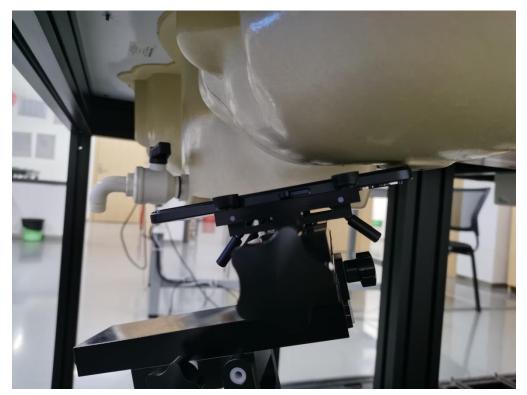
Picture 6: Left Tilt 15° Position

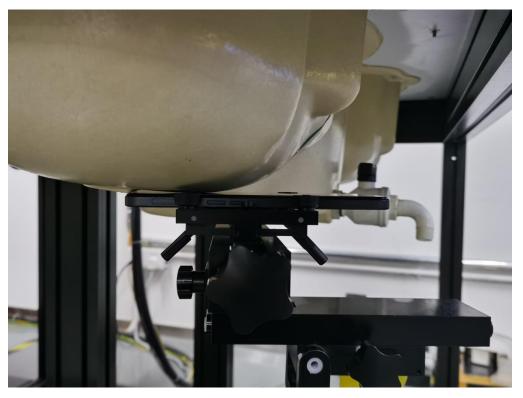
Picture 7: Right Cheek Position

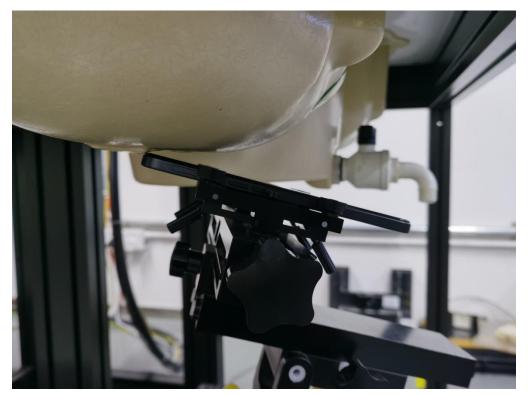
Picture 8: Right Tilt 15° Position

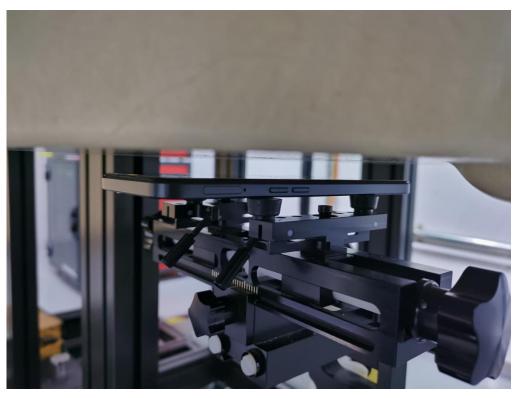
Picture 9: Front Side (10mm)

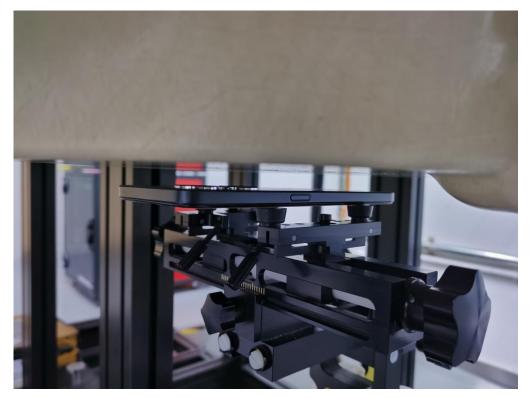
Picture 10: Rear Side (10mm)

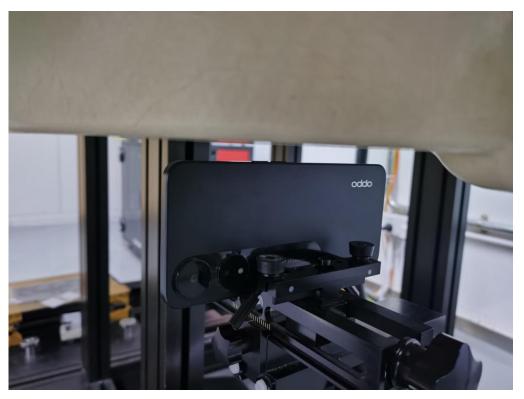
Picture 11: Left Side (10mm)

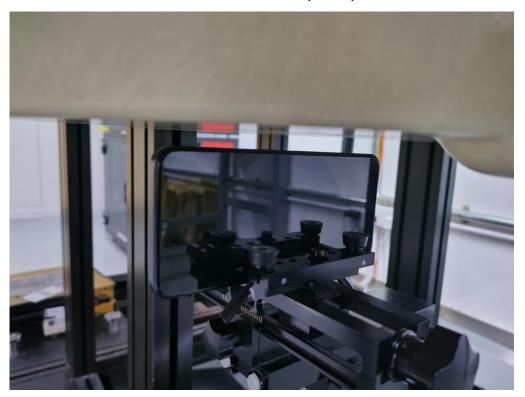
Picture 12: Right Side (10mm)

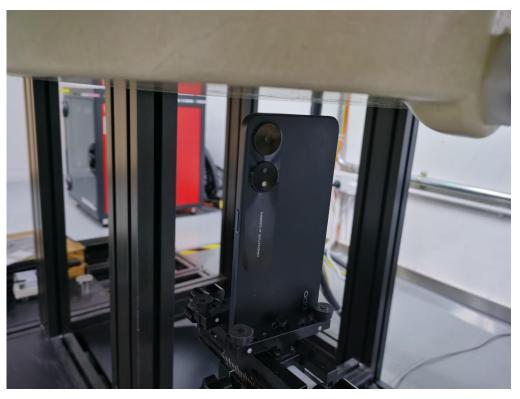
Picture 13: Top Side (10mm)

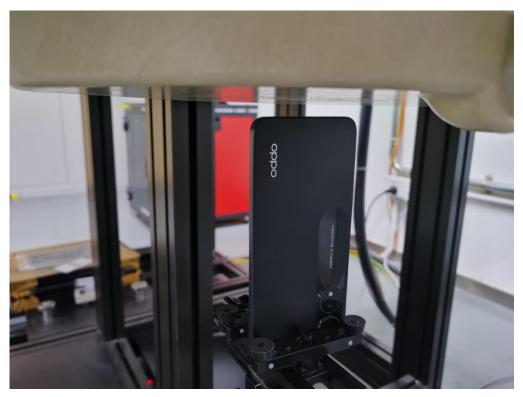
Picture 14: Bottom Side (10mm)

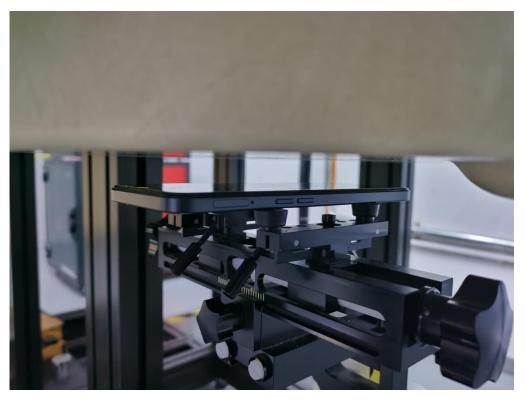
Picture 15: Front Side (15mm)

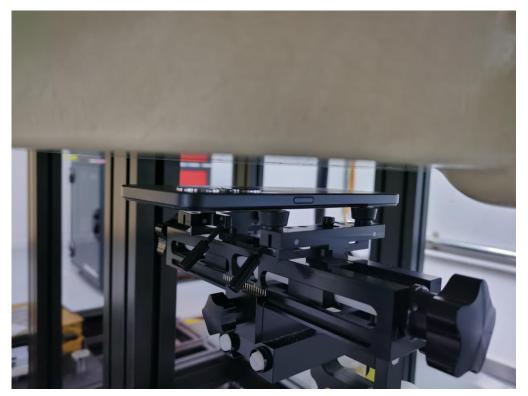
Picture 16: Rear Side (15mm)

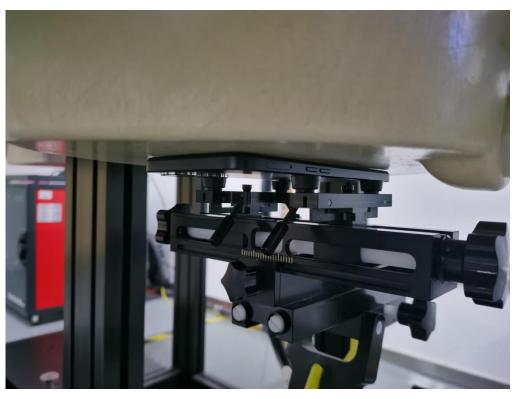
Picture 17: Front Side (0mm)

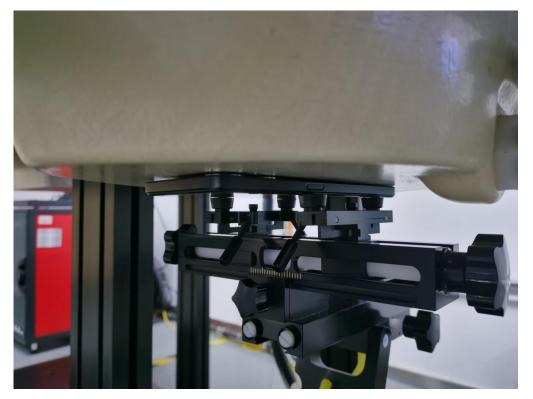
Picture 18: Rear Side (0mm)

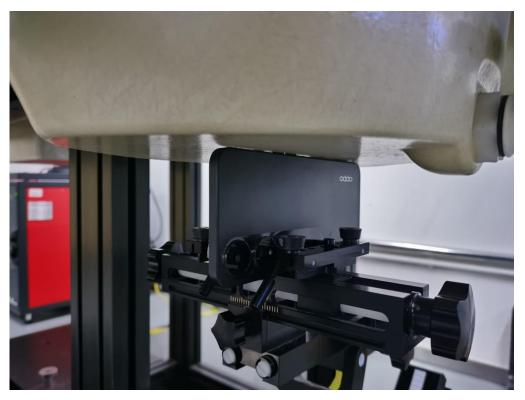
Picture 19: Left Side (0mm)

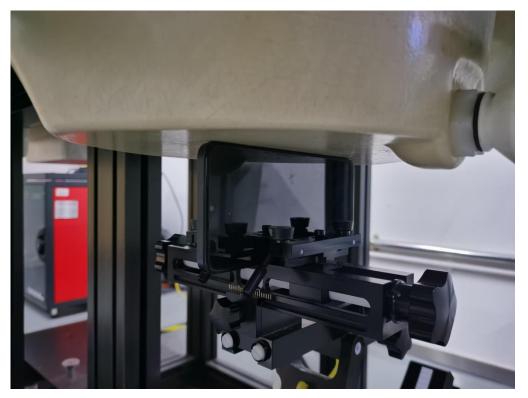
Picture 20: Right Side (0mm)

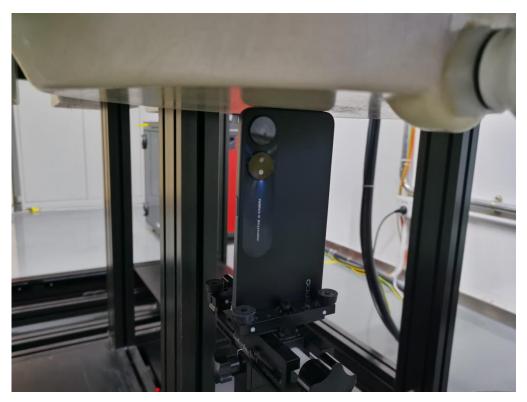
Picture 21: Top Side (0mm)
