# Radiated Emission Measurement

Condition : FCC\_part 15 RE-Class C\_Above 1GHz\_PK

EUT : W6M22311-23090

Test Mode : TX 802.11n40 CH1

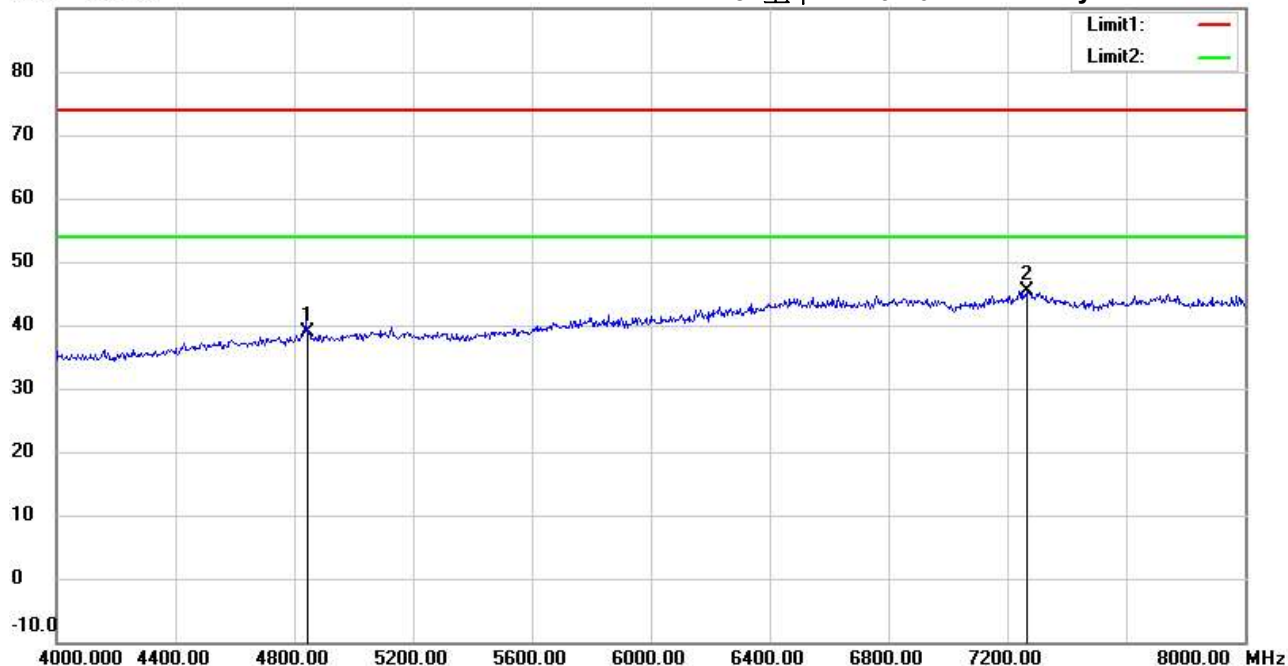
Data : #7

Polarization: Vertical

| Mk. | Frequency (MHz) | Reading (dBuV) | Detector | Corr. factor (dB/m) | Result (dBuV/m) | Limit (dBuV/m) | Ant.Pos (cm) | Tab.Pos (deg.) | Margin (dB) | Comment |
|---|---|---|---|---|---|---|---|---|---|---|
| | 4844.000 | 33.86 | peak | 5.13 | 38.99 | 74.00 | 150 | 299 | -35.01 | |
| * | 7266.000 | 33.76 | peak | 11.62 | 45.38 | 74.00 | 150 | 89 | -28.62 | |

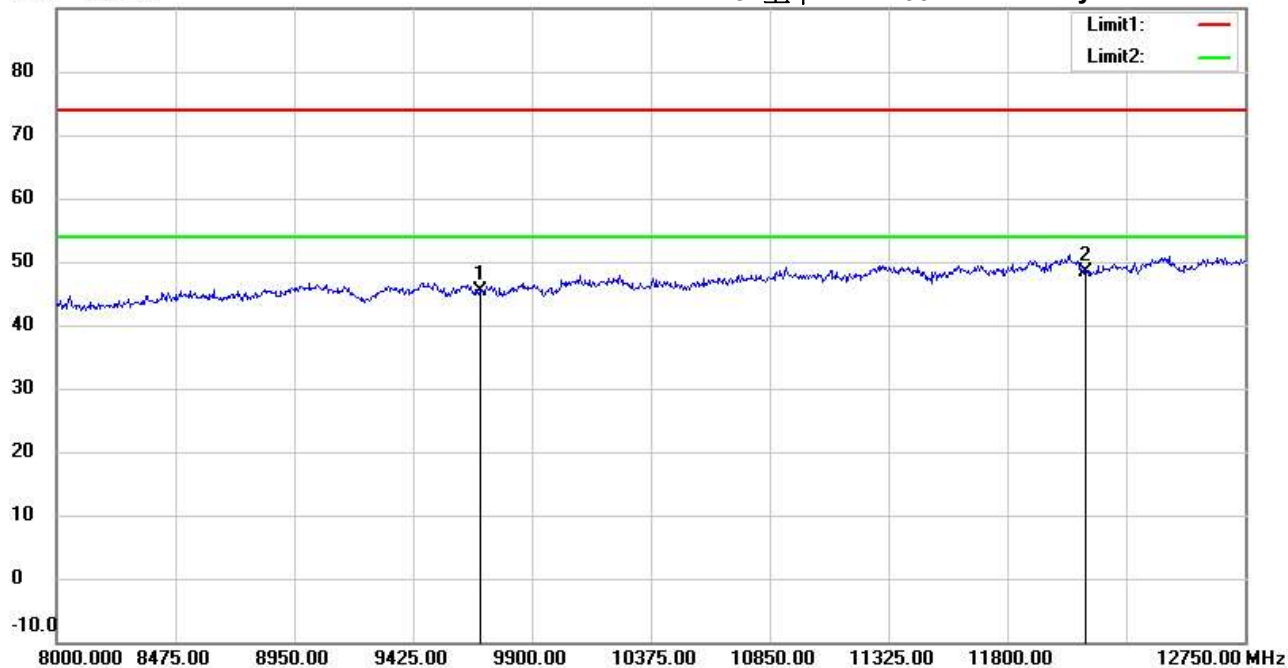
Data : #3

Test Mode : TX 802.11n40 CH1

Polarization: **Horizontal**

| Mk. | Frequency (MHz) | Reading (dBuV) | Detector | Corr. factor (dB/m) | Result (dBuV/m) | Limit (dBuV/m) | Ant.Pos (cm) | Tab.Pos (deg.) | Margin (dB) | Comment |
|---|---|---|---|---|---|---|---|---|---|---|
| | 9688.000 | 31.86 | peak | 13.49 | 45.35 | 74.00 | 150 | 165 | -28.65 | |
| * | 12110.000 | 31.51 | peak | 16.97 | 48.48 | 74.00 | 150 | 113 | -25.52 | |

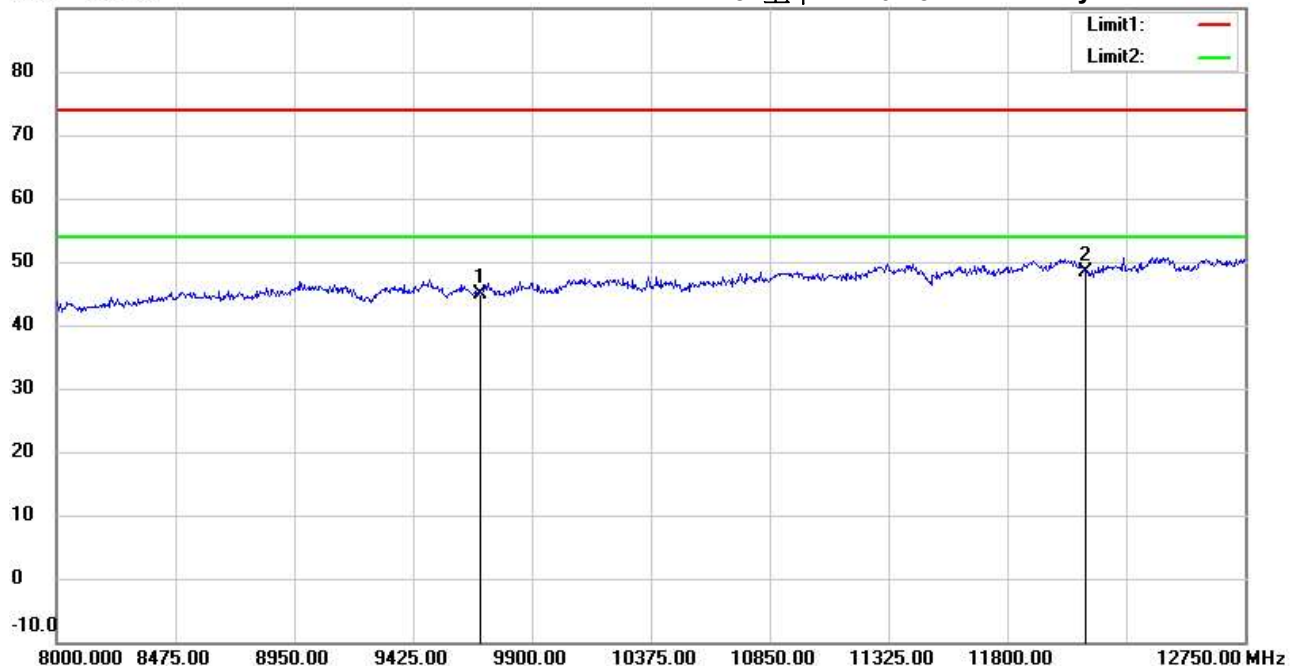
Data : #8

Test Mode : TX 802.11n40 CH1

Polarization: Vertical

| Mk. | Frequency (MHz) | Reading (dBuV) | Detector | Corr. factor (dB/m) | Result (dBuV/m) | Limit (dBuV/m) | Ant.Pos (cm) | Tab.Pos (deg.) | Margin (dB) | Comment |
|---|---|---|---|---|---|---|---|---|---|---|
| | 9688.000 | 31.47 | peak | 13.49 | 44.96 | 74.00 | 150 | 299 | -29.04 | |
| * | 12110.000 | 31.36 | peak | 16.97 | 48.33 | 74.00 | 150 | 263 | -25.67 | |

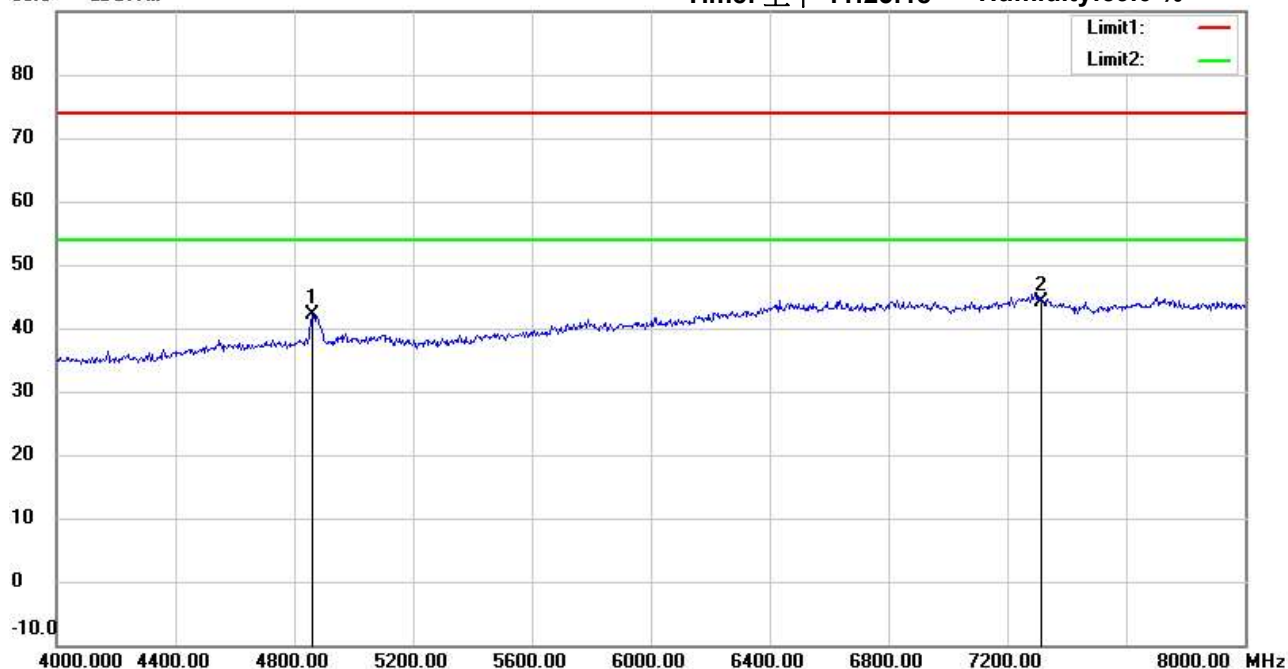
Data :#2

Test Mode : TX 802.11n40 CH4

Polarization: **Horizontal**

| Mk. | Frequency (MHz) | Reading (dBuV) | Detector | Corr. factor (dB/m) | Result (dBuV/m) | Limit (dBuV/m) | Ant.Pos (cm) | Tab.Pos (deg.) | Margin (dB) | Comment |
|---|---|---|---|---|---|---|---|---|---|---|
| | 4860.000 | 36.88 | peak | 5.18 | 42.06 | 74.00 | 150 | 150 | -31.94 | |
| * | 7311.000 | 32.54 | peak | 11.70 | 44.24 | 74.00 | 150 | 282 | -29.76 | |

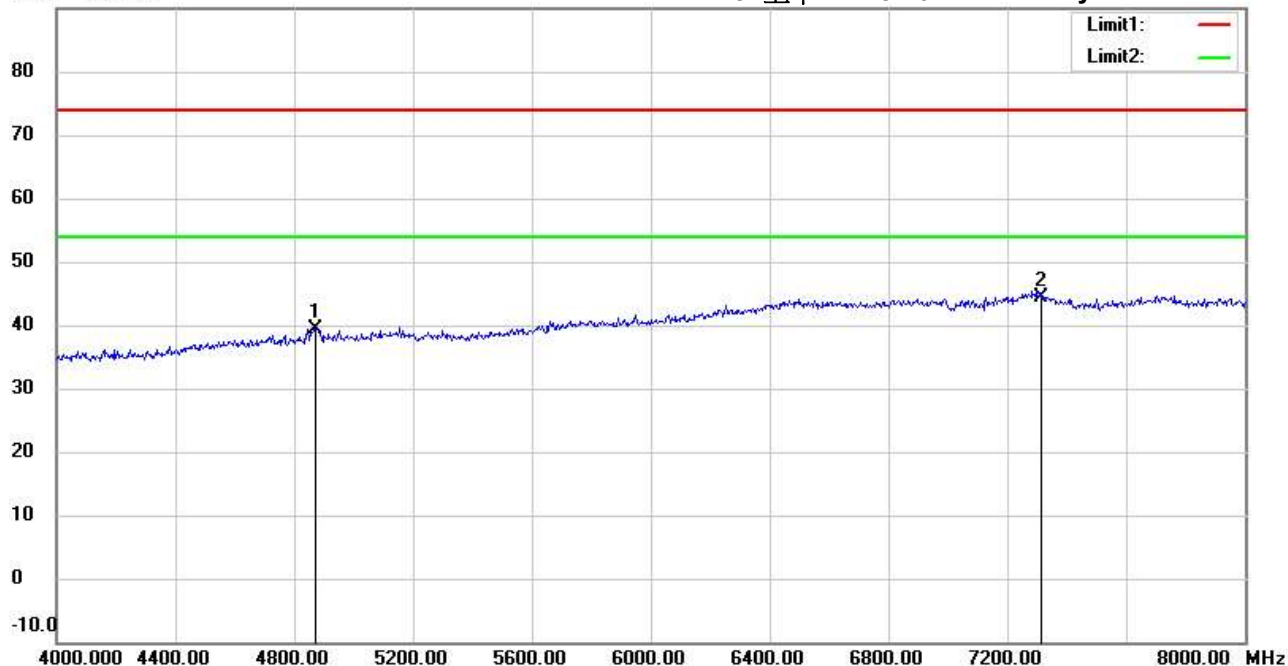
Data : #7

Test Mode : TX 802.11n40 CH4

Polarization: Vertical

| Mk. | Frequency (MHz) | Reading (dBuV) | Detector | Corr. factor (dB/m) | Result (dBuV/m) | Limit (dBuV/m) | Ant.Pos (cm) | Tab.Pos (deg.) | Margin (dB) | Comment |
|---|---|---|---|---|---|---|---|---|---|---|
| | 4870.000 | 34.25 | peak | 5.20 | 39.45 | 74.00 | 150 | 125 | -34.55 | |
| * | 7311.000 | 32.57 | peak | 11.70 | 44.27 | 74.00 | 150 | 102 | -29.73 | |

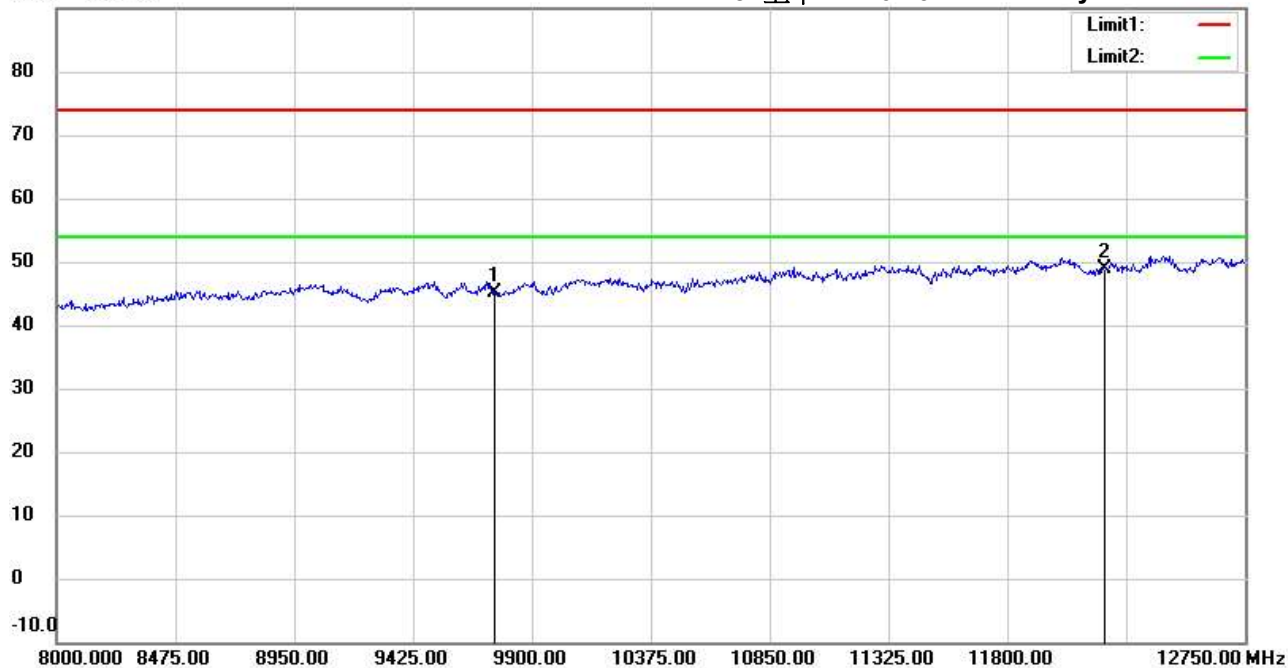
Data : #3

Test Mode : TX 802.11n40 CH4

Polarization: **Horizontal**

| Mk. | Frequency (MHz) | Reading (dBuV) | Detector | Corr. factor (dB/m) | Result (dBuV/m) | Limit (dBuV/m) | Ant.Pos (cm) | Tab.Pos (deg.) | Margin (dB) | Comment |
|---|---|---|---|---|---|---|---|---|---|---|
| | 9748.000 | 31.41 | peak | 13.70 | 45.11 | 74.00 | 150 | 71 | -28.89 | |
| * | 12185.000 | 31.97 | peak | 17.02 | 48.99 | 74.00 | 150 | 255 | -25.01 | |

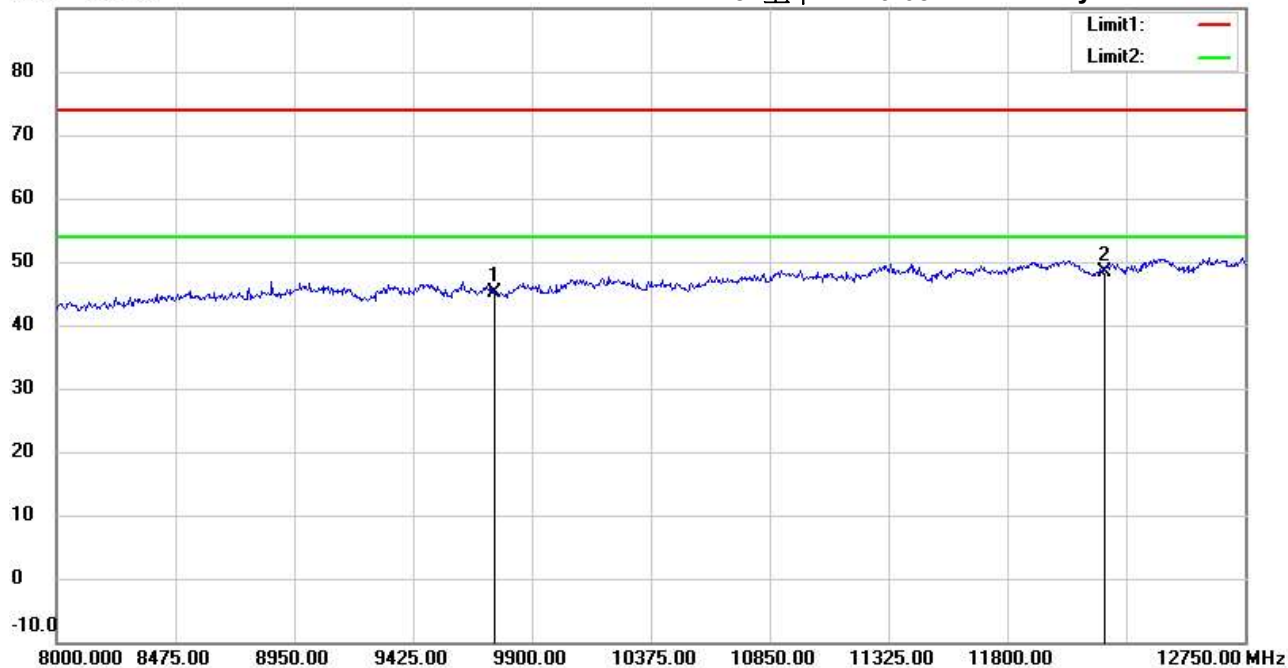
Data : #8

Test Mode : TX 802.11n40 CH4

Polarization: Vertical

| Mk. | Frequency (MHz) | Reading (dBuV) | Detector | Corr. factor (dB/m) | Result (dBuV/m) | Limit (dBuV/m) | Ant.Pos (cm) | Tab.Pos (deg.) | Margin (dB) | Comment |
|---|---|---|---|---|---|---|---|---|---|---|
| | 9748.000 | 31.51 | peak | 13.70 | 45.21 | 74.00 | 150 | 84 | -28.79 | |
| * | 12185.000 | 31.33 | peak | 17.02 | 48.35 | 74.00 | 150 | 315 | -25.65 | |

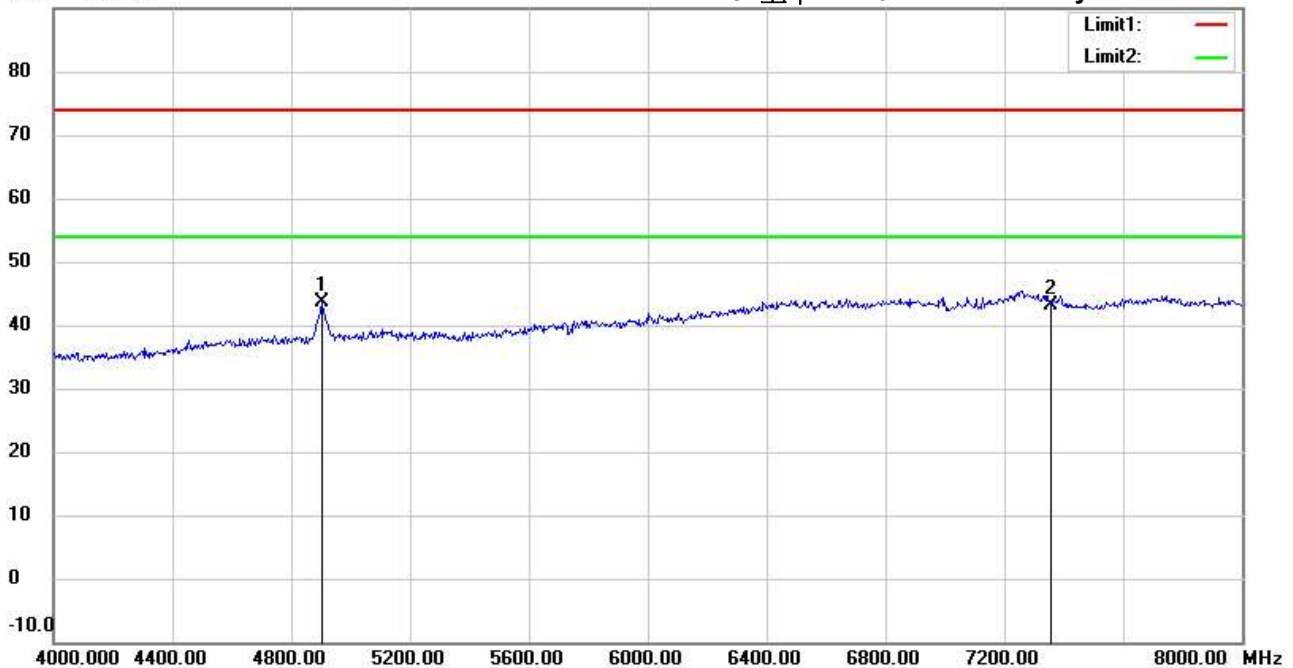
Data : #2

Test Mode : TX 802.11n40 CH7

Polarization: **Horizontal**

| Mk. | Frequency (MHz) | Reading (dBuV) | Detector | Corr. factor (dB/m) | Result (dBuV/m) | Limit (dBuV/m) | Ant.Pos (cm) | Tab.Pos (deg.) | Margin (dB) | Comment |
|---|---|---|---|---|---|---|---|---|---|---|
| * | 4904.000 | 38.29 | peak | 5.30 | 43.59 | 74.00 | 150 | 33 | -30.41 | |
| | 7356.000 | 31.71 | peak | 11.51 | 43.22 | 74.00 | 150 | 258 | -30.78 | |

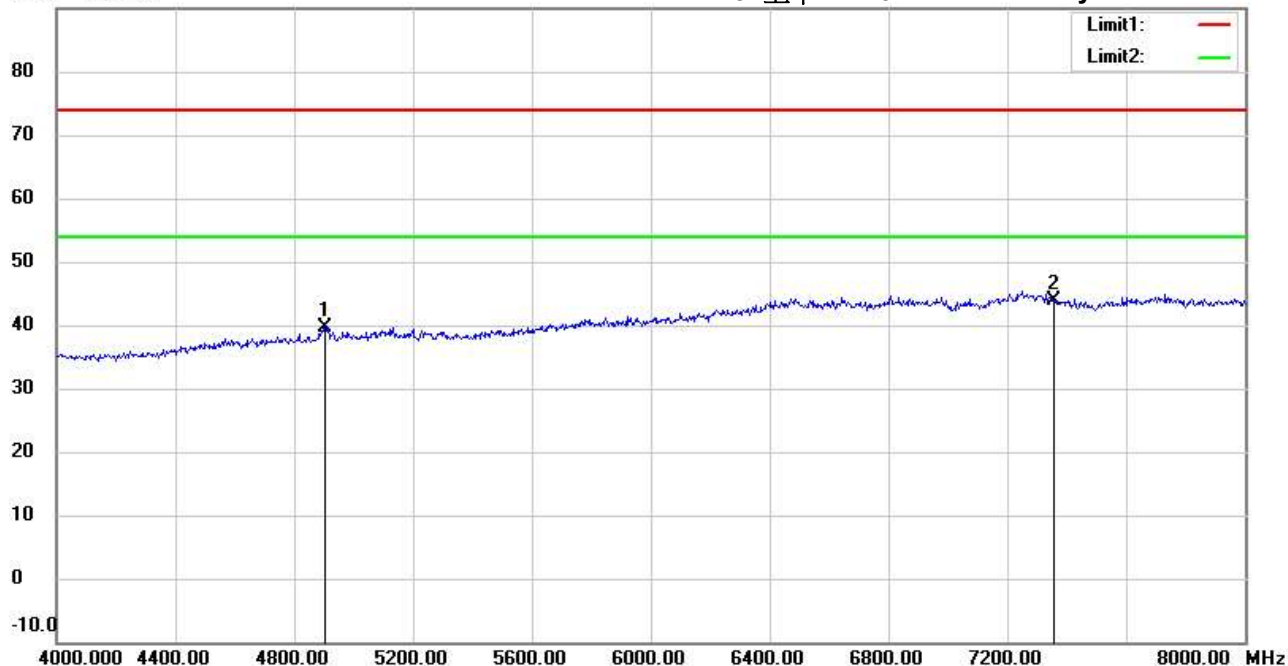
Data :#7

Test Mode : TX 802.11n40 CH7

Polarization: **Vertical**

| Mk. | Frequency (MHz) | Reading (dBuV) | Detector | Corr. factor (dB/m) | Result (dBuV/m) | Limit (dBuV/m) | Ant.Pos (cm) | Tab.Pos (deg.) | Margin (dB) | Comment |
|---|---|---|---|---|---|---|---|---|---|---|
| | 4904.000 | 34.22 | peak | 5.30 | 39.52 | 74.00 | 150 | 129 | -34.48 | |
| * | 7356.000 | 32.25 | peak | 11.51 | 43.76 | 74.00 | 150 | 318 | -30.24 | |

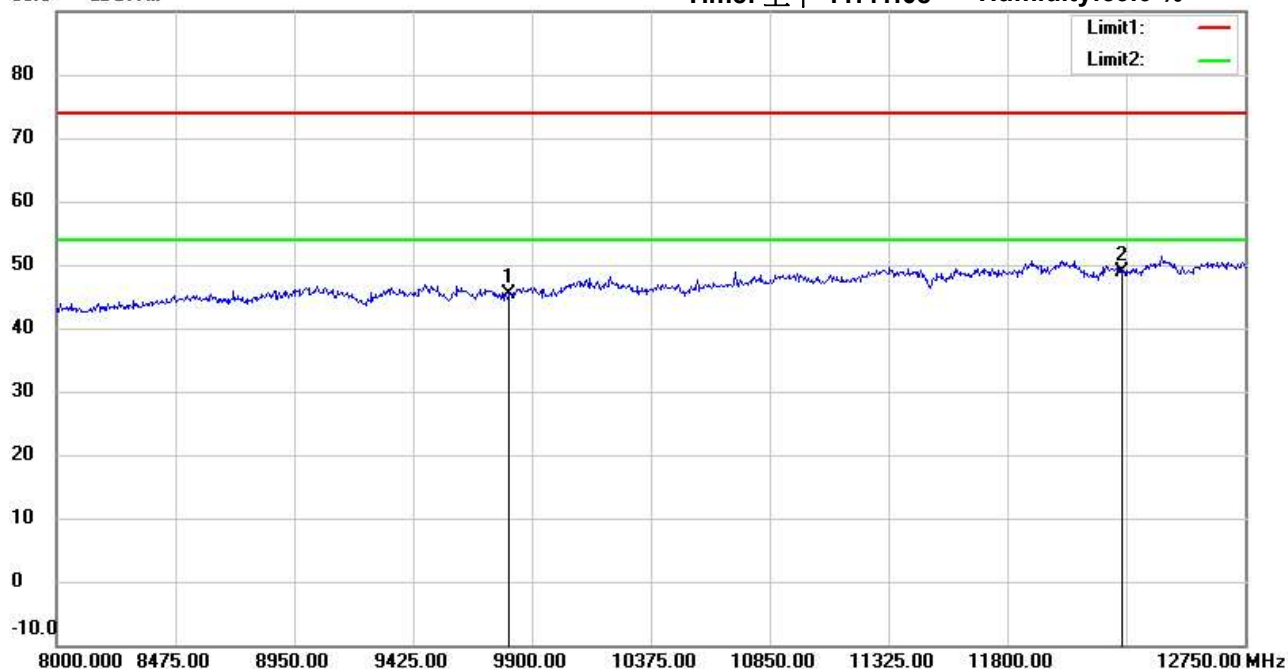
Data : #3

Test Mode : TX 802.11n40 CH7

Polarization: **Horizontal**

| Mk. | Frequency (MHz) | Reading (dBuV) | Detector | Corr. factor (dB/m) | Result (dBuV/m) | Limit (dBuV/m) | Ant.Pos (cm) | Tab.Pos (deg.) | Margin (dB) | Comment |
|---|---|---|---|---|---|---|---|---|---|---|
| | 9808.000 | 31.44 | peak | 13.92 | 45.36 | 74.00 | 150 | 272 | -28.64 | |
| * | 12260.000 | 32.04 | peak | 16.72 | 48.76 | 74.00 | 150 | 336 | -25.24 | |

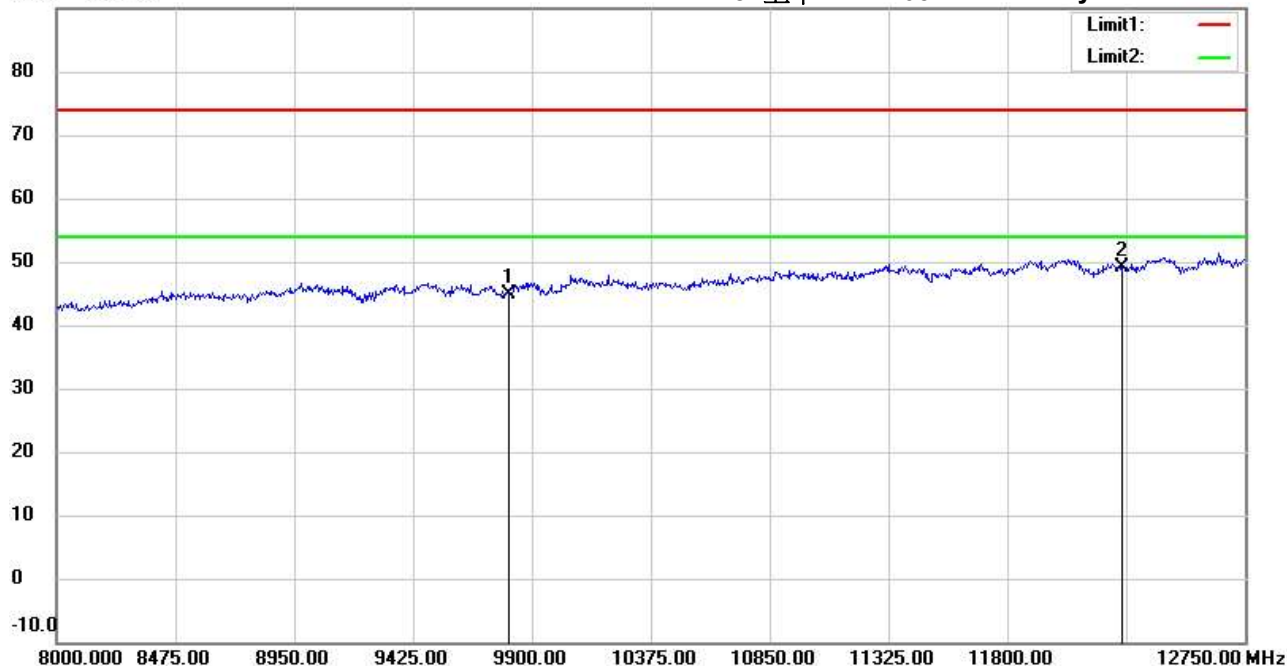
Data : #8

Test Mode : TX 802.11n40 CH7

Polarization: Vertical

| Mk. | Frequency (MHz) | Reading (dBuV) | Detector | Corr. factor (dB/m) | Result (dBuV/m) | Limit (dBuV/m) | Ant.Pos (cm) | Tab.Pos (deg.) | Margin (dB) | Comment |
|---|---|---|---|---|---|---|---|---|---|---|
| | 9808.000 | 31.02 | peak | 13.92 | 44.94 | 74.00 | 150 | 335 | -29.06 | |
| * | 12260.000 | 32.44 | peak | 16.72 | 49.16 | 74.00 | 150 | 202 | -24.84 | |
