### Tx. Spurious NVNT GFSK 5825MHz Ant1 Emission

## Appendix B: photographs of test setup

Reference to the test report no. BLA-EMC-202502-A3801

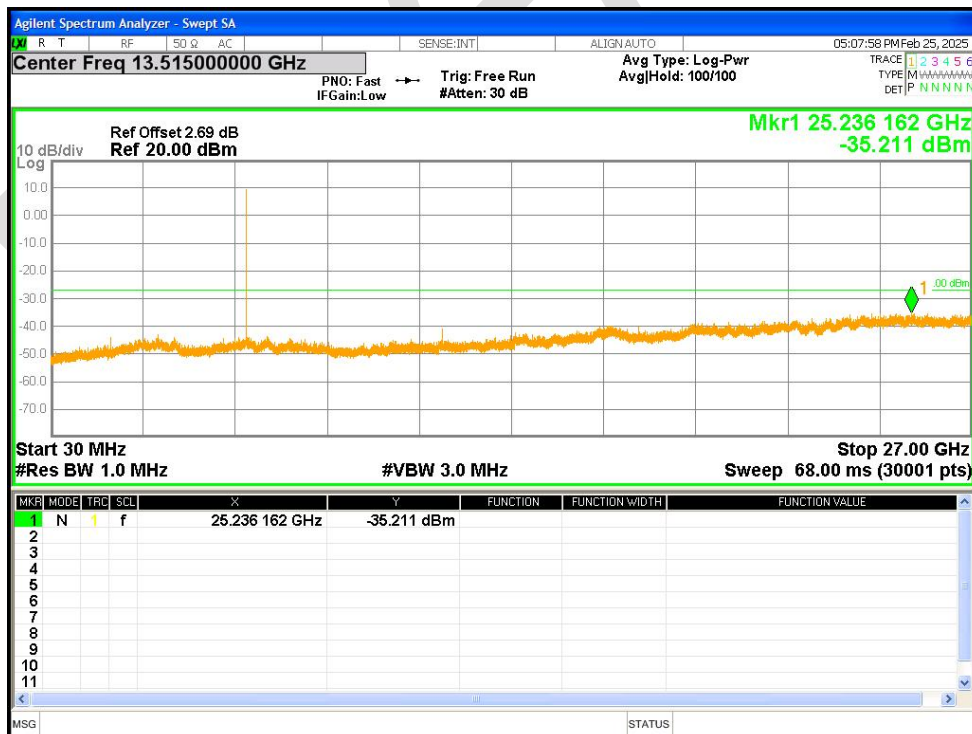
### Tx. Spurious NVNT GFSK 5745MHz Ant2 Emission

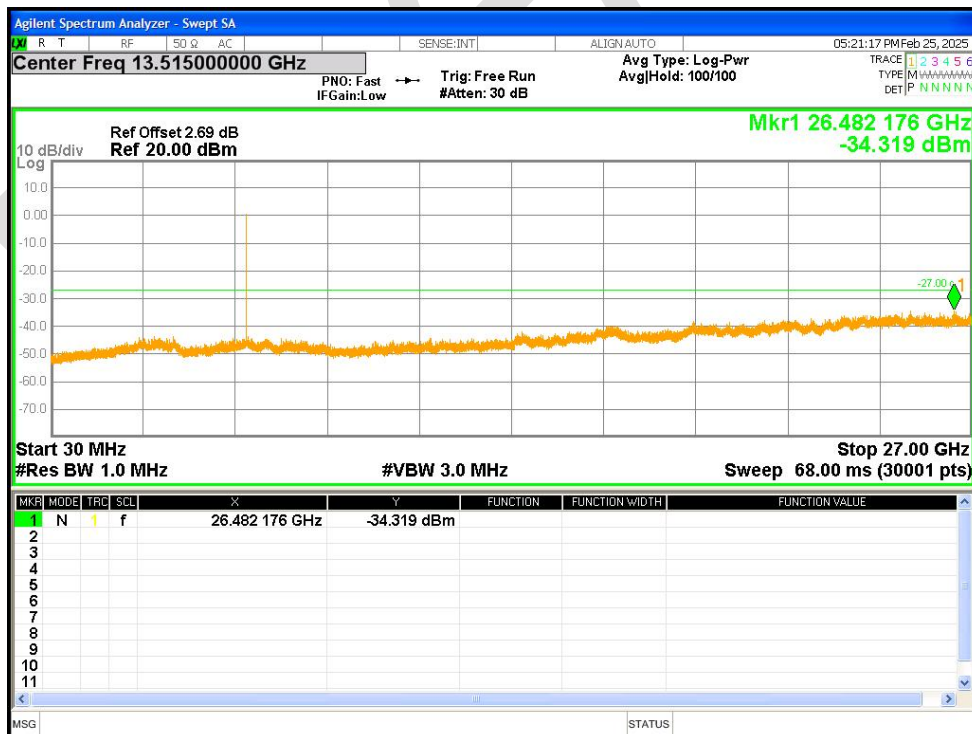
### Tx. Spurious NVNT GFSK 5745MHz Ant2 Emission

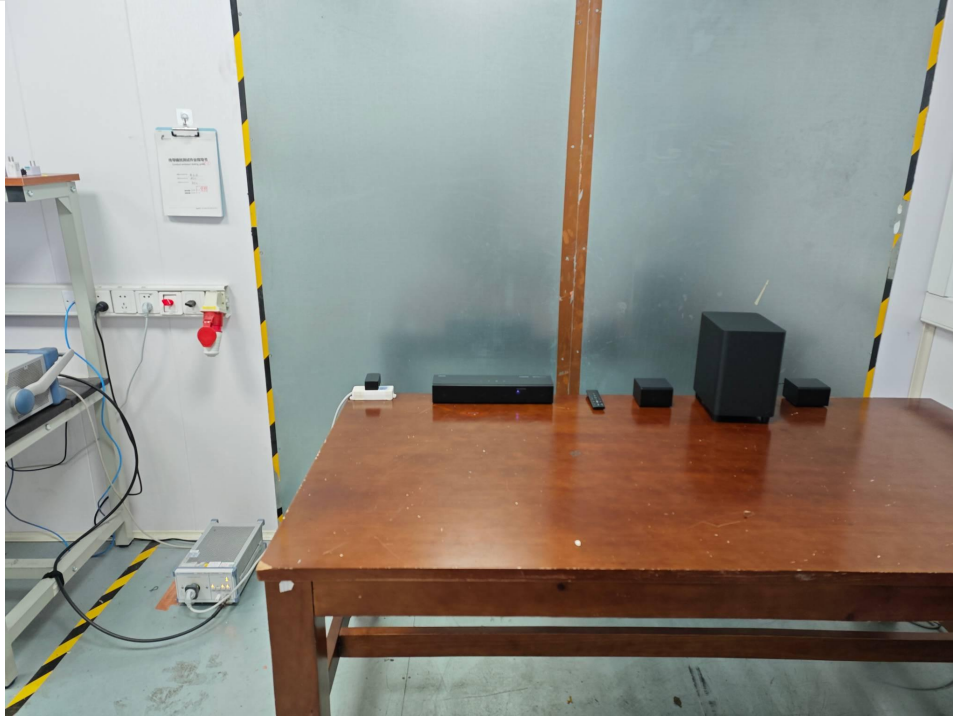
Conducted emissions at AC power line (150kHz-30MHz)
