## APPENDIX A: PHOTOGRAPHS OF TEST SETUP

Reference to the test report No. BLA-EMC-202210-A6201

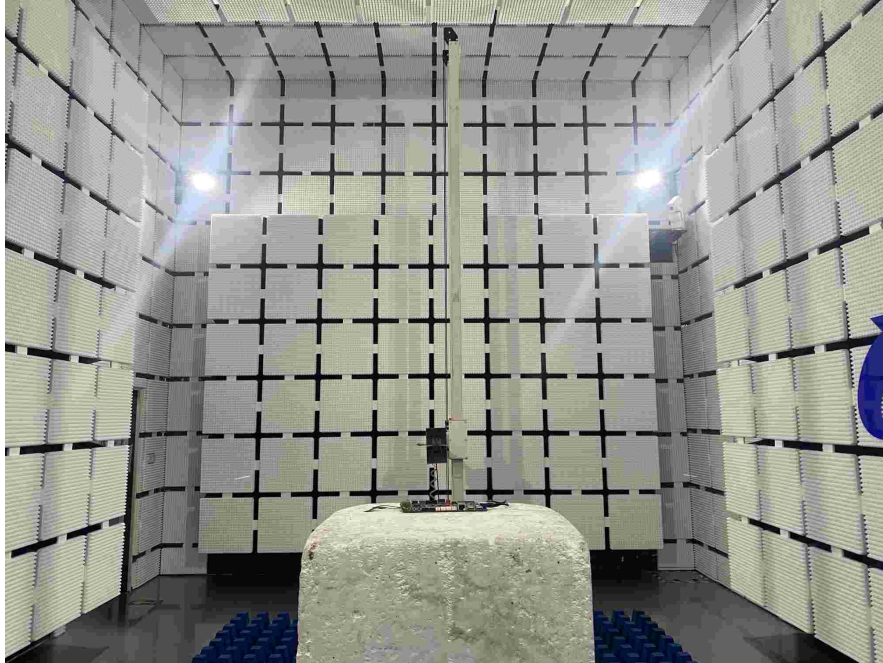
### Radiated Spurious Emissions

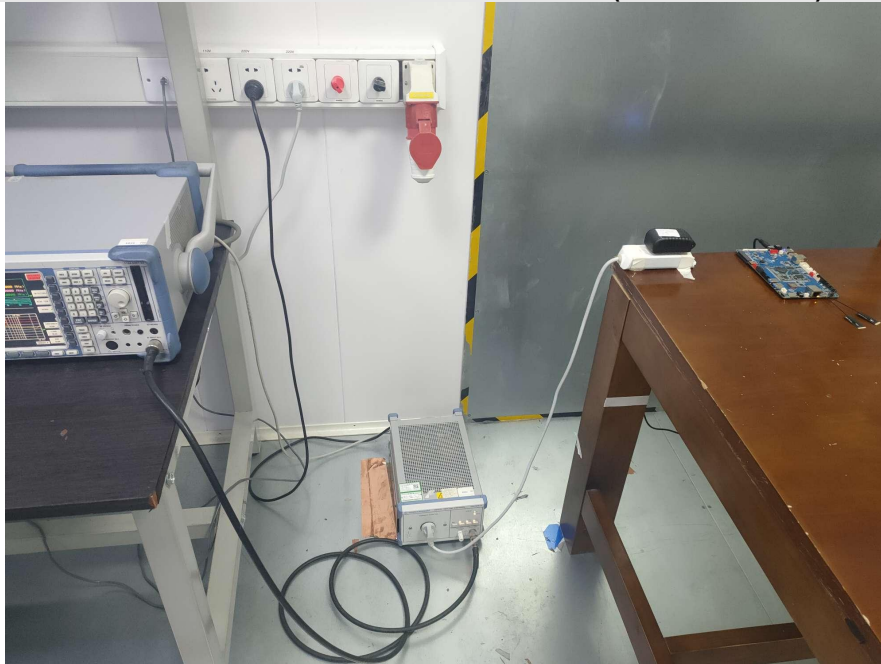
**Conducted Emissions at AC Power Line (150kHz-30MHz)**
