## 6 Photographs of the Test Set-Up

**Prüfbericht - Nr.: CN22LJYU 002**  
Test report no.

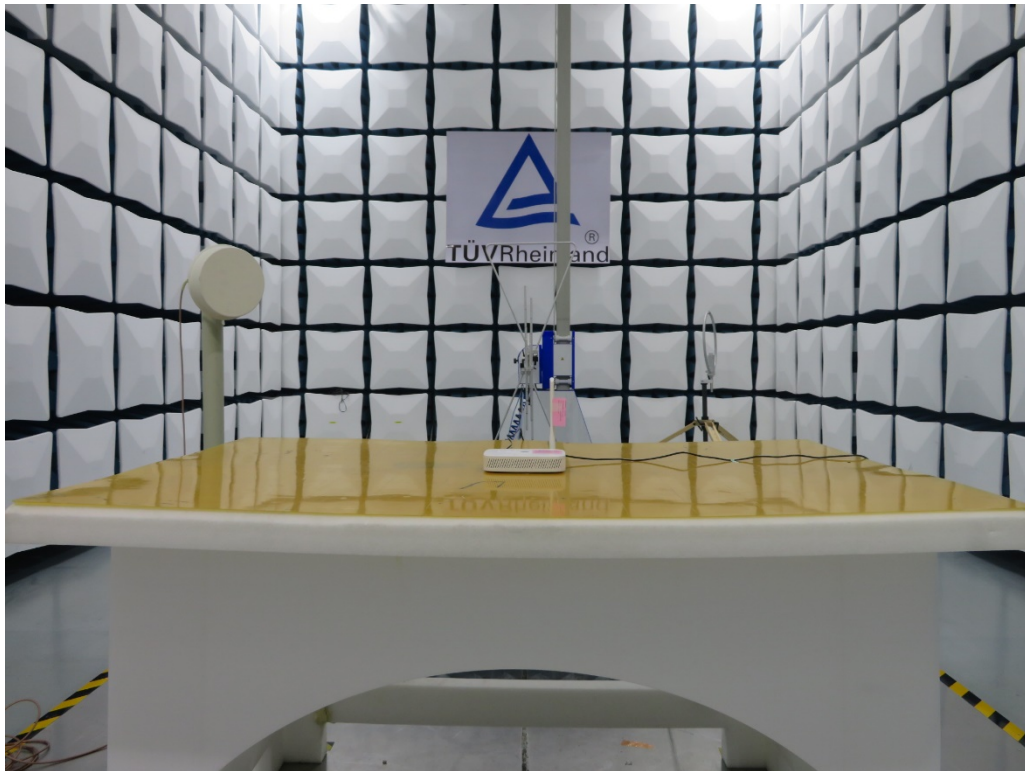
**Photograph 1: Set-up for Co-Located Radiated Spurious Emissions, below 1GHz**

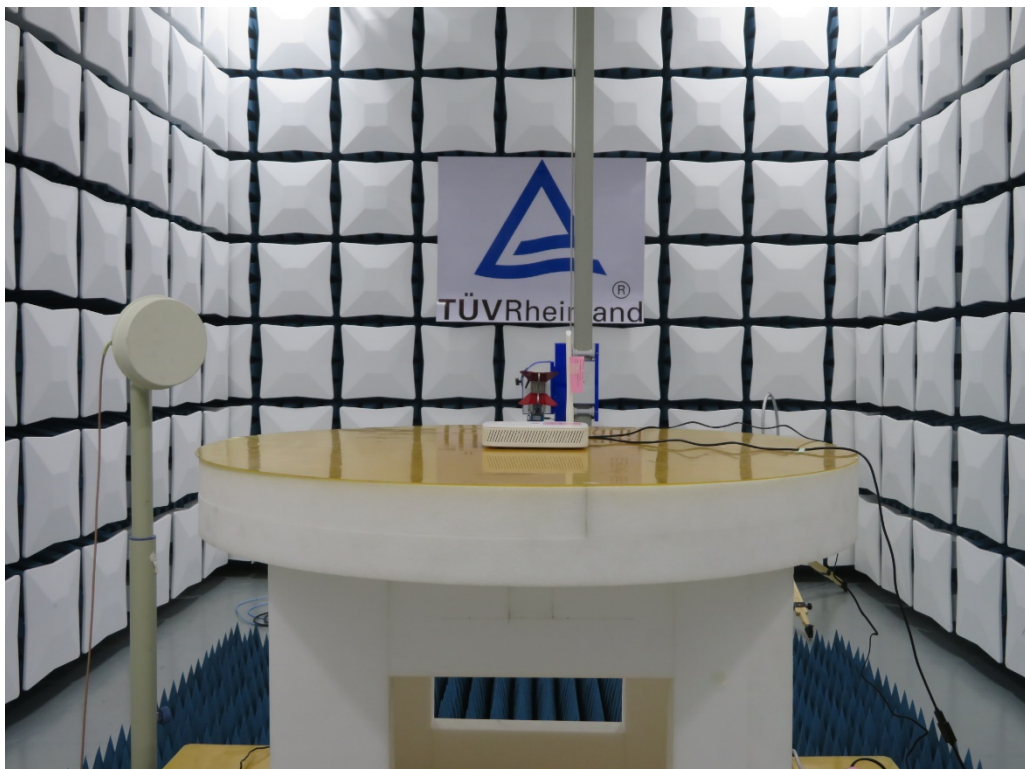
**Photograph 2: Set-up for Co-Located Radiated Spurious Emissions, above 1GHz**
