## Appendix B: photographs of test setup

## Appendix C: photographs of EUT

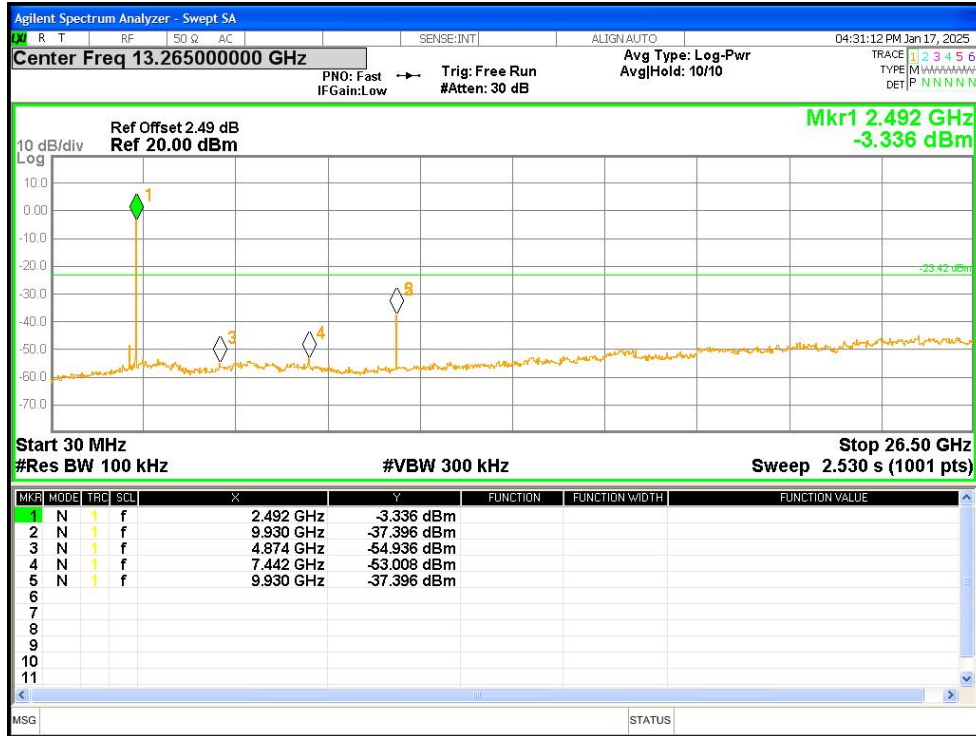
Tx. Spurious NVNT BLE 2M 2402MHz Ant1 Ref

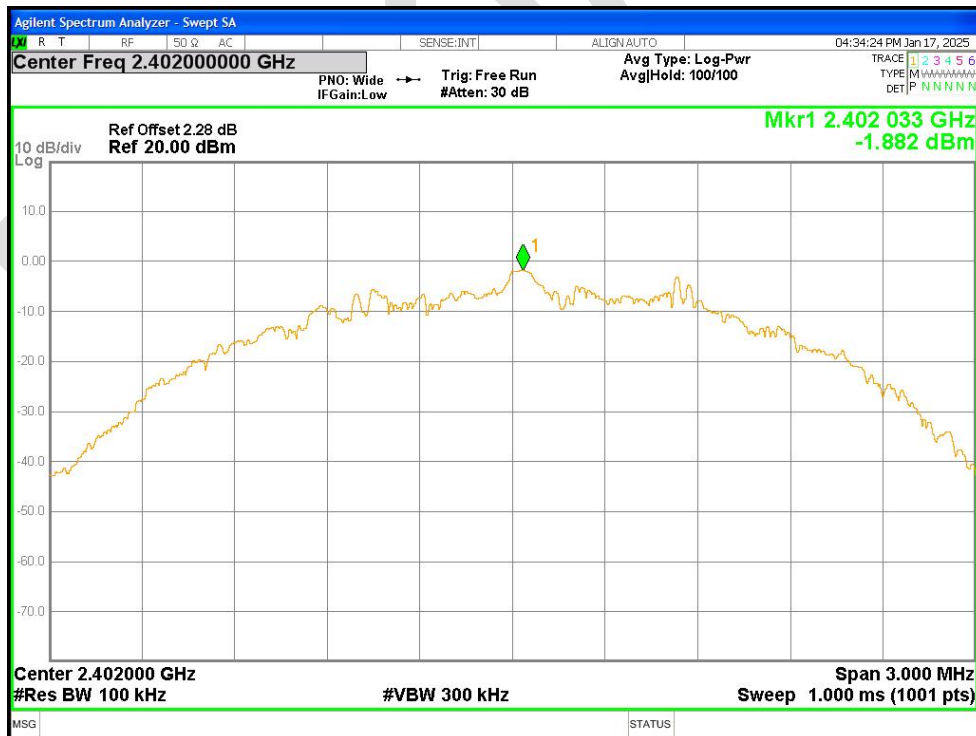
Tx. Spurious NVNT BLE 2M 2402MHz Ant1 Emission

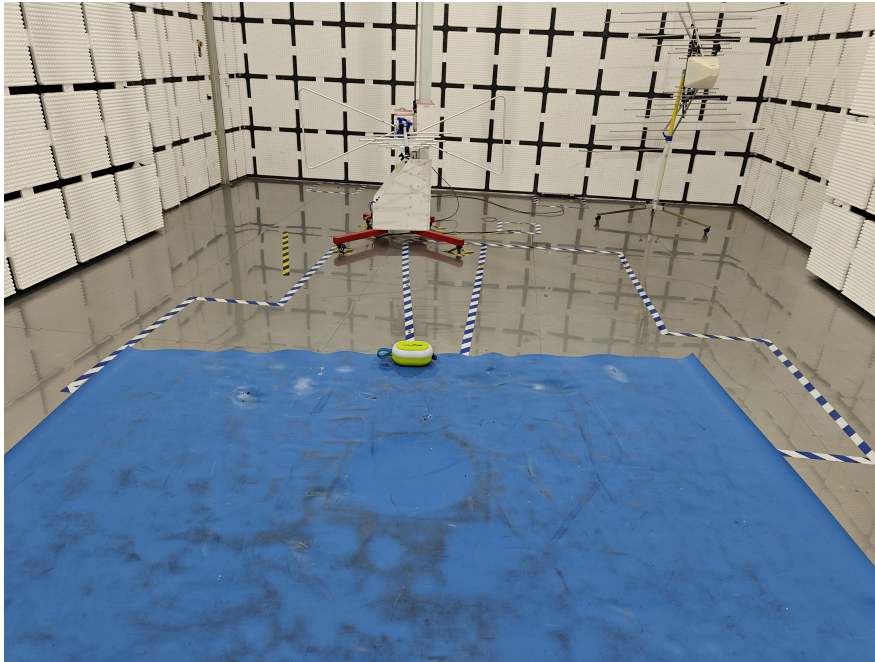
Radiated Emissions (30MHz-1GHz)

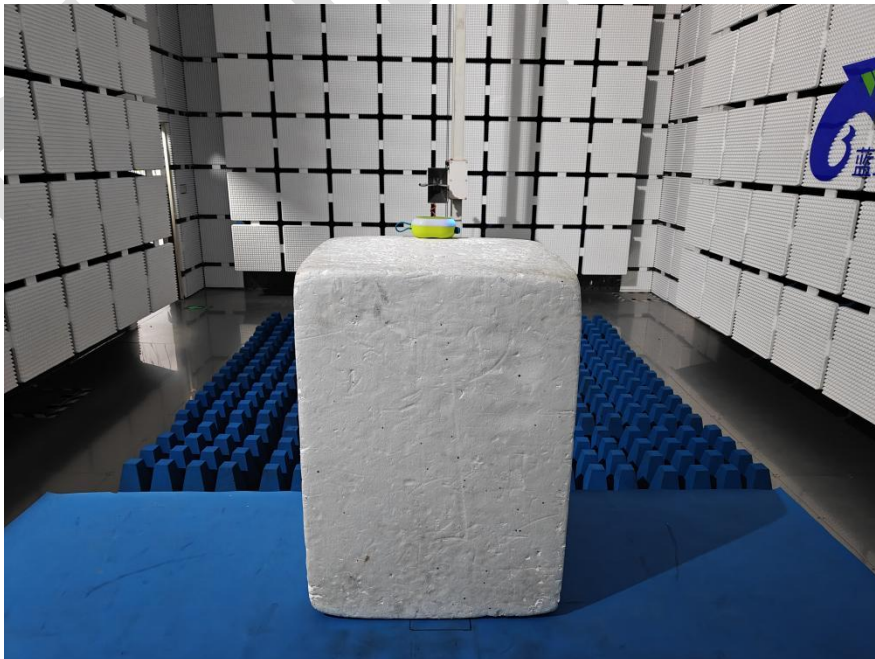
Radiated Emissions (above 1GHz)
