## APPENDIX A: PHOTOGRAPHS OF TEST SETUP

Reference to the test report No. BLA-EMC-202302-A4401

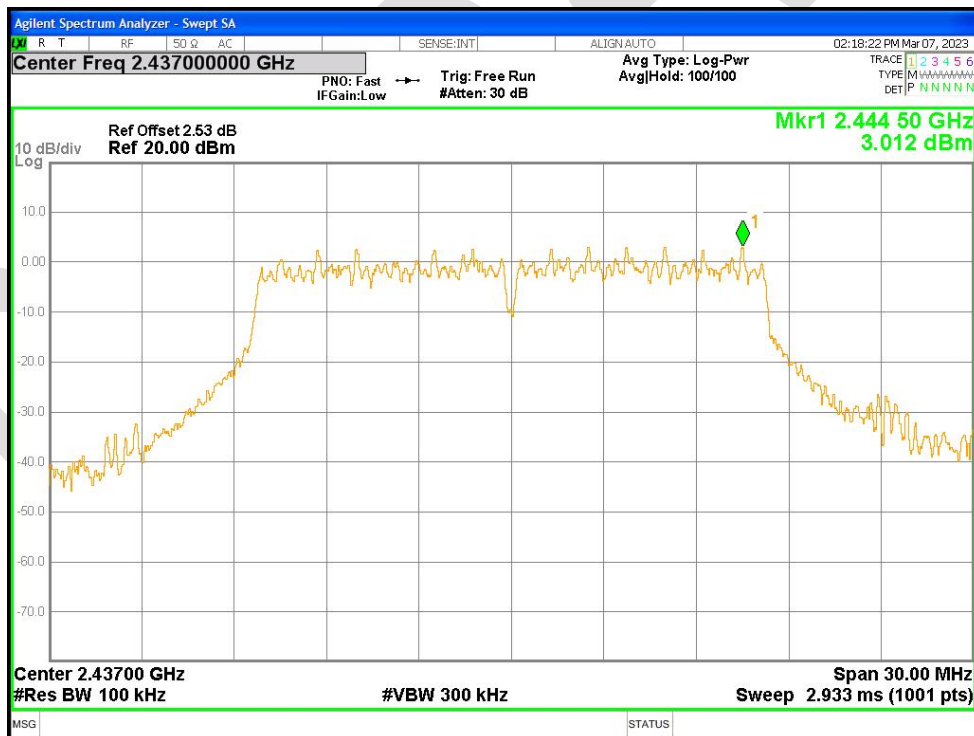
Tx. Spurious NVNT g 2437MHz Ant1 Emission

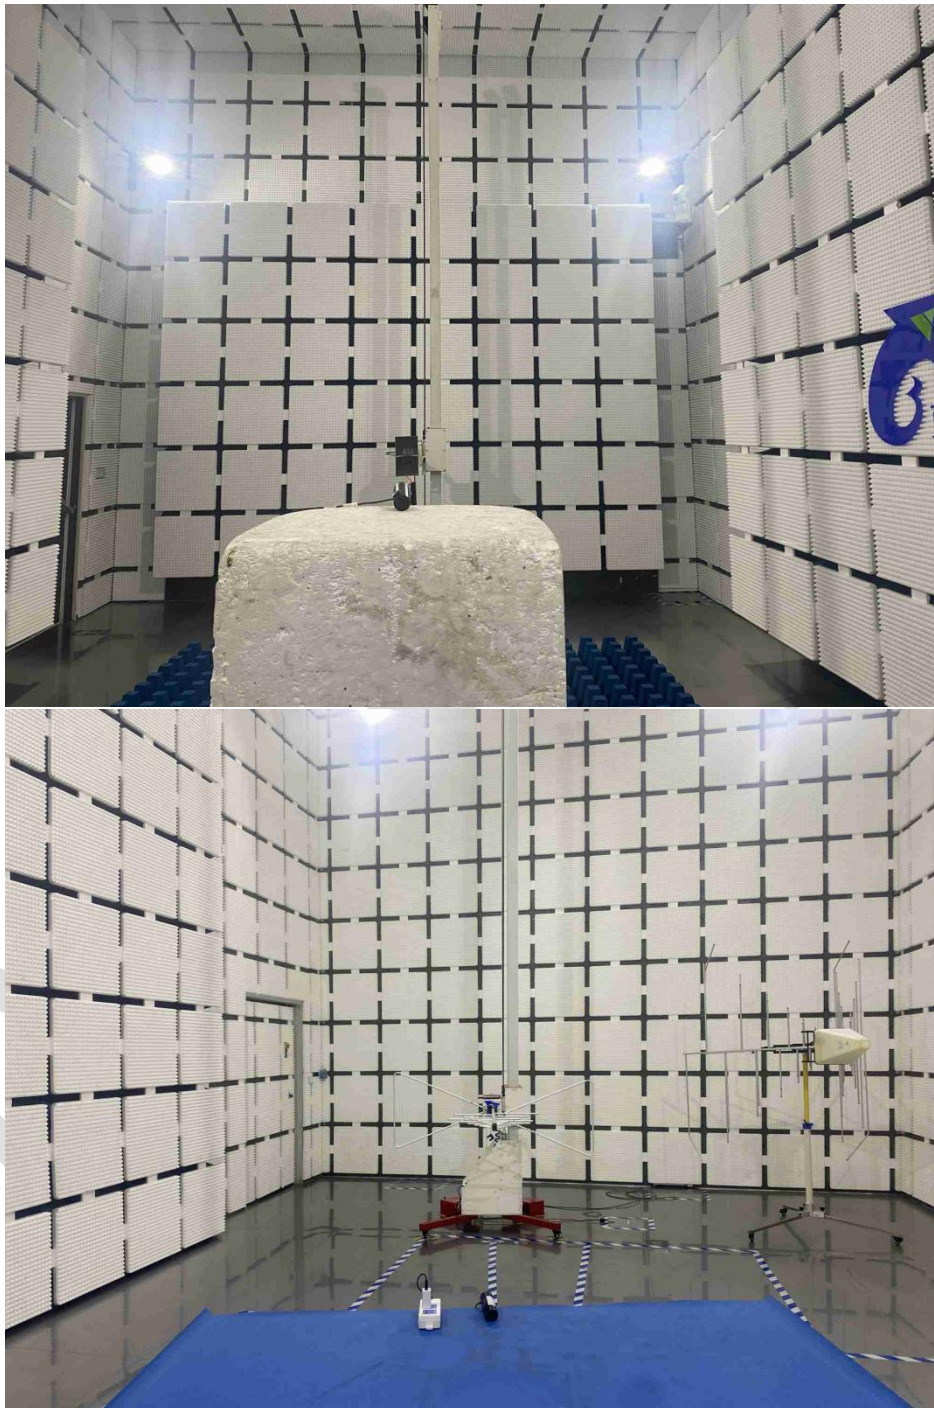
### Radiated Spurious Emissions

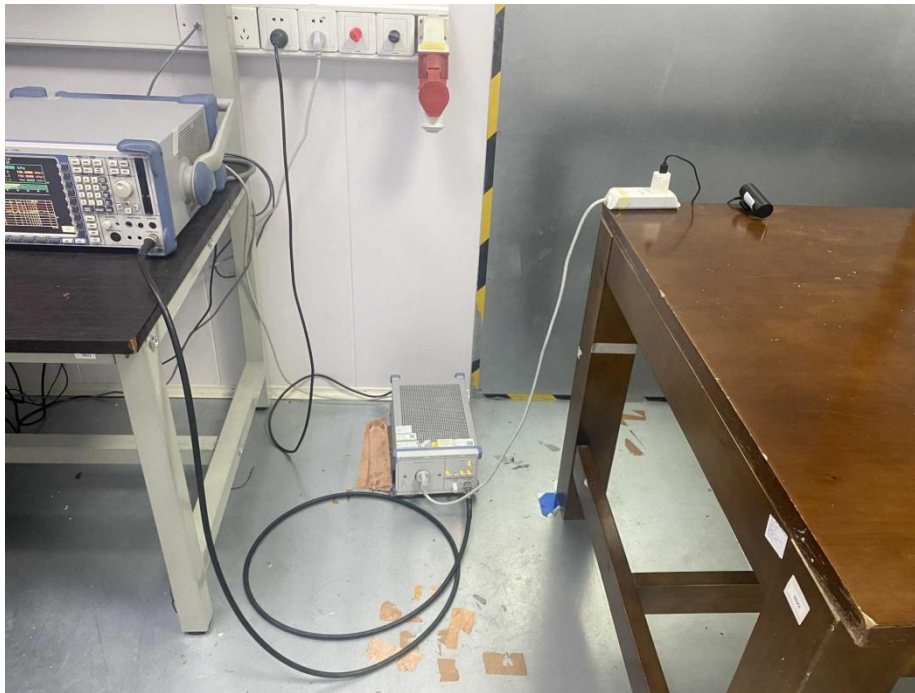
**Conducted Emissions at AC Power Line (150kHz-30MHz)**
