## APPENDIX A: PHOTOGRAPHS OF TEST SETUP

Reference to the test report No. BLA-EMC-202303-A12601

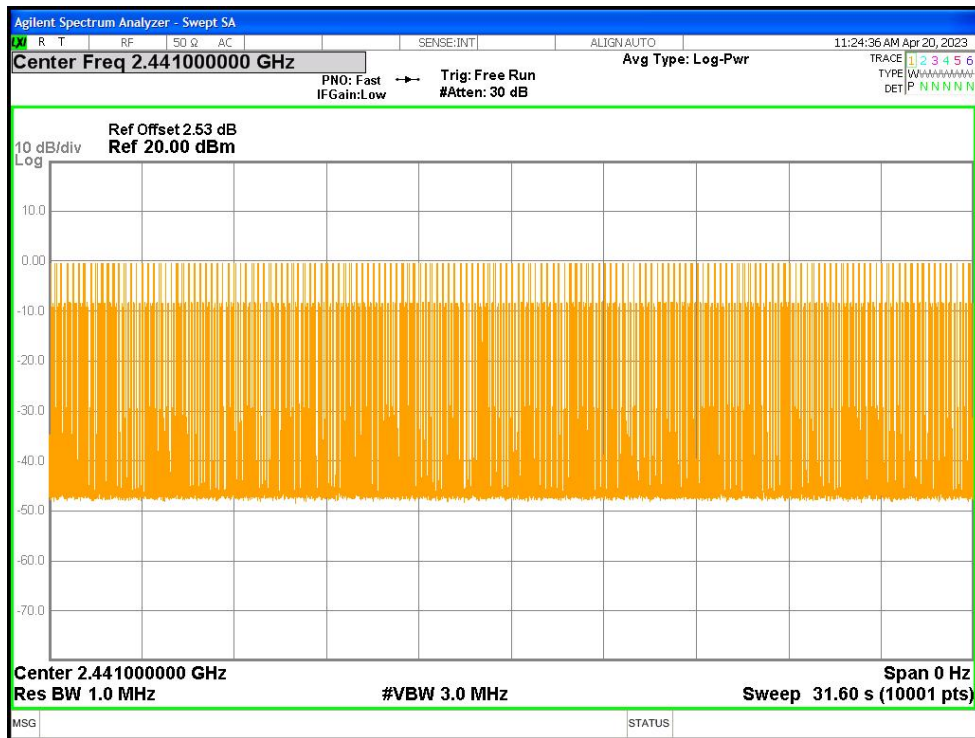
Dwell NVNT 1-DH3 2441MHz Ant1 One Burst

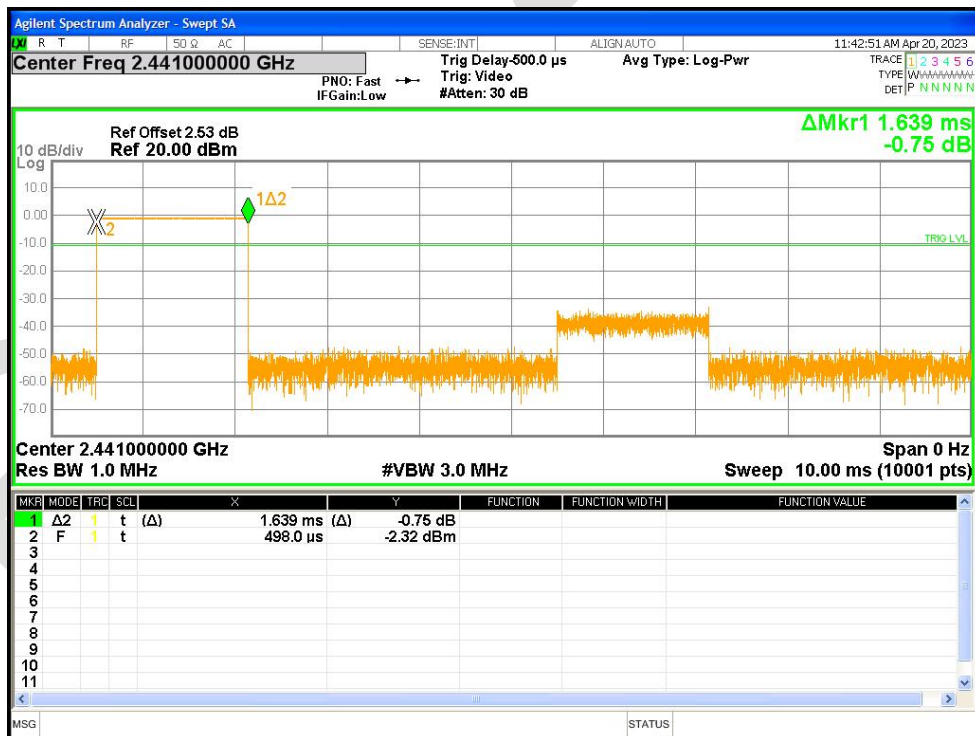
Dwell NVNT 1-DH3 2441MHz Ant1 Accumulated

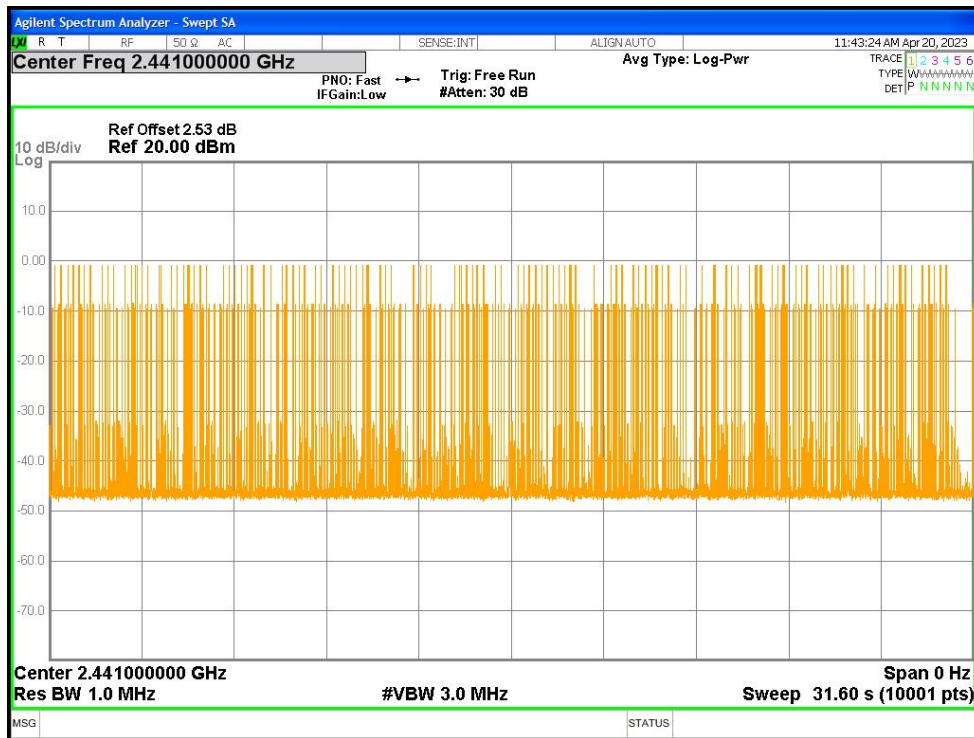
Dwell NVNT 1-DH5 2441MHz Ant1 One Burst

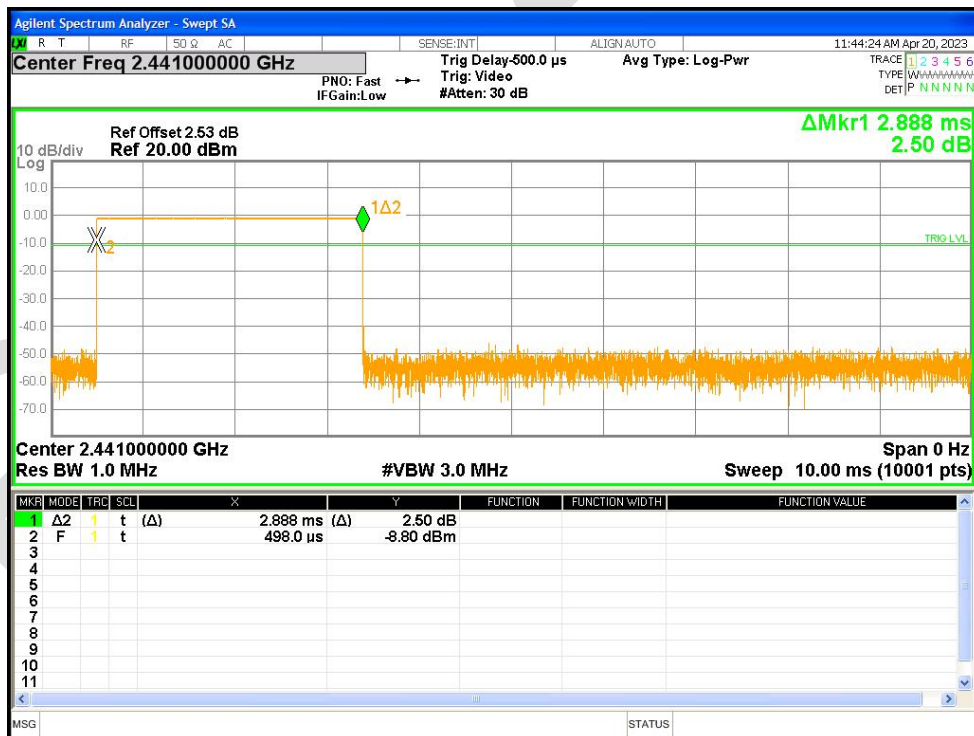
Dwell NVNT 1-DH5 2441MHz Ant1 Accumulated

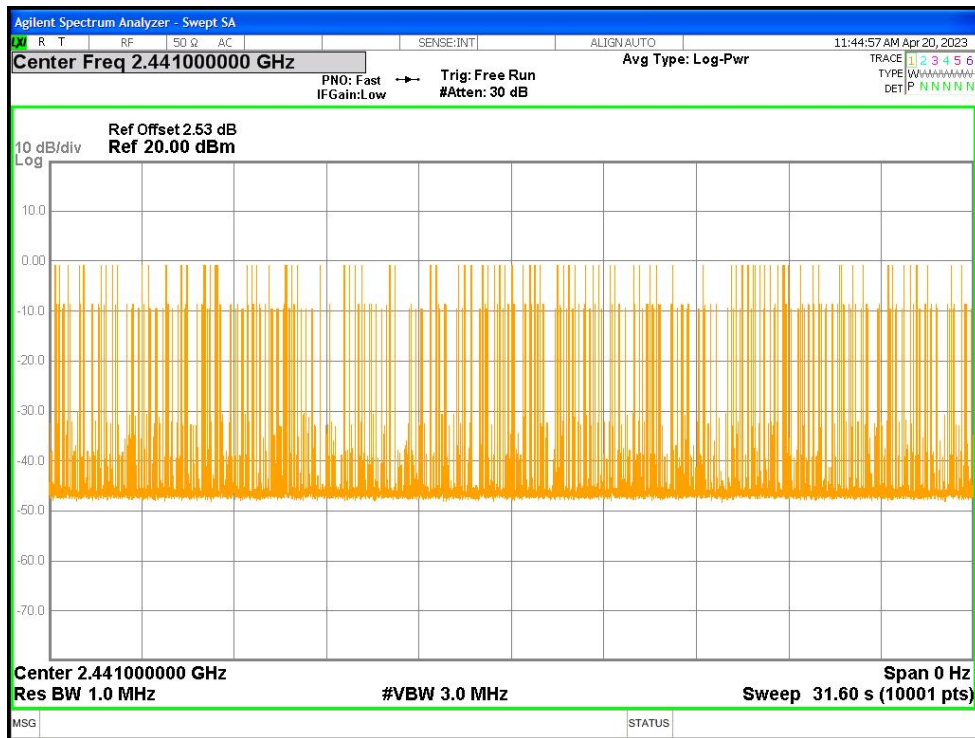
Dwell NVNT 2-DH5 2441MHz Ant1 One Burst

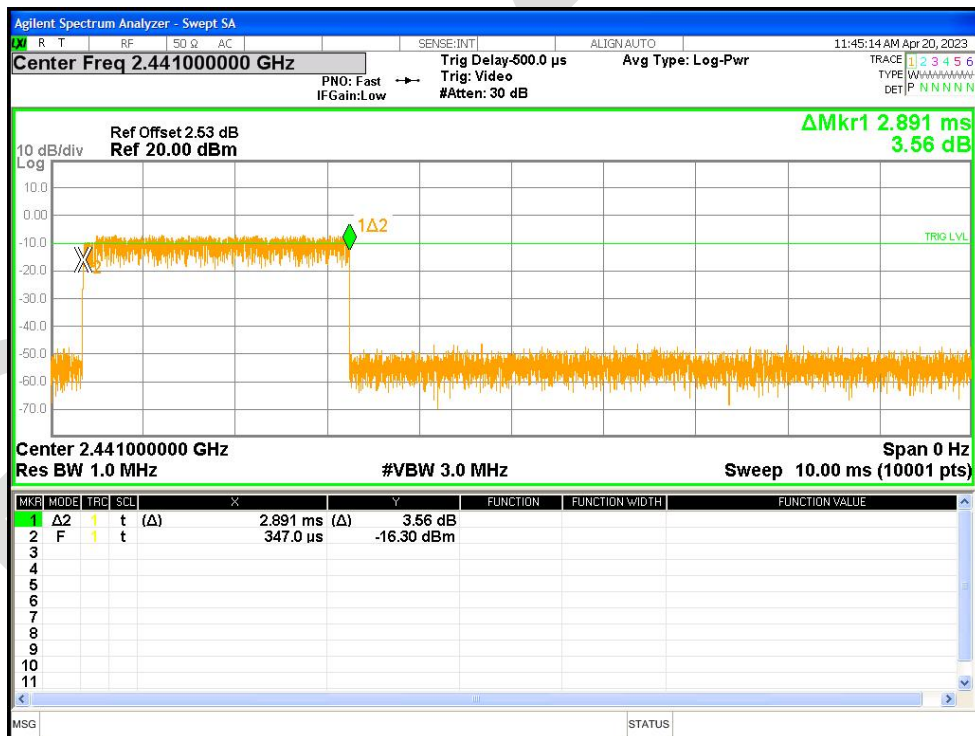
Dwell NVNT 2-DH5 2441MHz Ant1 Accumulated

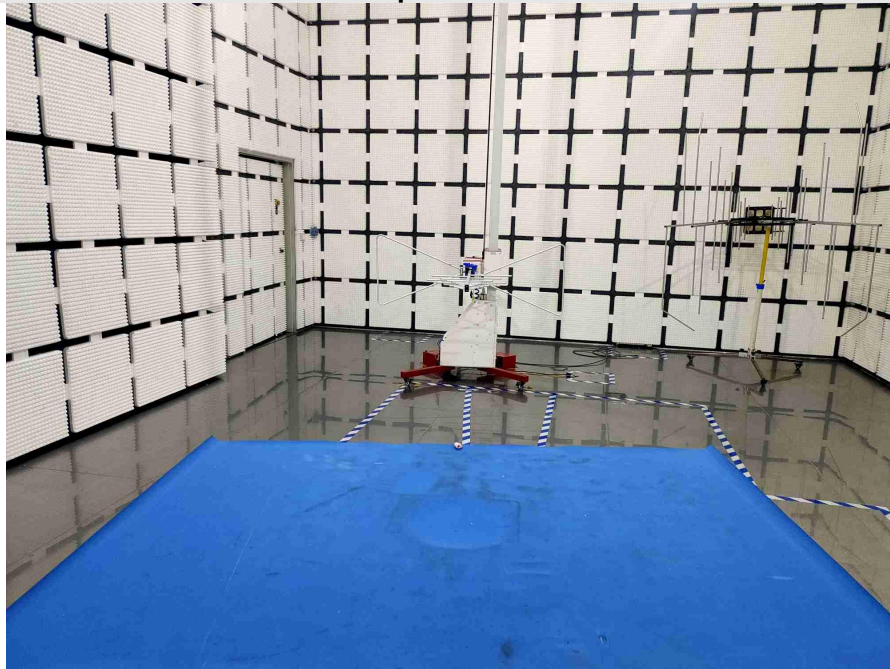
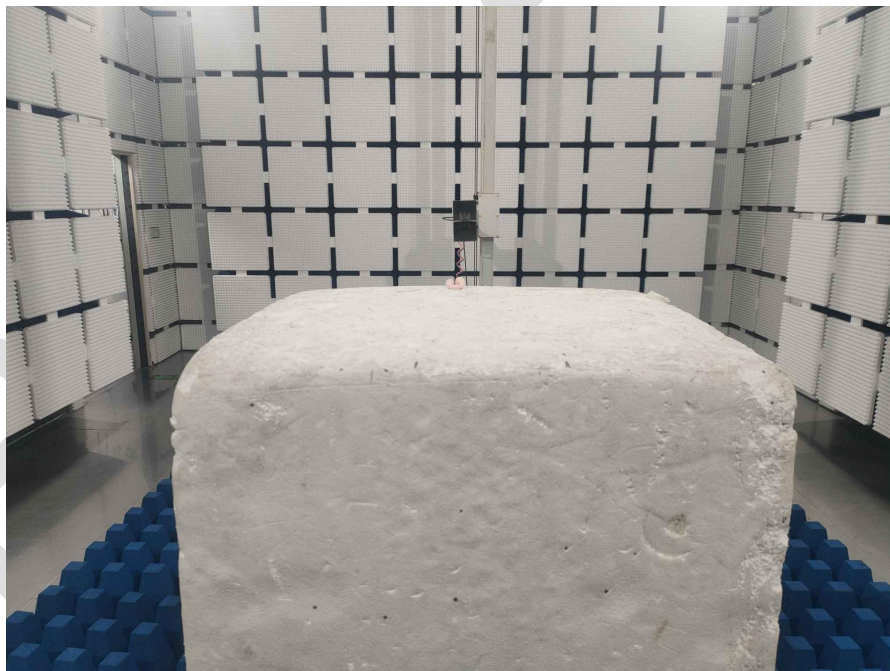
### Radiated Spurious Emissions

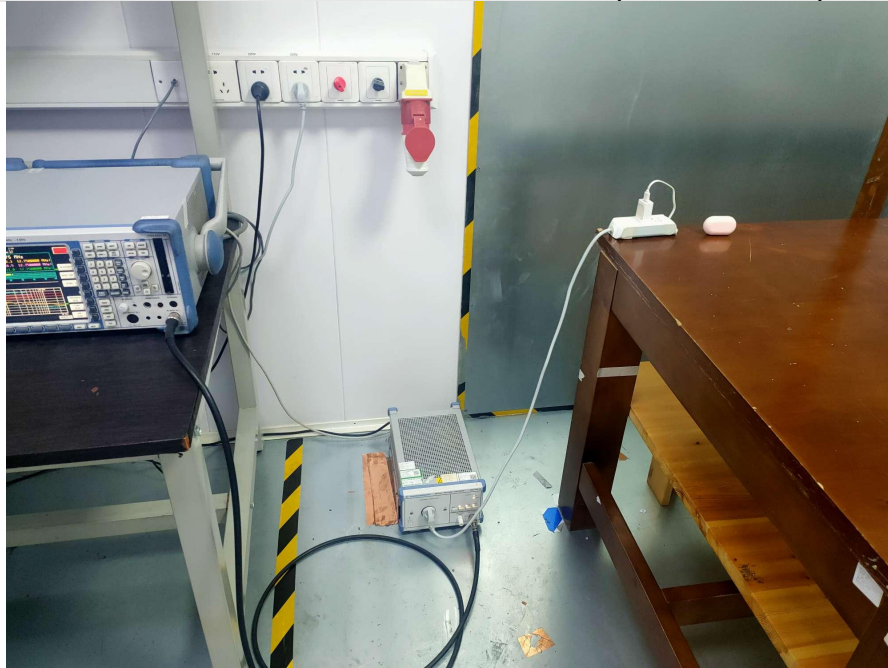
**Conducted Emissions at AC Power Line (150kHz-30MHz)**
