# Radiated Emission Measurement

Condition : FCC\_part 15E RE\_Above 1GHz\_PK

EUT : W6M22311-23090

Test Mode : TX 802.11n20 CH149

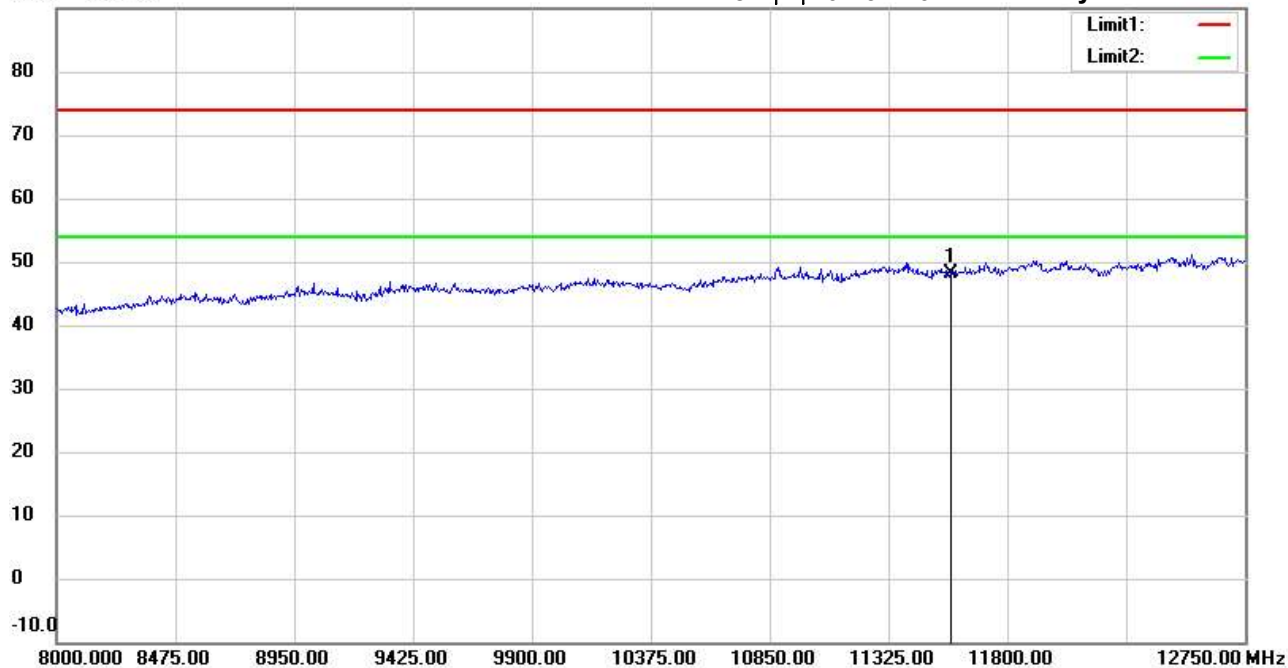
Data : #3

Test Mode : TX 802.11n20 CH157

Polarization: **Horizontal**

| Mk. | Frequency (MHz) | Reading (dBuV) | Detector | Corr. factor (dB/m) | Result (dBuV/m) | Limit (dBuV/m) | Ant.Pos (cm) | Tab.Pos (deg.) | Margin (dB) | Comment |
|---|---|---|---|---|---|---|---|---|---|---|
| * | 11570.000 | 31.43 | peak | 16.60 | 48.03 | 74.00 | 150 | 337 | -25.97 | |

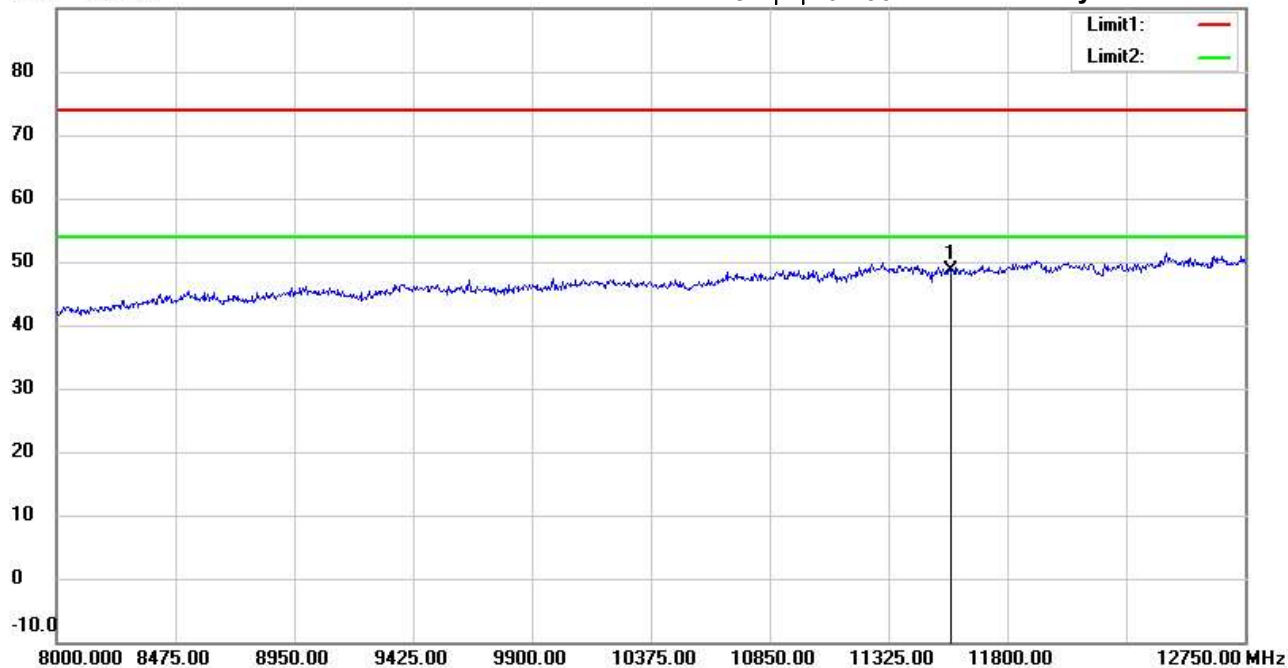
Data :#9

Test Mode : TX 802.11n20 CH157

Polarization: **Vertical**

| Mk. | Frequency (MHz) | Reading (dBuV) | Detector | Corr. factor (dB/m) | Result (dBuV/m) | Limit (dBuV/m) | Ant.Pos (cm) | Tab.Pos (deg.) | Margin (dB) | Comment |
|---|---|---|---|---|---|---|---|---|---|---|
| * | 11570.000 | 32.00 | peak | 16.60 | 48.60 | 74.00 | 150 | 10 | -25.40 | |

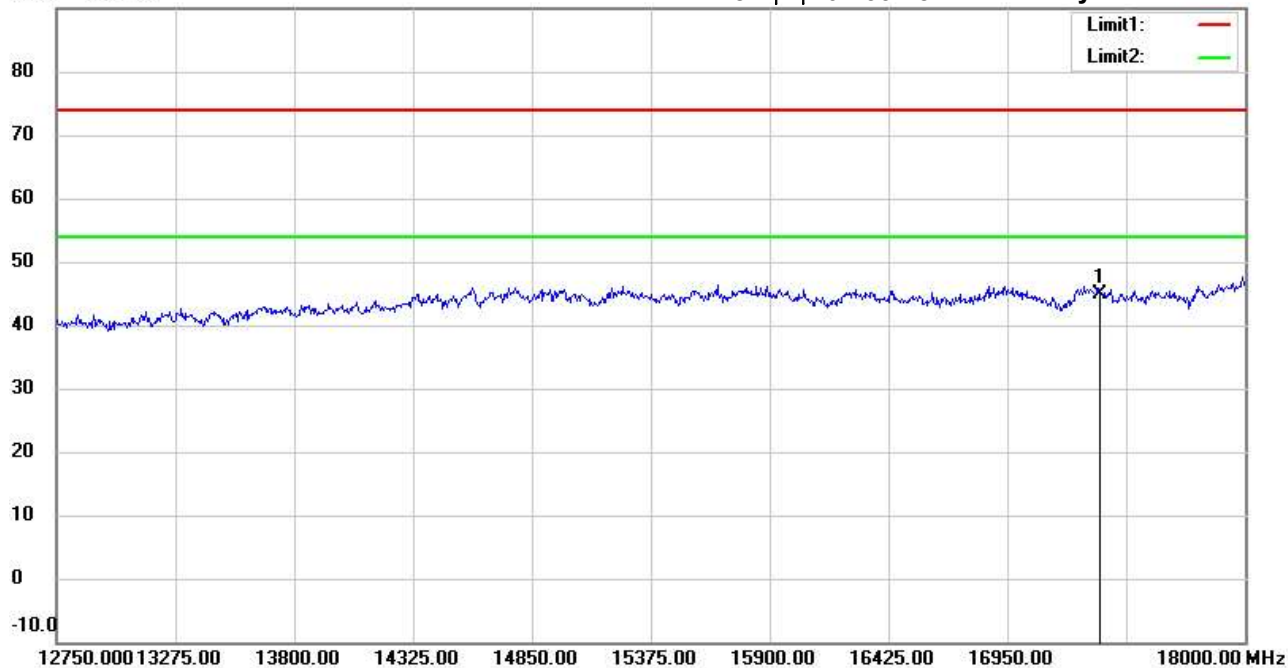
Data : #4

Test Mode : TX 802.11n20 CH157

Polarization: **Horizontal**

| Mk. | Frequency (MHz) | Reading (dBuV) | Detector | Corr. factor (dB/m) | Result (dBuV/m) | Limit (dBuV/m) | Ant.Pos (cm) | Tab.Pos (deg.) | Margin (dB) | Comment |
|---|---|---|---|---|---|---|---|---|---|---|
| * | 17355.000 | 20.92 | peak | 23.97 | 44.89 | 74.00 | 150 | 12 | -29.11 | |

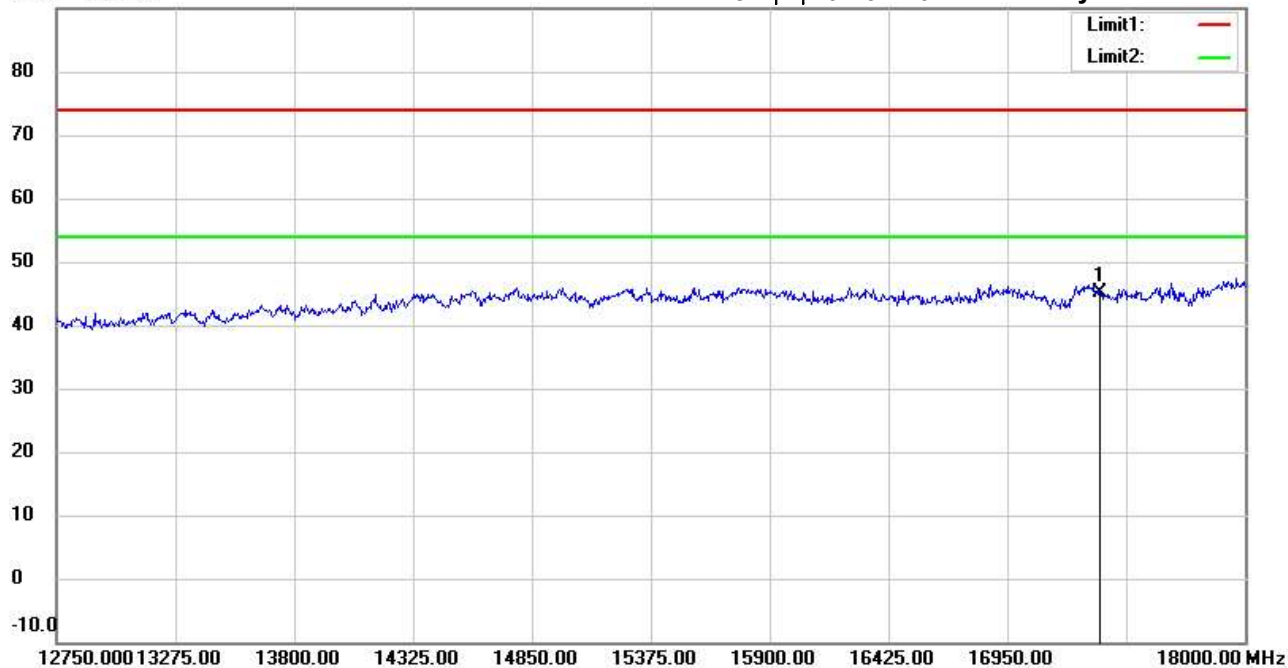
Data : #10

Test Mode : TX 802.11n20 CH157

Polarization: Vertical

| Mk. | Frequency (MHz) | Reading (dBuV) | Detector | Corr. factor (dB/m) | Result (dBuV/m) | Limit (dBuV/m) | Ant.Pos (cm) | Tab.Pos (deg.) | Margin (dB) | Comment |
|---|---|---|---|---|---|---|---|---|---|---|
| * | 17355.000 | 21.07 | peak | 23.97 | 45.04 | 74.00 | 150 | 27 | -28.96 | |

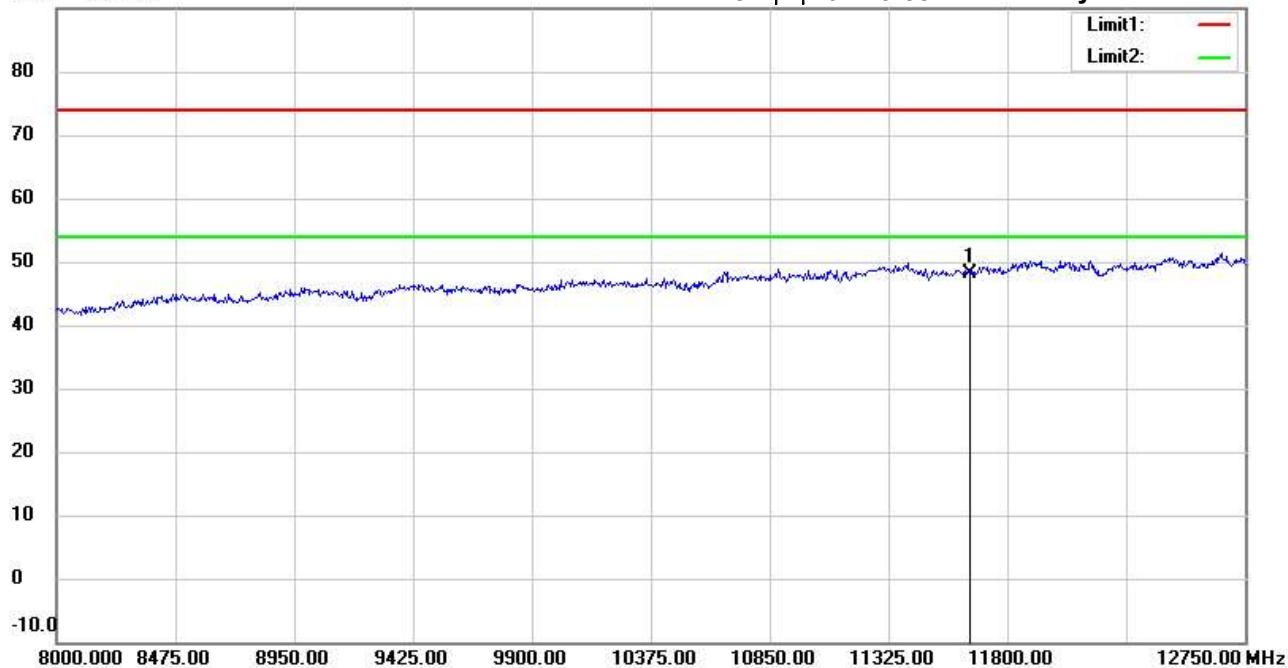
Data : #3

Test Mode : TX 802.11n20 CH165

Polarization: **Horizontal**

| Mk. | Frequency (MHz) | Reading (dBuV) | Detector | Corr. factor (dB/m) | Result (dBuV/m) | Limit (dBuV/m) | Ant.Pos (cm) | Tab.Pos (deg.) | Margin (dB) | Comment |
|---|---|---|---|---|---|---|---|---|---|---|
| * | 11650.000 | 31.73 | peak | 16.48 | 48.21 | 74.00 | 150 | 260 | -25.79 | |

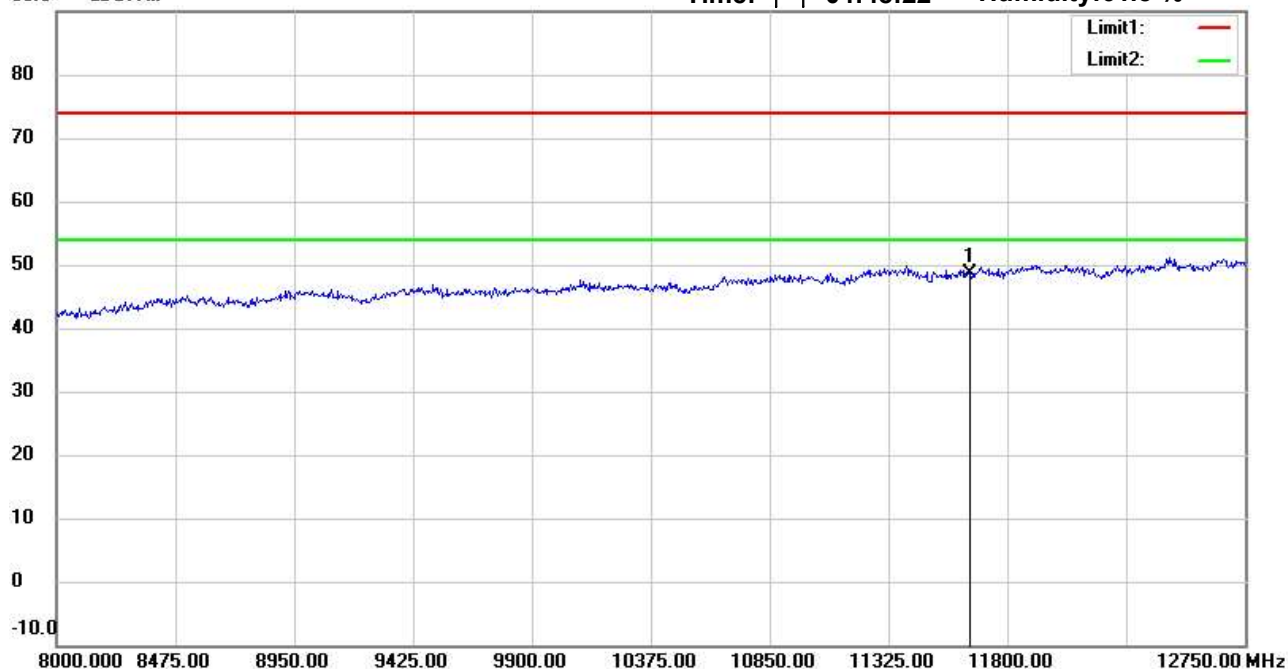
Data : #9

Test Mode : TX 802.11n20 CH165

Polarization: **Vertical**

| Mk. | Frequency (MHz) | Reading (dBuV) | Detector | Corr. factor (dB/m) | Result (dBuV/m) | Limit (dBuV/m) | Ant.Pos (cm) | Tab.Pos (deg.) | Margin (dB) | Comment |
|---|---|---|---|---|---|---|---|---|---|---|
| * | 11650.000 | 32.07 | peak | 16.48 | 48.55 | 74.00 | 150 | 254 | -25.45 | |

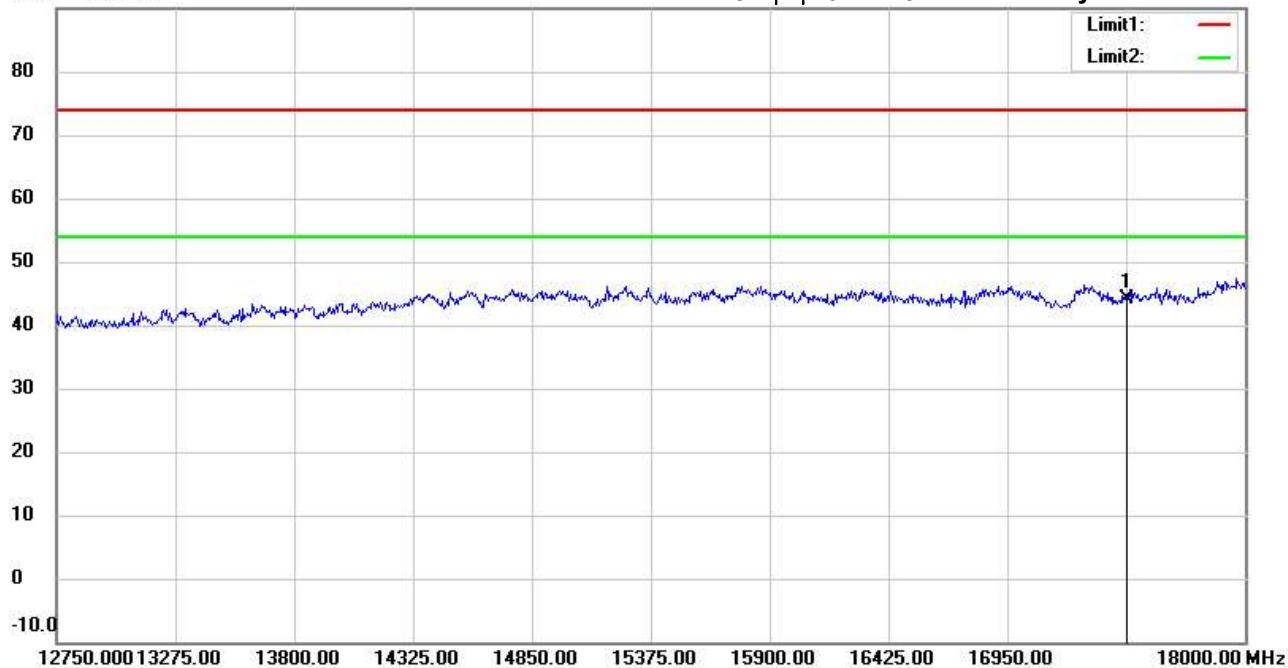
Data : #4

Test Mode : TX 802.11n20 CH165

Polarization: **Horizontal**

| Mk. | Frequency (MHz) | Reading (dBuV) | Detector | Corr. factor (dB/m) | Result (dBuV/m) | Limit (dBuV/m) | Ant.Pos (cm) | Tab.Pos (deg.) | Margin (dB) | Comment |
|---|---|---|---|---|---|---|---|---|---|---|
| * | 17475.000 | 20.87 | peak | 23.21 | 44.08 | 74.00 | 150 | 83 | -29.92 | |

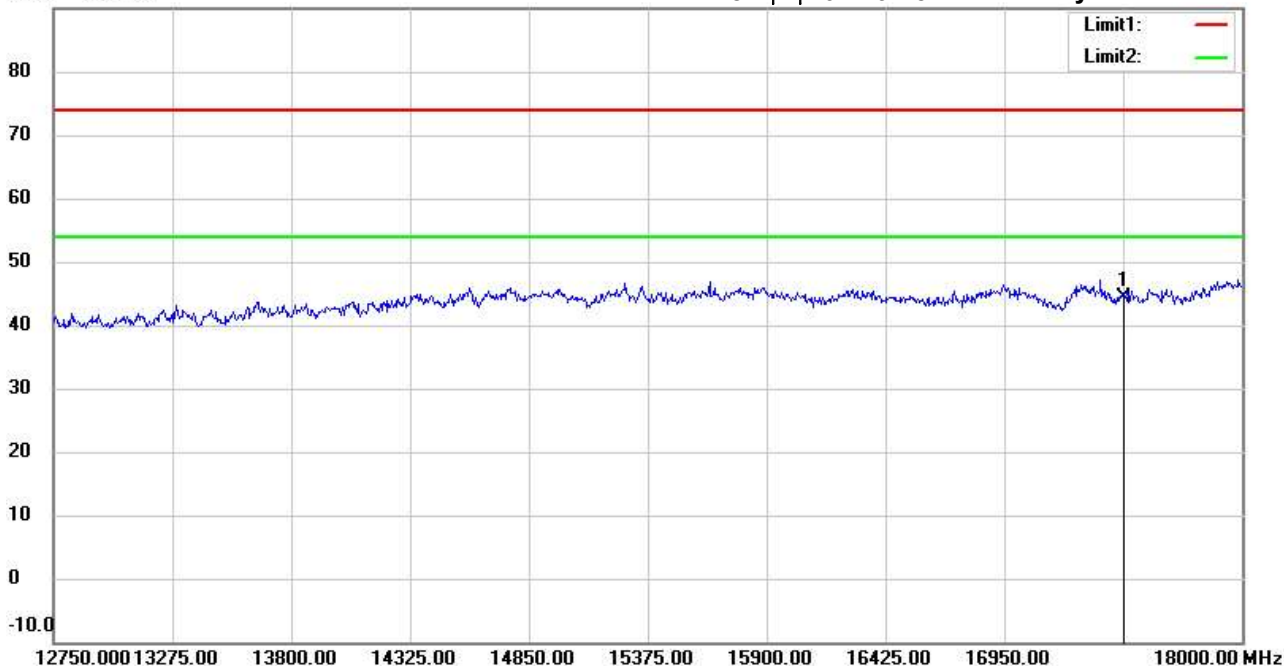
Data : #10

Test Mode : TX 802.11n20 CH165

Polarization: Vertical

| Mk. | Frequency (MHz) | Reading (dBuV) | Detector | Corr. factor (dB/m) | Result (dBuV/m) | Limit (dBuV/m) | Ant.Pos (cm) | Tab.Pos (deg.) | Margin (dB) | Comment |
|---|---|---|---|---|---|---|---|---|---|---|
| * | 17475.000 | 21.14 | peak | 23.21 | 44.35 | 74.00 | 150 | 168 | -29.65 | |
